**To:** Ian Toovey  
**Cc:** davidw@evansbuilt.com.au; Rodney Carsburg  
**Subject:** RE: Site Inspection 22.07  
**Attachments:** 2021.05.14 - Cof - CBR.pdf; 2021.05.14 - Cof - QOM,EMC.pdf; VW004 Variation Charge Sheet .pdf; Proof Roll 28.07.21.pdf; Balmoral Unsuitable Volume

## Variation Charge Sheet

| <b>DESCRIPTION</b> | Remove and replace unsuitable material in Bldg pad | | |

| <b>Project:</b> | Site Works | <b>Project Number:</b> | 2624/P/1157 |

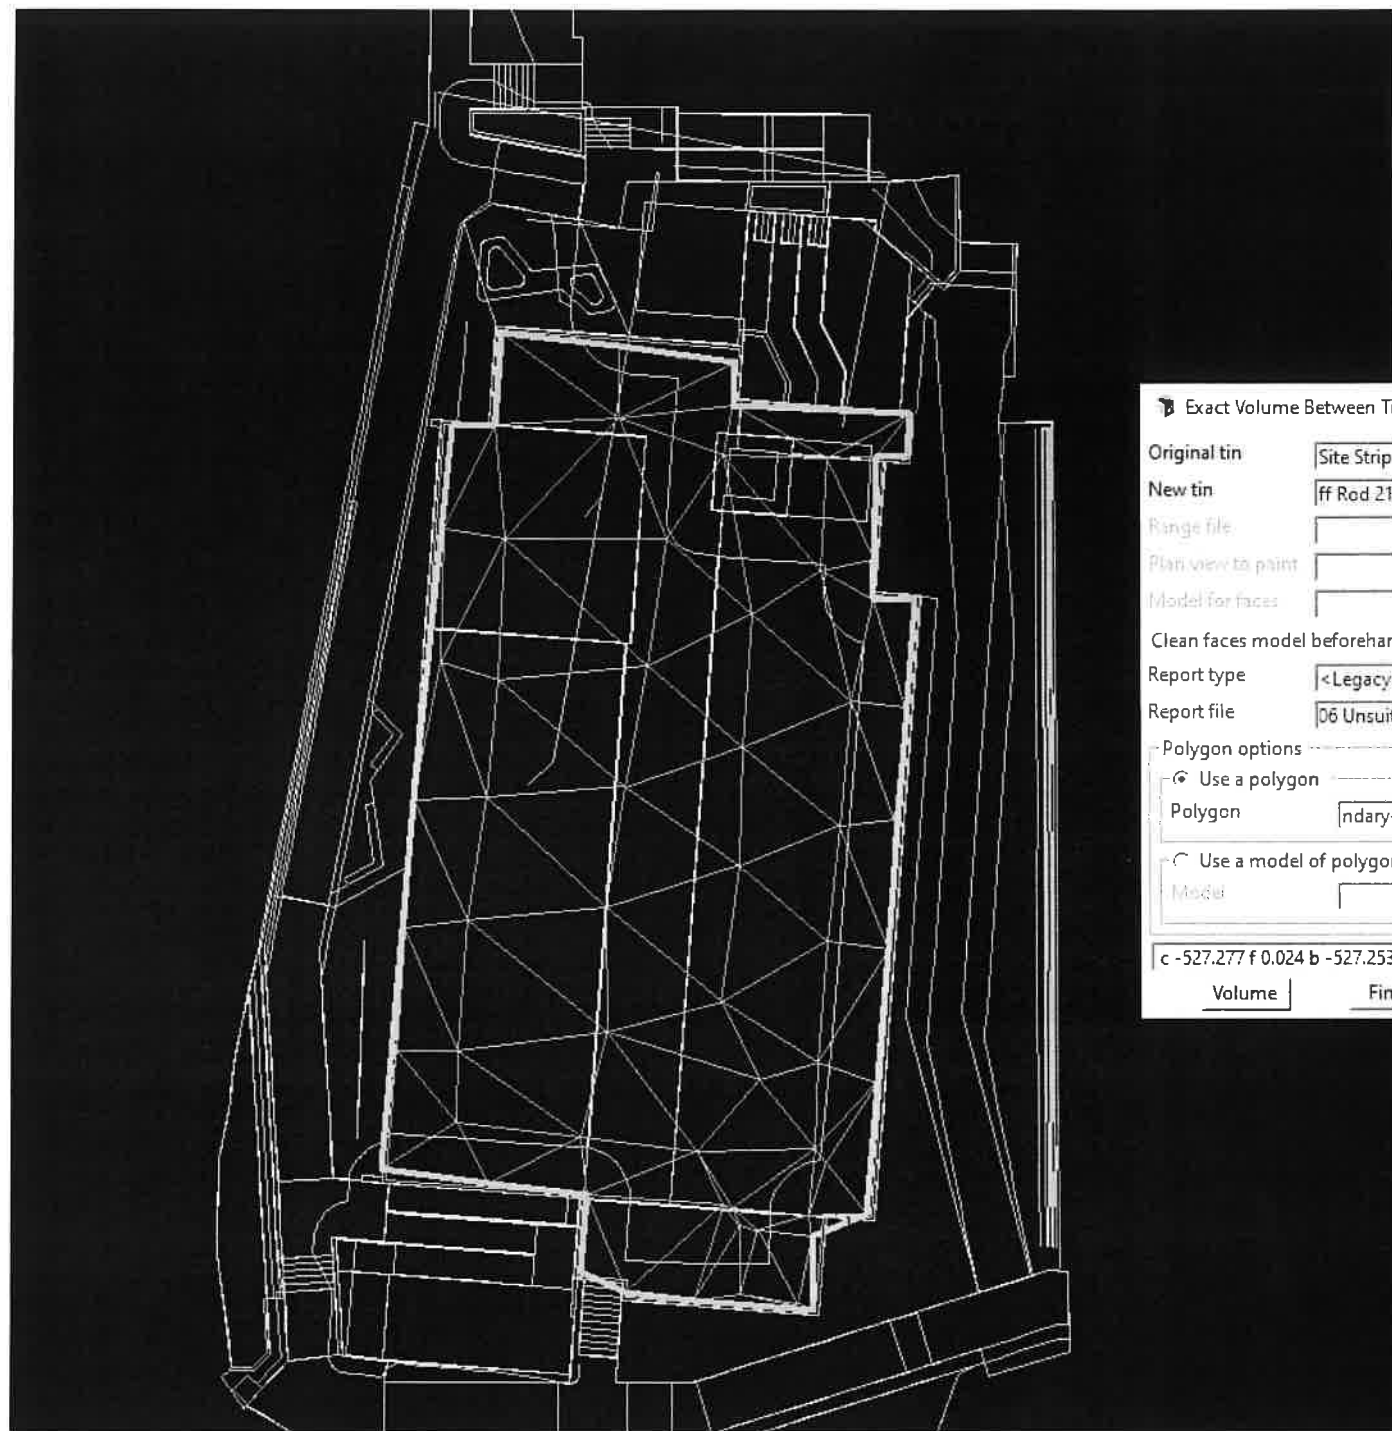
Site Strip 100mm to your Unsuitable Pickup from 29/7/21

Total cut           -527.277  
Total fill            0.024  
Total balance       -527.253  
ie excess of cut over fill    527.253m<sup>3</sup>

Polygon plan area = 802.499<sup>2</sup>

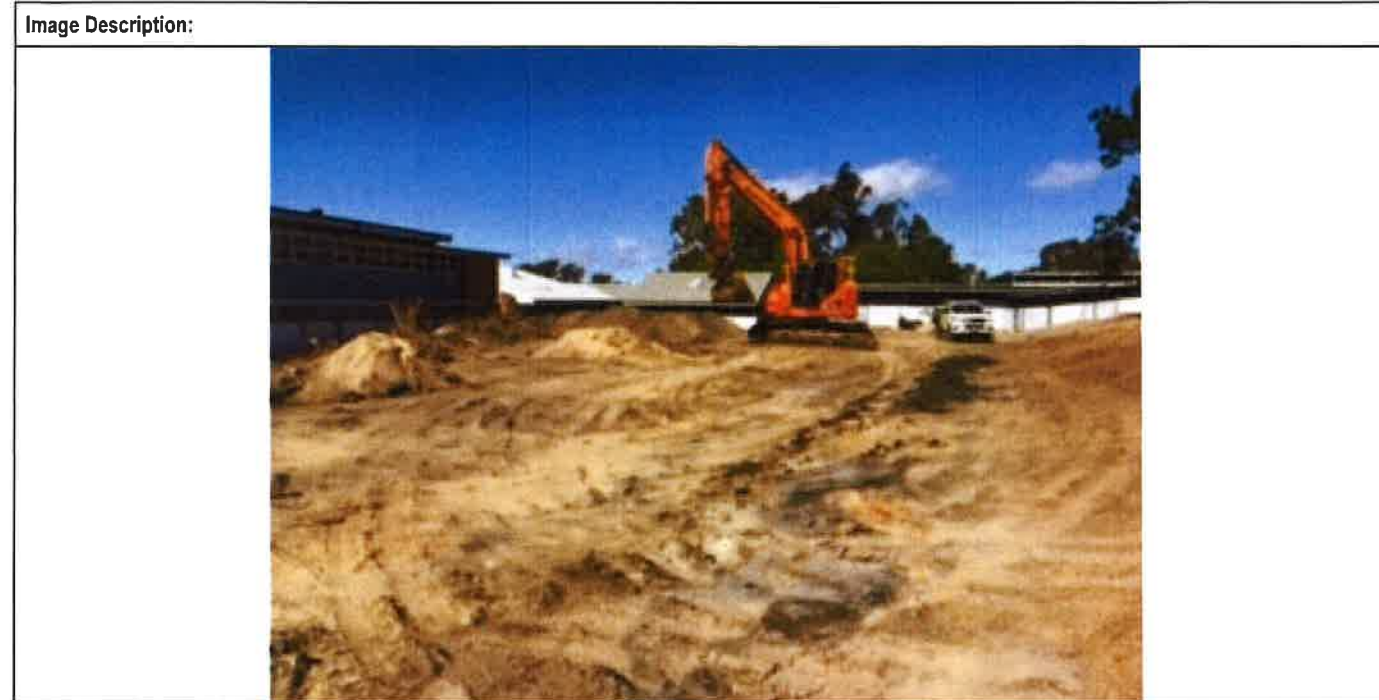
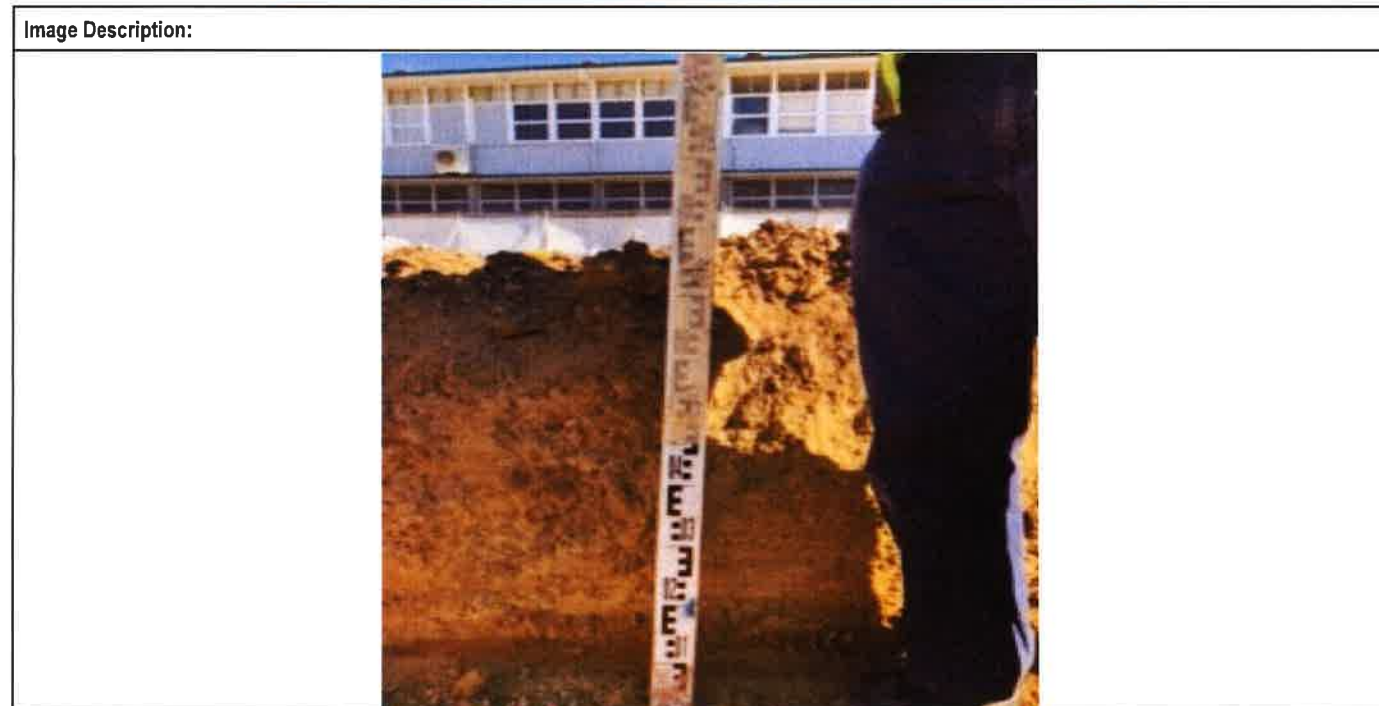
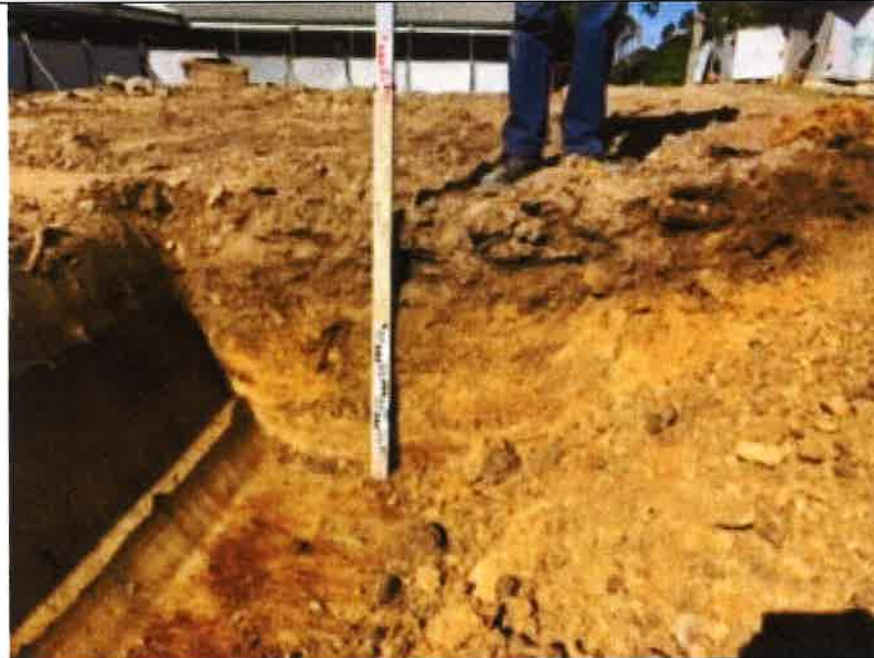
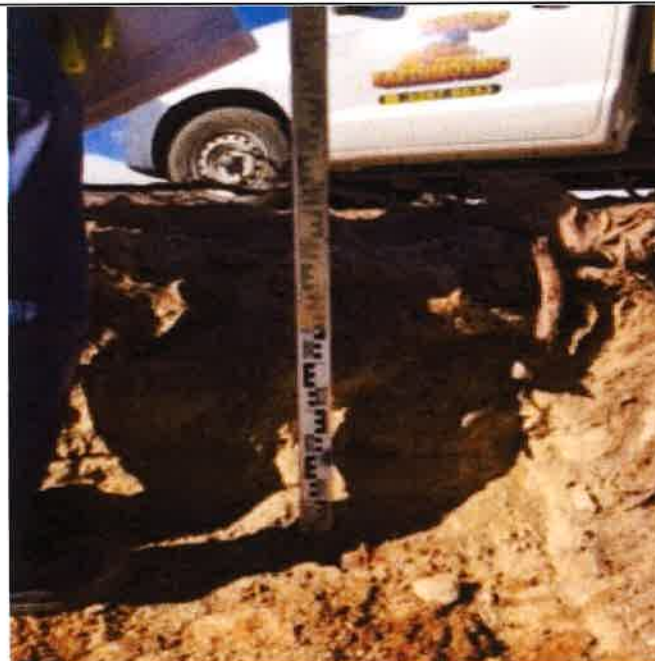
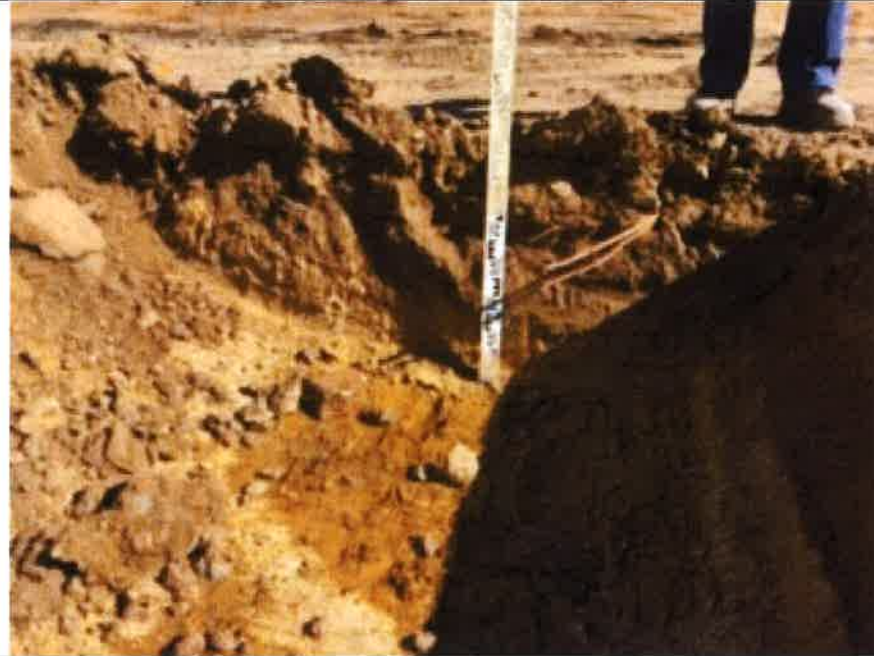
| | <b>Result:</b> | Inspection carried out to determine extent of uncontrolled fill on site.<br>A number of test pits were excavated across the site. the depth of uncontrolled fill was determined to be approx 600-700mm, this aligns with the BH report from Soil Surveys. | |

| <b>Corrective Action Details</b> | The uncontrolled fill will have to be removed to expose the natural ground to conduct a proof roll before fill can be reinstated on the site under level 1 supervision. | | | | |

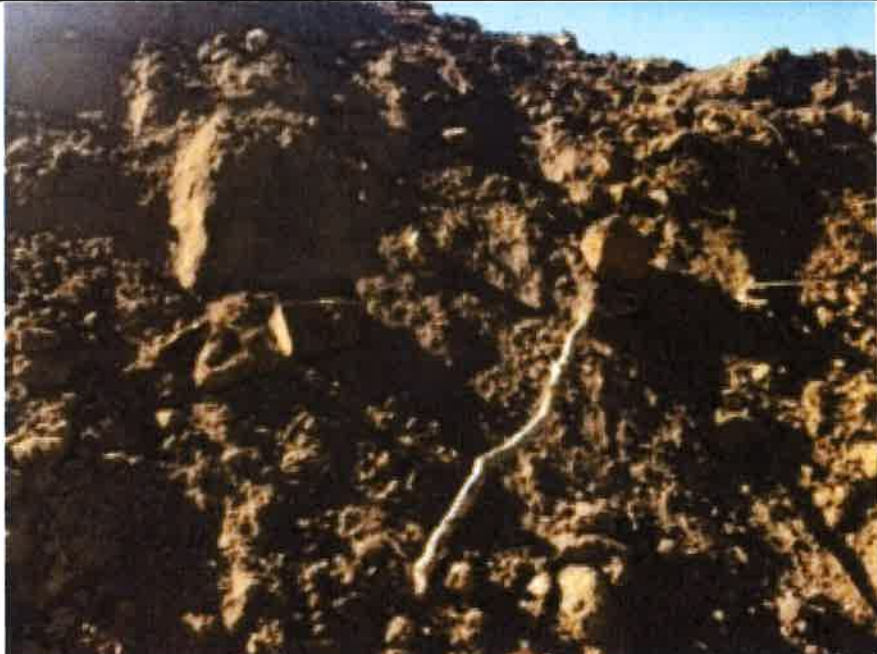
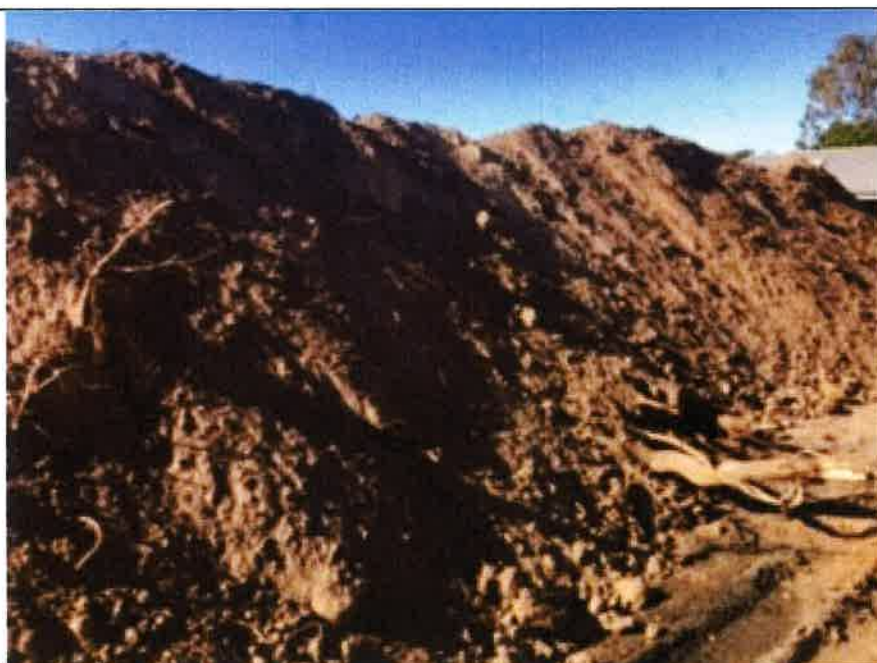
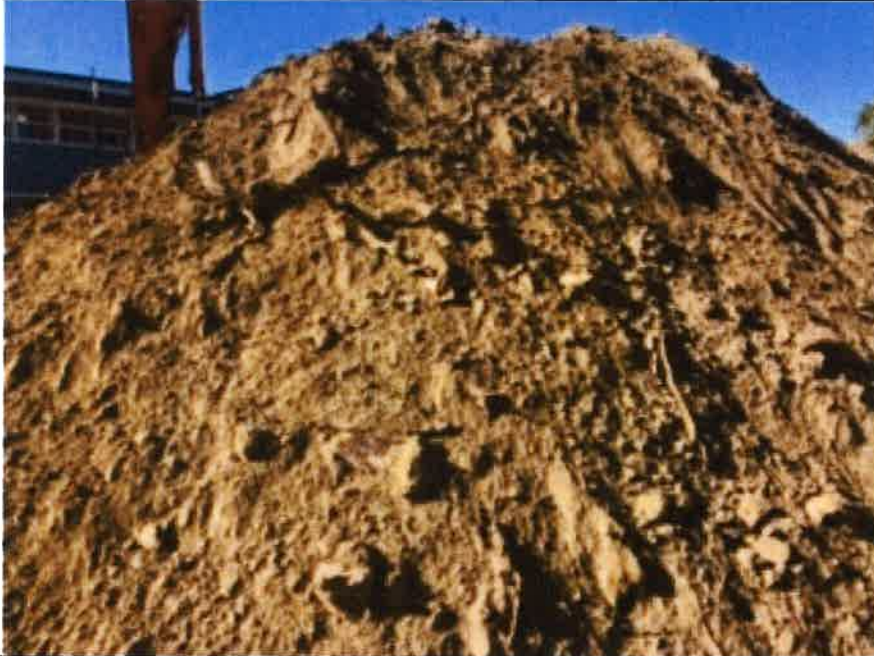
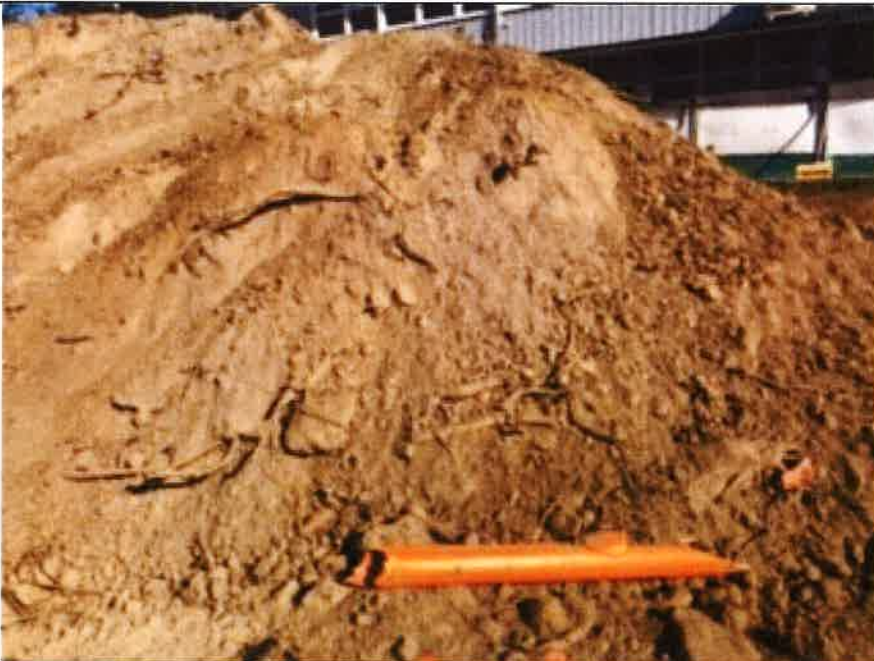
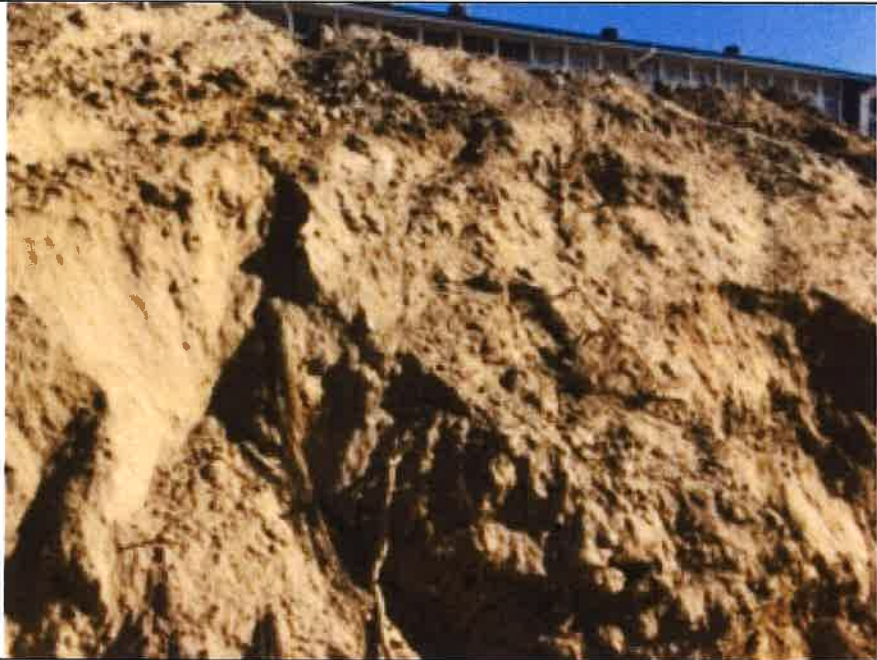
| | <b>Result:</b> | Inspection to determine suitability of on site material for reinstatement as fill.<br>The stockpile inspected on site showed to have large volumes of topsoil, severely root-affected subsoils and peat. Other contaminants such as wood, metal, plastic, and building waste were also observed. As per AS 3798 section 4.3 (a), (f) The stockpiled material is unsuitable to be used in structural fill areas. | |

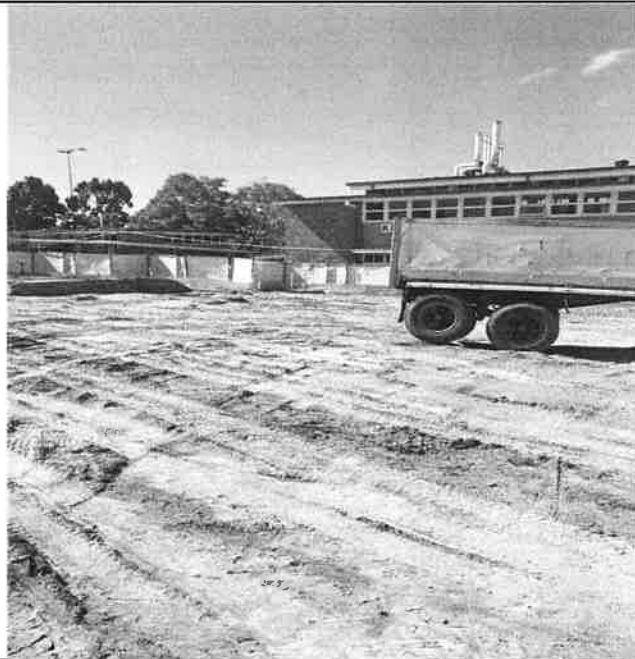
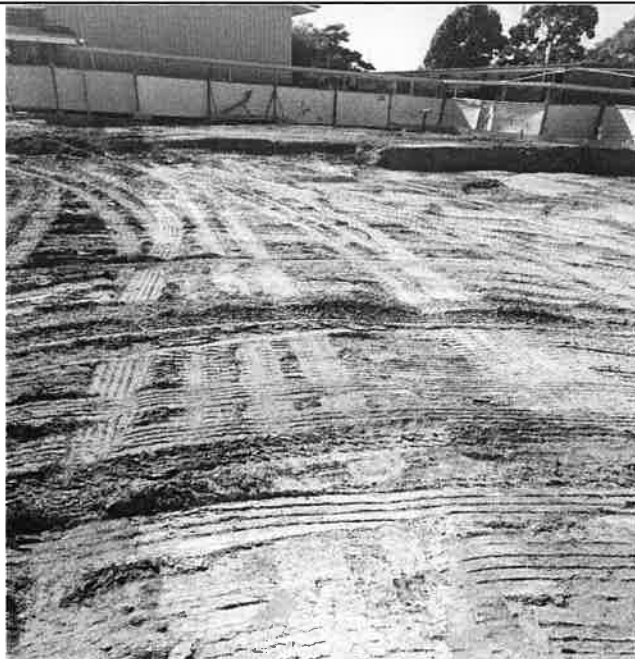
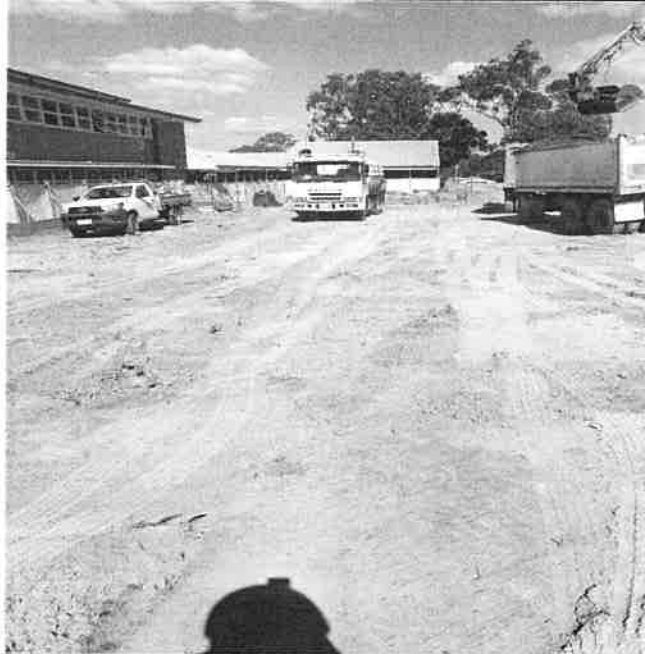
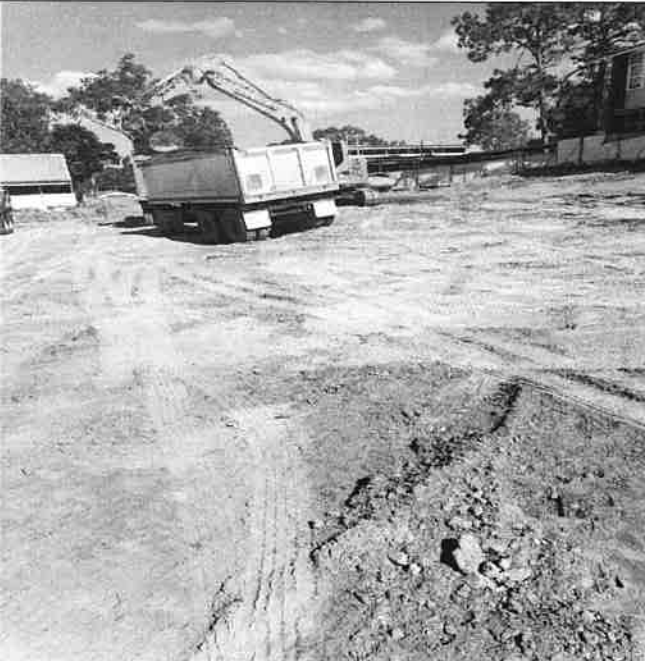
| | <b>Result:</b> | The area was compacted prior to inspection, some loose material visible during inspection. |
