## New Construction Inspection - Handover Stage (QLD)

Inspection Date: Mon, 29 Apr 2019

Property Address: Lot 16 Dell Street, Rochdale Qld 4123

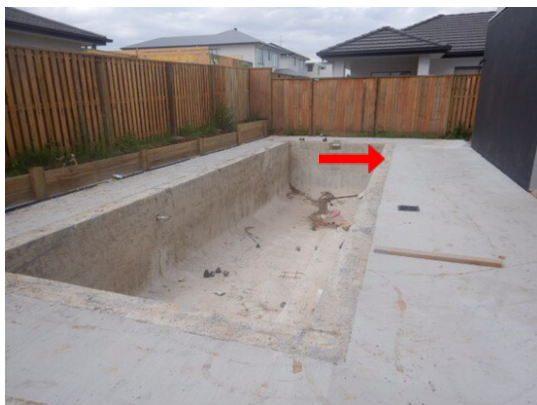
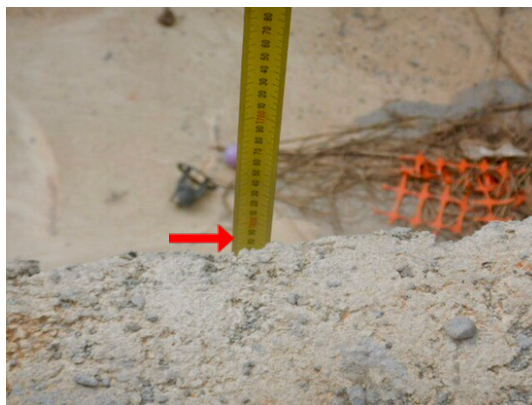
#### Defects 1.01

Building: Yard

Location: Pool Area

Finding: Safe Work Practices - Concerns Noted

Information: It was noted during our inspection that there appears to be a deficiency in the safe work practices adopted by the builder. An inspection of the pool area indicated there is no fall restraint around the pool for the 1700mm fall into the concrete pool. There are also concerns in regard to the pool filling up with water after heavy rain and becoming a water safety hazard.

Reporting on the safe work practices of the builder is outside the scope of this report and this statement is made for the benefit of the builder to conduct further investigation so as to ensure a safe work environment.

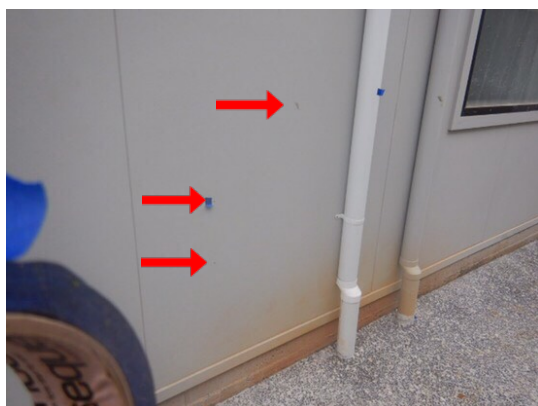
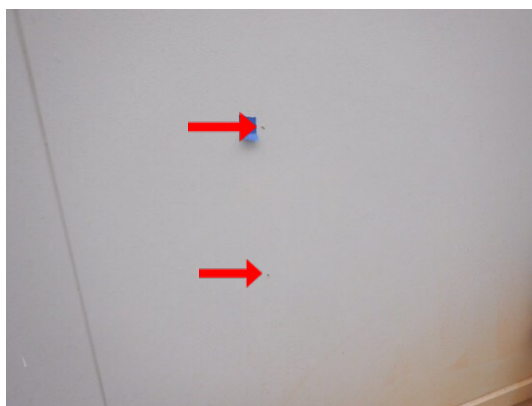
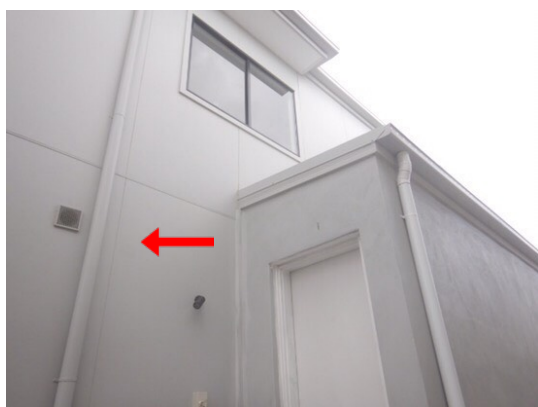
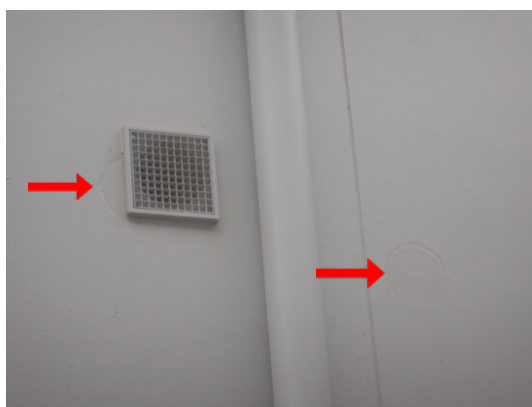
### Defects 2.01

Building: Main Building  
Location: Exterior Walls - All Areas  
Finding: Wall Cladding - Dents and Damage  
Information: At the time of inspection it was noted there was a few popped nails and dents to the fibre cement wall cladding was identified and this is considered to be a defect under Standards and Tolerances.

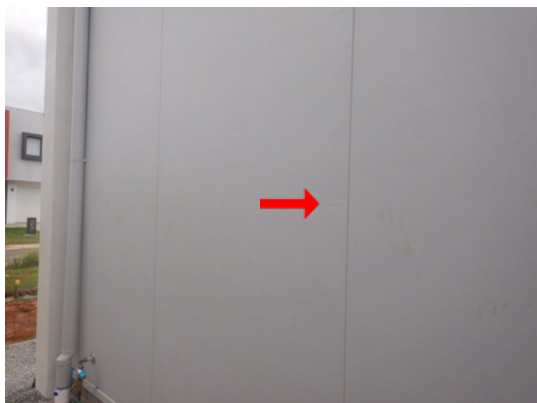
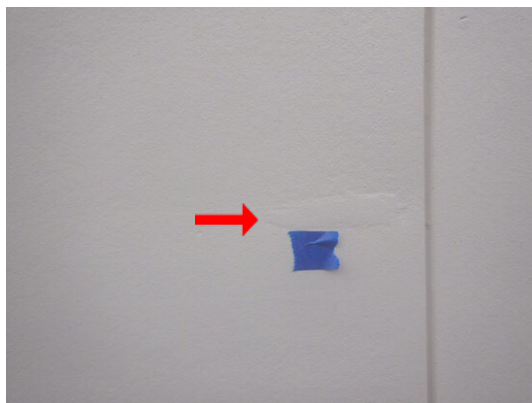
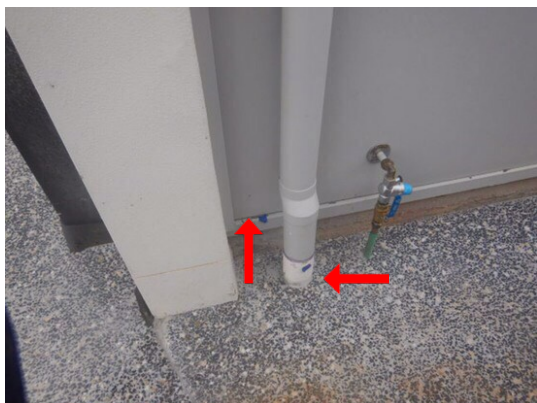
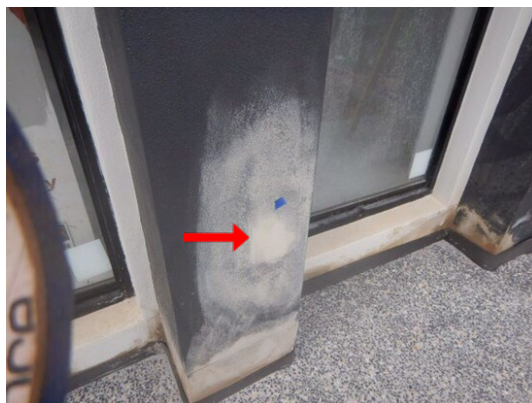
### Defects 2.02

Building: Main Building

Location: All Areas

Finding: Painting - Unfinished (AS2311)

Information: The paint finish in these areas was found to be incomplete at the time of inspection. Whilst incomplete or missing paint finish is generally an appearance defect, it can also lead to the development of secondary building defects over time.

Incomplete areas of paint finish exposes the area to moisture which could lead to deterioration of underlying building materials.

The incomplete painted areas have been marked for the painting contractor to touch up. These works are required to meet Australian Standards prior to final handover.

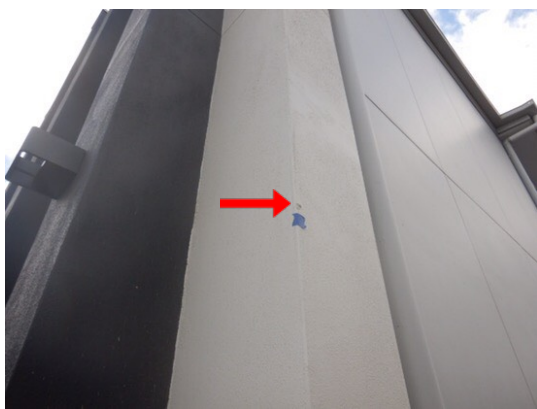
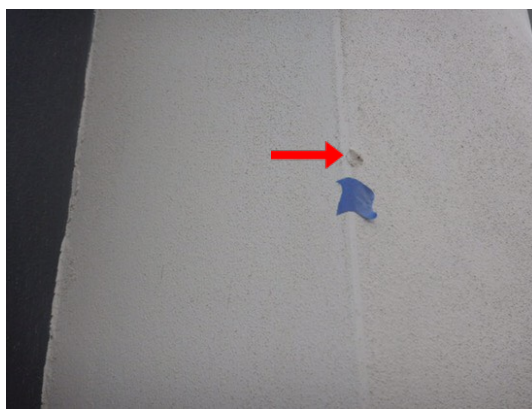
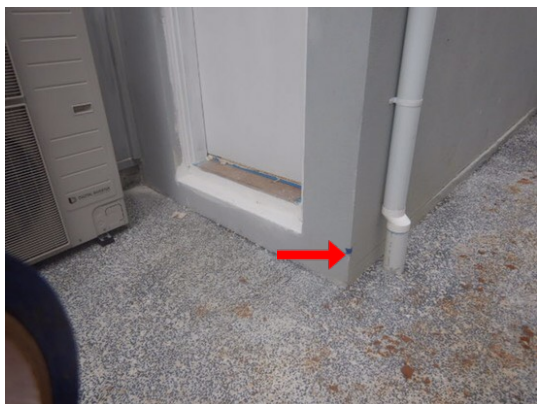
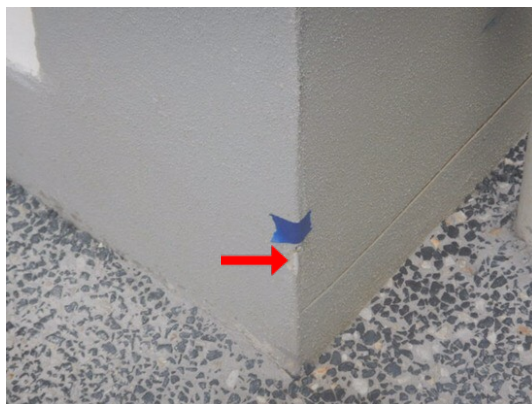
### Defects 2.03

Building: Main Building

Location: All Areas

Finding: Paint Finish - Damage (mechanical)

Information: Holes and / or other unfilled depressions resulting from mechanical damage are present to a number of different areas as indicated by the blue tape. Where these are visible from a normal viewing position they are considered a defect.

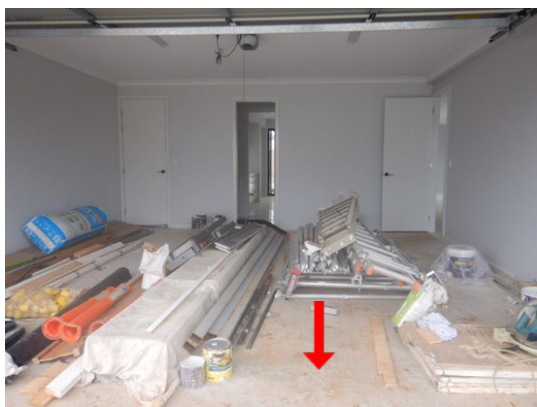
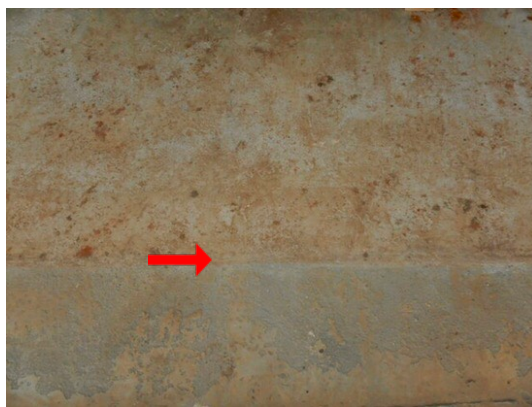
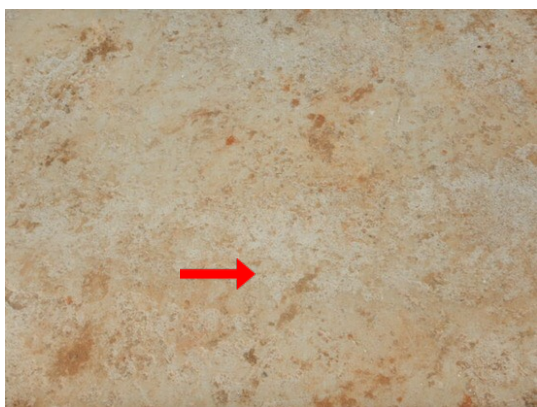
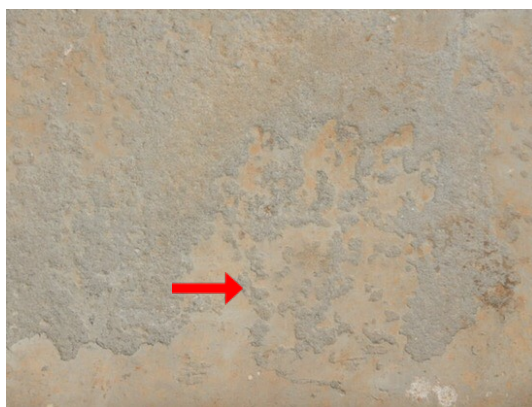
### Defects 2.04

Building: Main Building

Location: Garage

Finding: Concrete Slab Finish - Not Suitable for Purpose (AS2870)

Information: It was identified at the time of inspection that the garage area finish to the concrete slab does not match the specification. The finish to a concrete slab is considered defective if it is not suitable for the documented purpose of use or applied finishes such as tiles, polished concrete, carpet or sheet flooring including set downs where required.

Polishing or applying a surface coating will be required to bring this finished surface up to an acceptable standard.

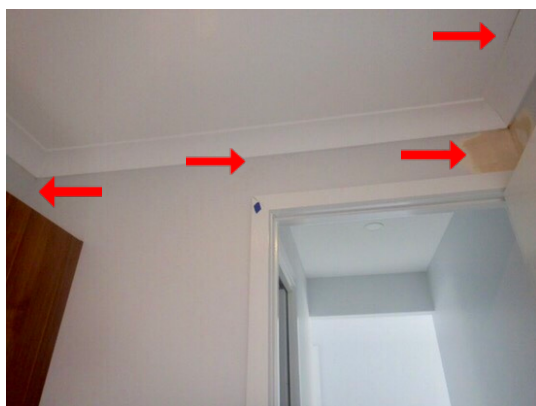
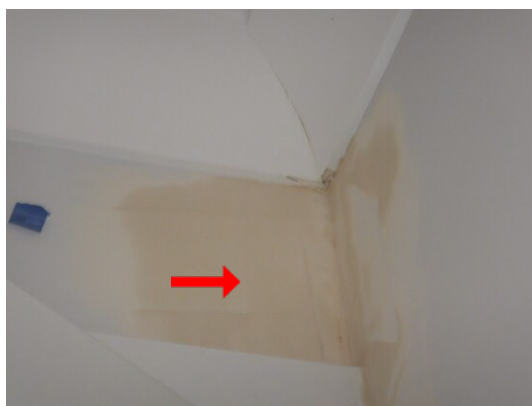
### Defects 2.05

Building: Main Building  
Location: Laundry  
Finding: Water leak & Gyprock Damage- Internal  
Information: A previous water leak was found to have affected the ceiling and walls in the laundry at the time of inspection. Internal water leaks can be detrimental to surrounding building elements, their potential causes include poorly installed plumbing fittings and fixtures, through to failing water proofing.

The plumber was there at the time of inspection and informed me he had carried out a pressure test with no problems encountered. We also ran the water in the upper shower in the ensuite for at least 10mins and no problems were recorded with my thermal camera in the lower ceiling area where the original damage was sustained. These areas should be monitored over the next few weeks to determine if this problem reoccurs.

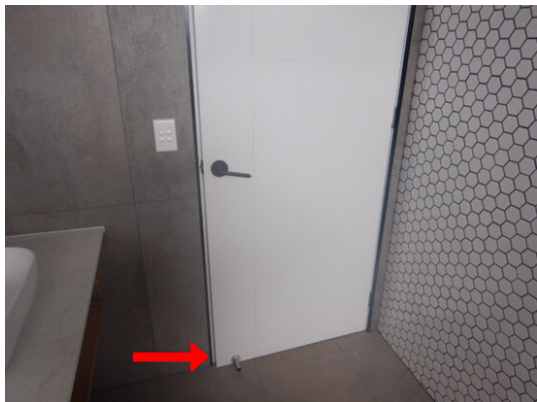
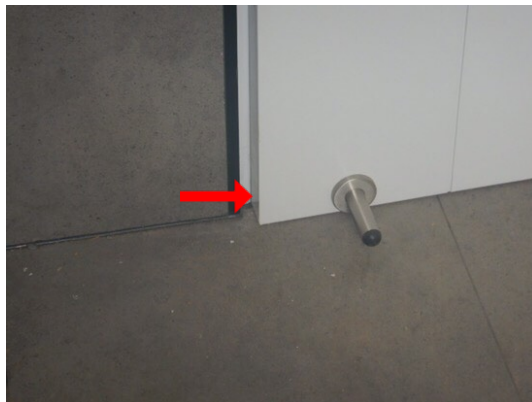
## Defects 3.02

Building: Main Building

Location: Upper Bathroom

Finding: Door Binding

Information: Binding of the upper bathroom door was evident during standard operation. This defect inhibits the functionality of the affected door as well as creating potential for secondary defects to associated building elements. A door that binds to flooring or to the associated door frame may have several causes, ranging from minor defects, such as poor installation of the door or deteriorated hinges.

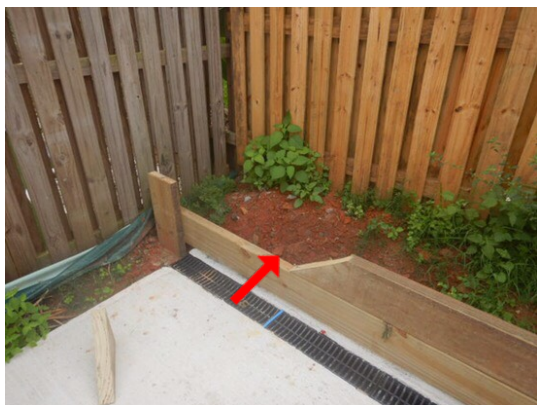
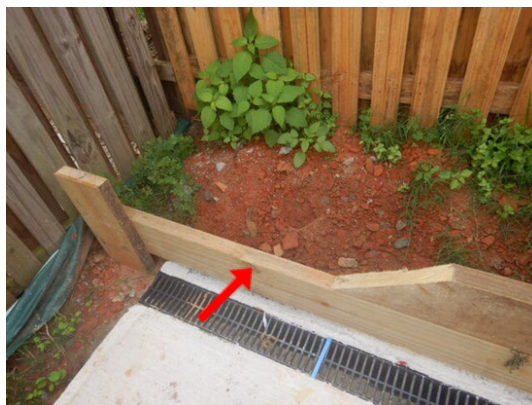
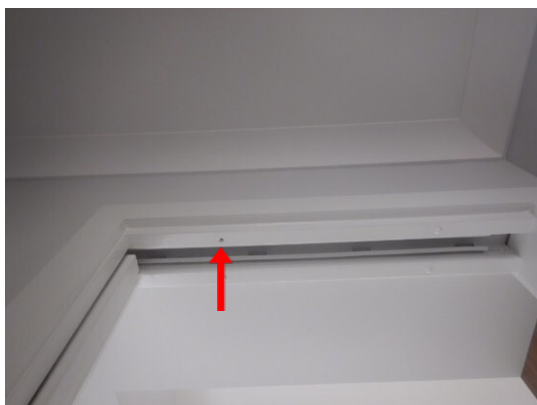
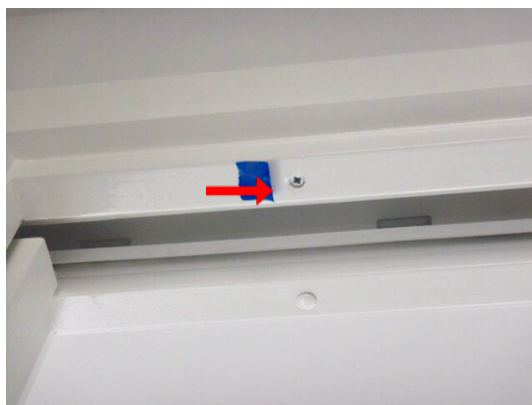
### Defects 4.01

Building: Main Building

Location: All Areas

Finding: Installation - Substandard or Incomplete

Information: The installation of these building element appears to have been completed to a substandard level of workmanship or is incomplete. Generally substandard repairs or installation are related to poor workmanship, the use of inappropriate materials, or a failure to complete installation to a suitable standard.

Where installation is substandard and/or incomplete, the client should contact the responsible trade to undertake rectification. Unfinished and substandard building works are likely to degrade more quickly and may create potential for secondary defects to associated building elements.

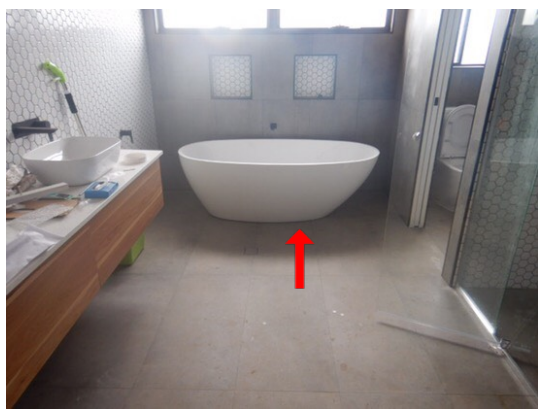
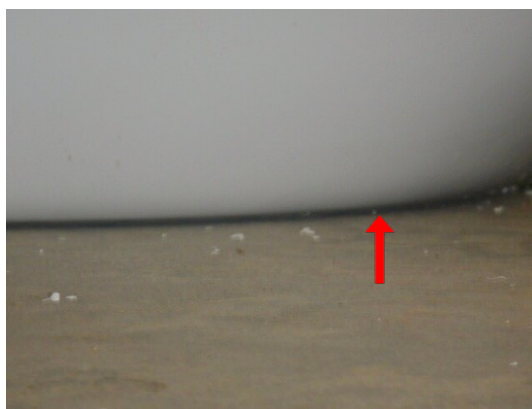
### Defects 4.02

| Building: | Main Building |
| Location: | Ensuite |
| Finding: | Bath Tub - Installation Substandard |
| Information: | At the time of inspection it was noted the bath tub was loose and moving around as you lent on it and has not been fixed to the floor properly. A plumber should be engaged to perform these works before handover takes place. |

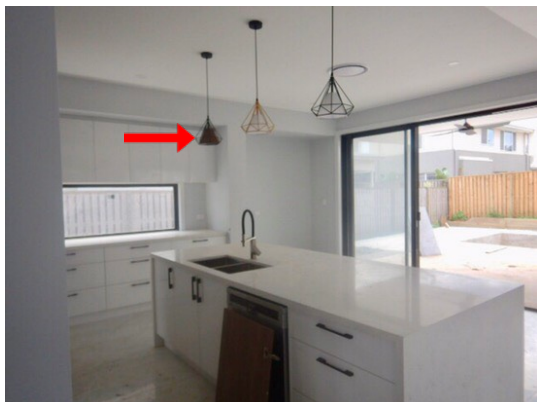
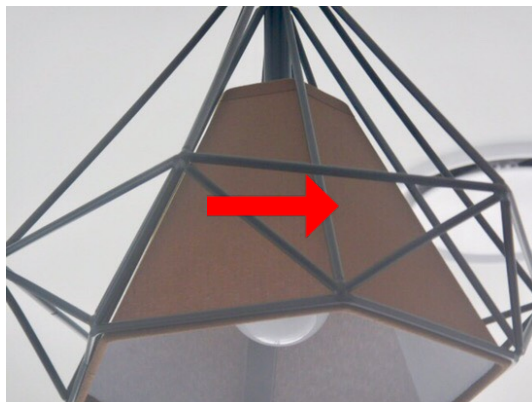
Building: Main Building

Location: Kitchen

Finding: Light Fitting Different Colour

Information: At the time of inspection it was noted one of the lights over the bench kitchen is a different colour as indicated in the photo's below.

This is noted as a caution only as I am not sure if this is a defect or it was meant to be like this.
