# FIRST FLOOR - GENERAL ARRANGEMENT

SECOND FLOOR - GENERAL ARRANGEMENT  
1. LAYOUT IS INDICATIVE ONLY & SHOULD NOT BE CONSIDERED ACCURATE

### THIRD FLOOR - GENERAL ARRANGEMENT

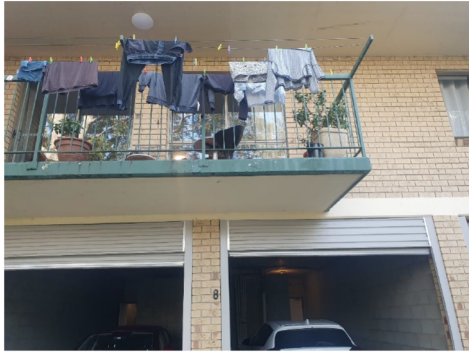
PHOTOGRAPH 28.: No evidence of concrete cancer, minor indications of deterioration. Minor defects to paint coating

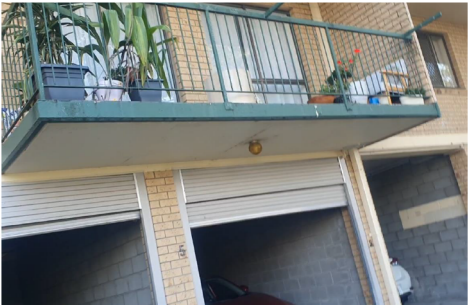
PHOTOGRAPH 30.: No evidence of concrete cancer, minor indications of deterioration. Minor defects to paint coating

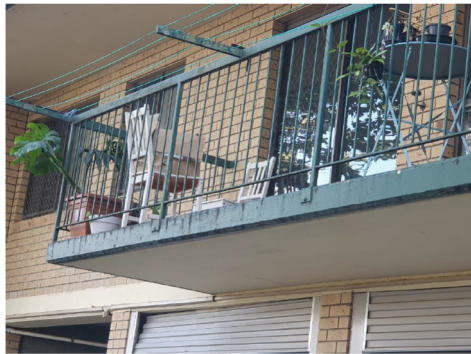
PHOTOGRAPH 29.: No evidence of concrete cancer, minor indications of deterioration. Minor defects to paint coating

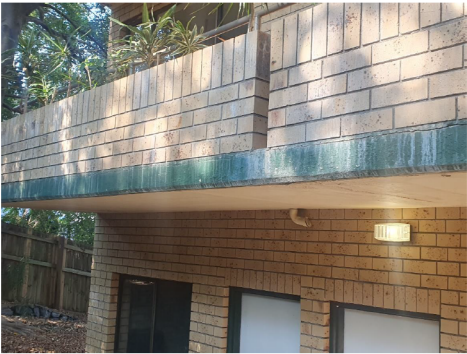
PHOTOGRAPH 13.: Slab in generally good condition, with some efflorescence, minor paint defects

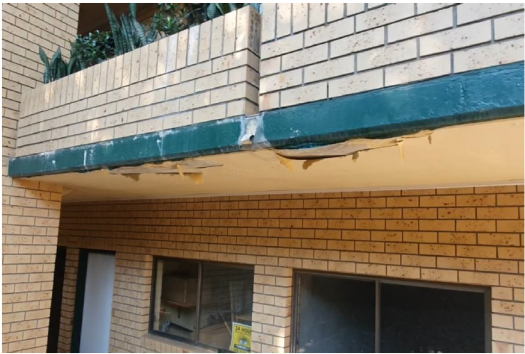
PHOTOGRAPH 7.: No evidence of concrete cancer, some efflorescence to concrete, paint is spalling/peeling

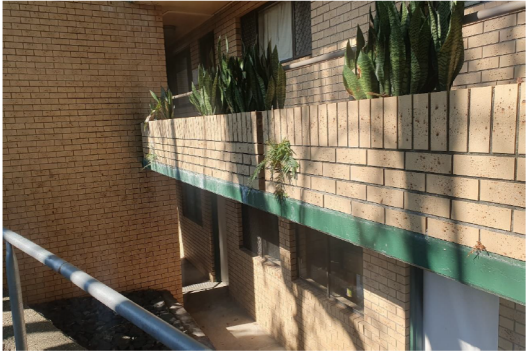
PHOTOGRAPH 2.: No evidence of concrete cancer. Efflorescence indicates on-going carbonation of concrete

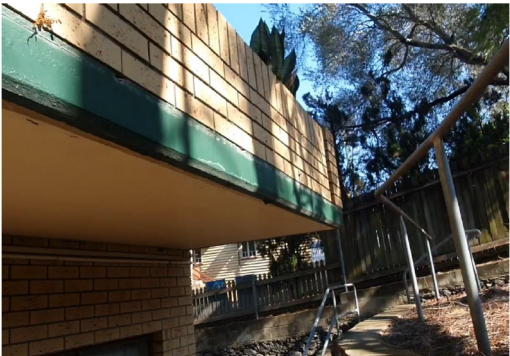
PHOTOGRAPH 1.: No evident concrete cancer, clean area of debris, clean surface & paint

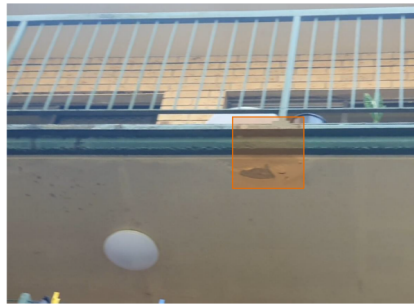
PHOTOGRAPH 32: Minor spalling/ blow out of concrete slab

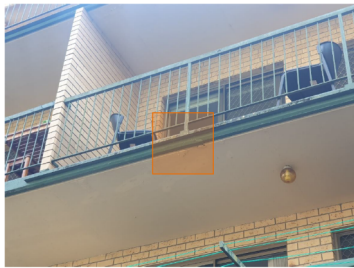
PHOTOGRAPH 33: Minor spalling/ blow out of concrete slab

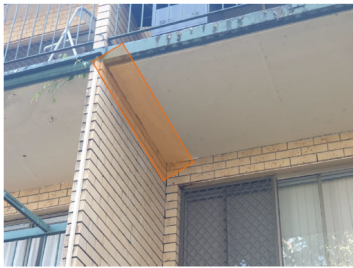
PHOTOGRAPH 34: Concrete slab expansion alongside brick support

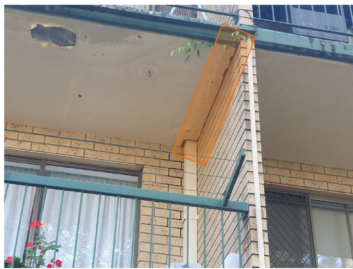
PHOTOGRAPH 35: Concrete slab expansion alongside brick support

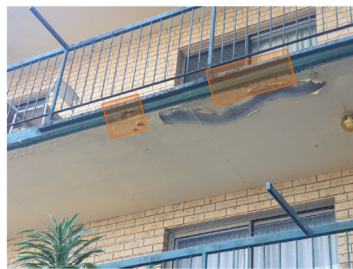
PHOTOGRAPH 36: Sections/ chunks of concrete slab have fallen away, sections of reinforcement corroded/ exposed

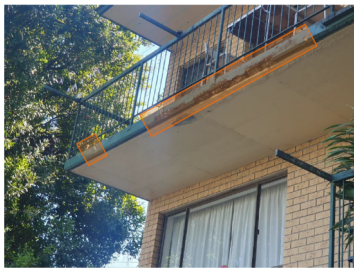
PHOTOGRAPH 37: Sections/ chunks of concrete slab have fallen away, sections of reinforcement corroded/ exposed

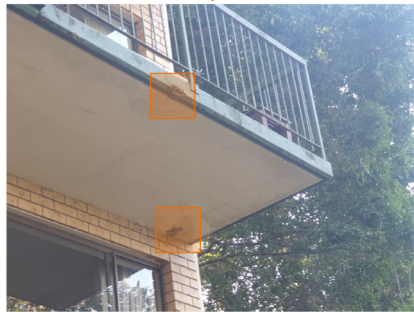
PHOTOGRAPH 31: Minor spalling/ blow out of concrete slab. Small area of reinforcement visible

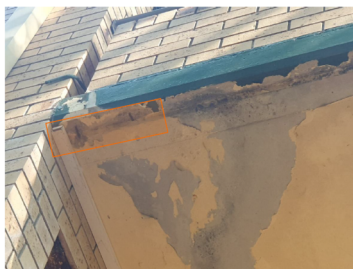
PHOTOGRAPH 15: Small area of exposed reinforcement, some minor slab spalling/ deterioration

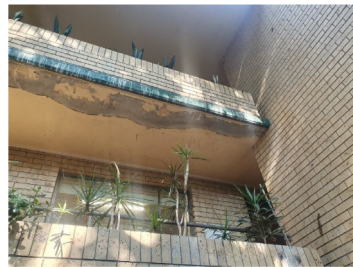
PHOTOGRAPH 14: no indication of slab spalling/ cracks. Paint work has peeled away in large sections

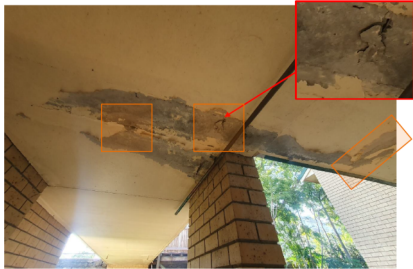
PHOTOGRAPH 9: Below walkway above concrete spalling/ falling away in small sections

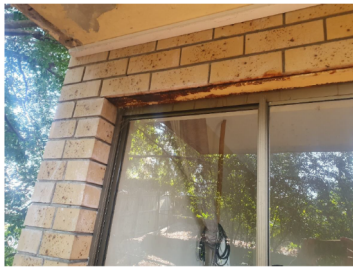
PHOTOGRAPH 16: Moderate corrosion to steel window lintel

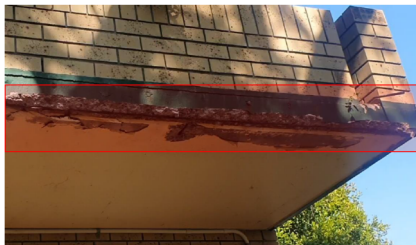
PHOTOGRAPH 3: Concrete cancer to balcony slab, extends back approx.400mm. Cancer along length of balcony at various points. Garden bed slab above slab

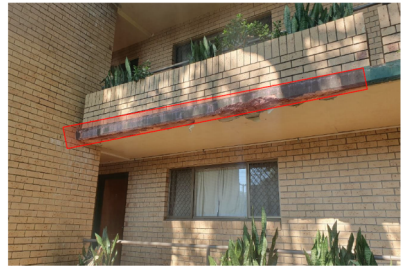
PHOTOGRAPH 4: Concrete cancer to balcony slab, extends back approx.400mm

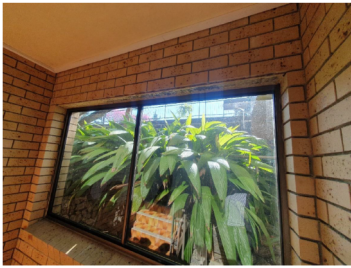
PHOTOGRAPH 20: Minor corrosion to steel window lintel

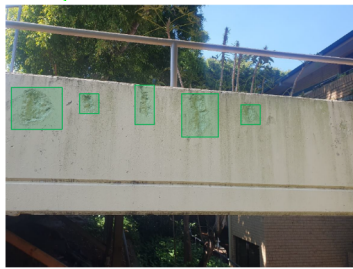
PHOTOGRAPH 25: Spalling of concrete wall over bridge, evident of concrete blow out due to concrete cancer

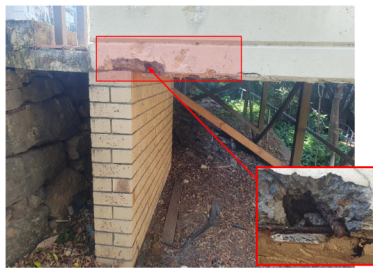
PHOTOGRAPH 24: Large void near bridge support wall, severe corrosion to reinforcement. Large chunks of slab are missing/ have fallen away

GENERAL TREATMENT OF  
SIDE WALLS & UNDERSIDE  
BRIDGE SHALL BE CLASS A  
ADDITIONAL TREATMENT  
AT END LOCATIONS AS  
SHOWN IN PHOTO 23-24

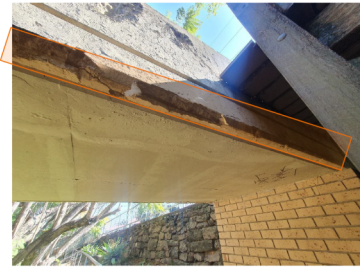
PHOTOGRAPH 23: Underside bridge, moderate concrete cancer. Concrete spalling/ deterioration along underside edge

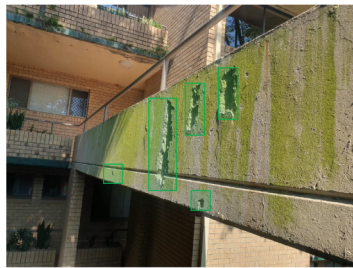
PHOTOGRAPH 22: Spalling of concrete wall over bridge, evident of concrete blow out due to concrete cancer

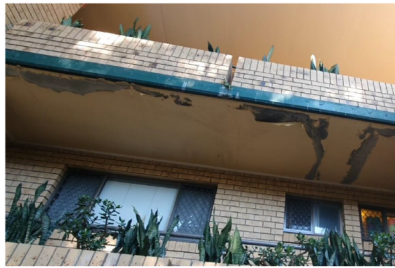
PHOTOGRAPH 8: LHS - paint peeling/ spalling, concrete generally in good condition. RHS - Concrete spalling, some voids to reinforcement

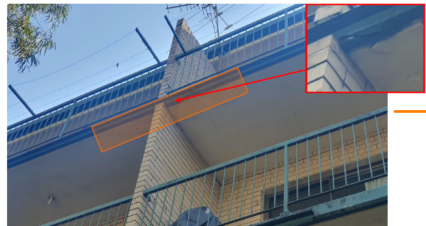
PHOTOGRAPH 39: Sections/ chunks of concrete slab have fallen away, sections of reinforcement corroded/ exposed

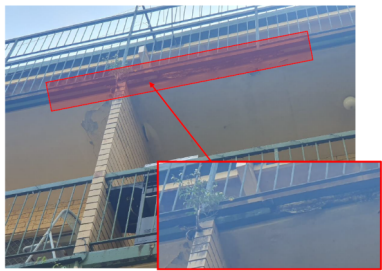
PHOTOGRAPH 42: No evidence of concrete cancer. Efflorescence indicates on-going carbonation of concrete

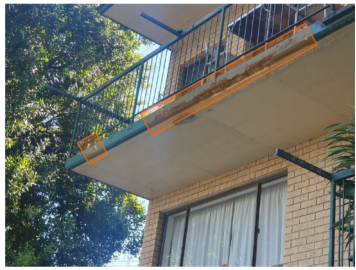
PHOTOGRAPH 37: Sections/ chunks of concrete slab have fallen away, sections of reinforcement corroded/ exposed

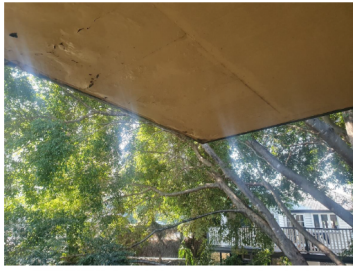
PHOTOGRAPH 19: Corner of slab appears to be in generally good condition

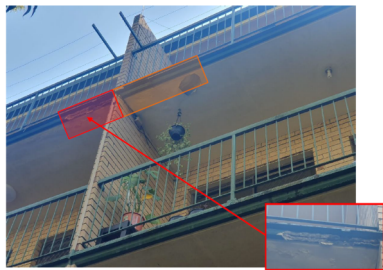
PHOTOGRAPH 40: Sections/ chunks of concrete slab have fallen away. Large areas of reinforcement reinforcement corroded/ exposed

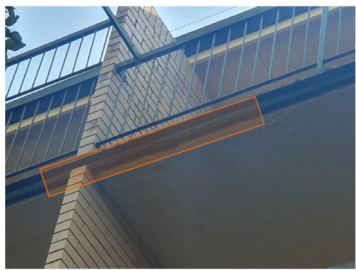
PHOTOGRAPH 41: No evidence of concrete cancer. Efflorescence indicates on-going carbonation of concrete

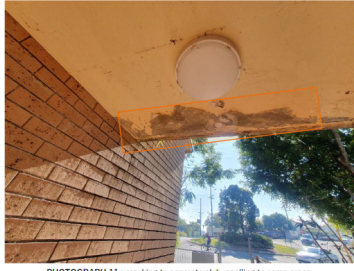
PHOTOGRAPH 11: cracking to concrete slab, spalling to some areas.

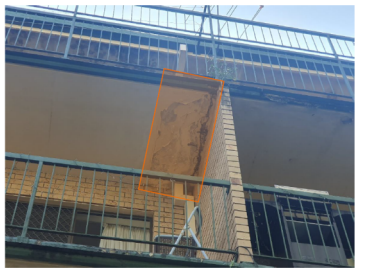
PHOTOGRAPH 43: No evidence of concrete cancer. Efflorescence indicates on-going carbonation of concrete

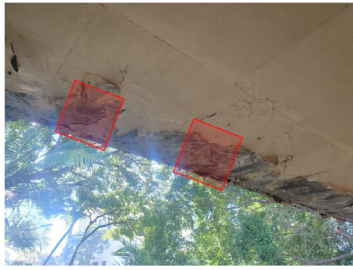
PHOTOGRAPH 18: Moderate cracking to concrete slab, evidence of early spalling/ blow-out from concrete cancer

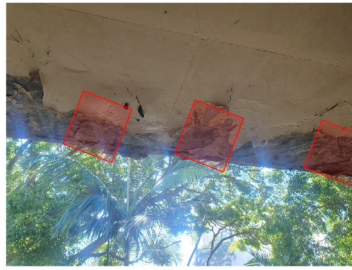
PHOTOGRAPH 17: Moderate cracking to concrete slab, evidence of early spalling/ blow-out from concrete cancer

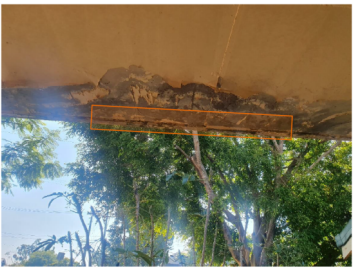
PHOTOGRAPH 12: cracking to concrete slab, spalling to some areas.

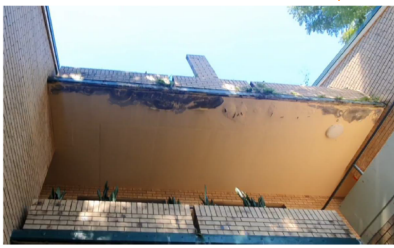
PHOTOGRAPH 10: Some spalling of concrete, areas of paint fully deteriorated.

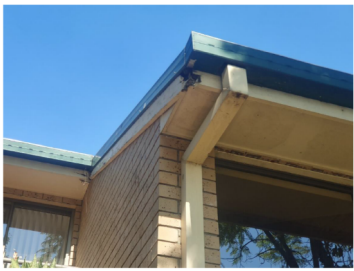
PHOTOGRAPH 21: Severe timber rot to timber skirting along roof eave

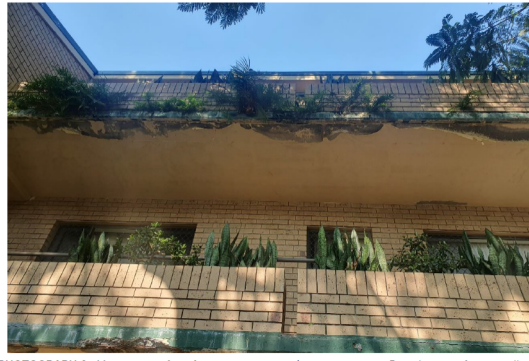
PHOTOGRAPH 6: Minor areas of reinforcement exposure/ concrete cancer. Paint has significant spalling/ peeling

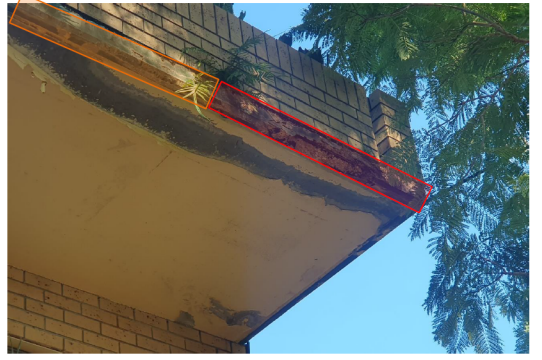
PHOTOGRAPH 5: Moderate concrete cancer 2.0m from corner along balcony.
