# Dilapidation Report - V1

## JCU buildings 112-119

JCU0201

Monkhouse Road  
Douglas

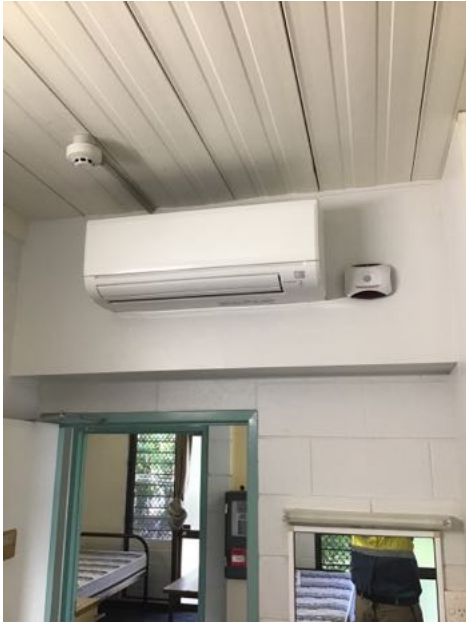
Appendix 1

| Question | Response | Details |
|---|---|---|
| Described Airconditioning | Wall Mounyted Split Systems | |

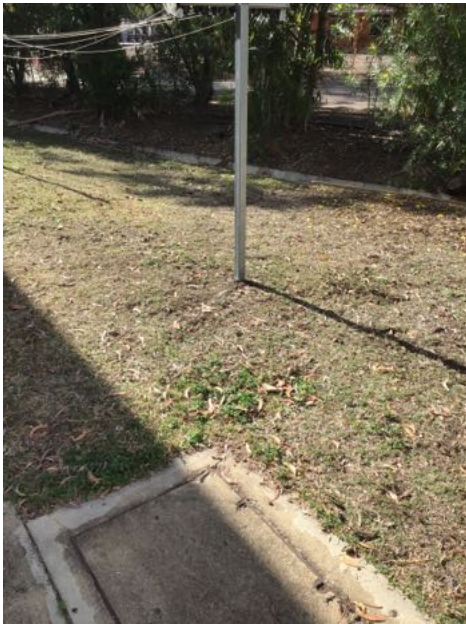
Appendix 3

| Question | Response | Details |
|---|---|---|
| Are the grassed areas in good condition? | No | |

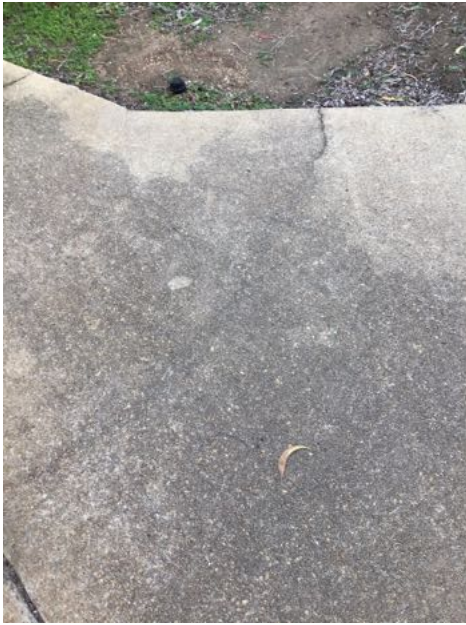
Appendix 5

| Is there any cracks evident in the road surface? | Yes | |
