# Dilapidation Inspection Report

Company Name: Jim's Building Inspections (Brighton)

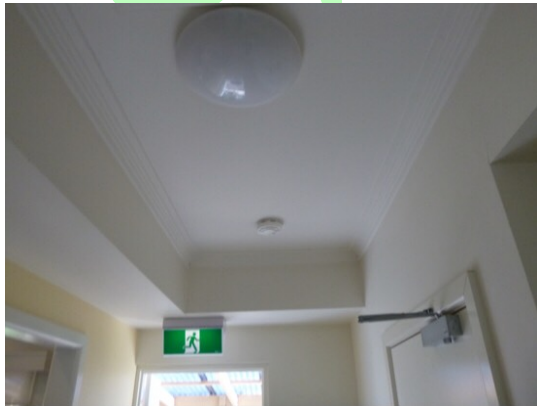
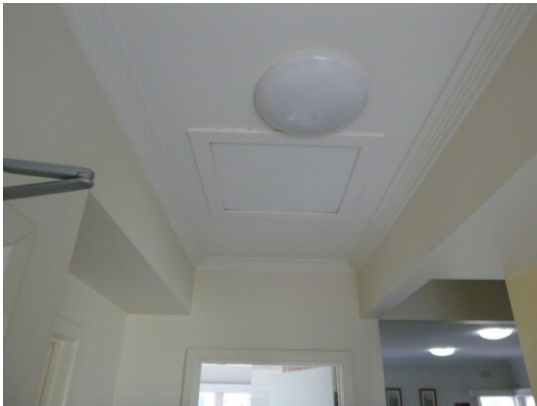
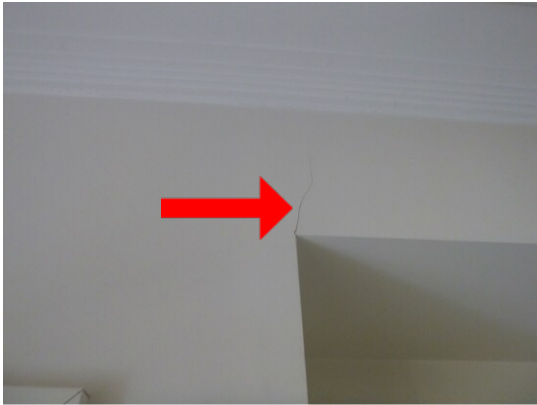
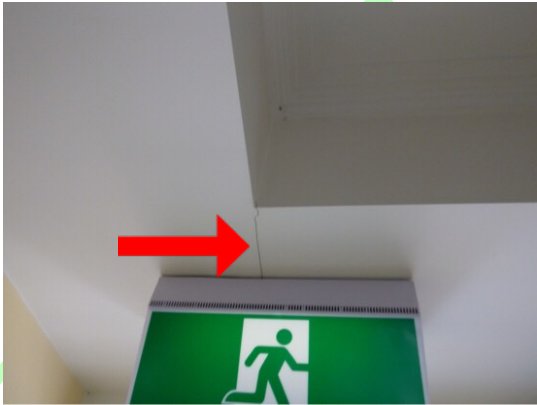
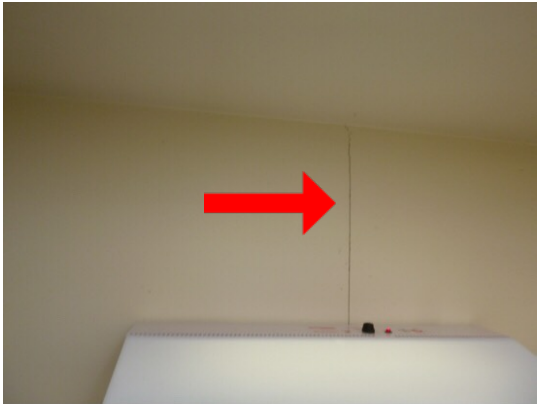
### Defects 3.01

Building: Main Building  
Location: Entry  
Finding: Plaster - Cracking x2  
Information: Cracking to the internal plaster was identified in this area at the time of inspection.

The plaster cracking is approximately up to 1mm wide by 250mm long at the time of inspection.

The plaster cracking is approximately up to 2mm wide by 400mm long at the time of inspection.

This cracking should be monitored frequently to identify whether further cracking results.

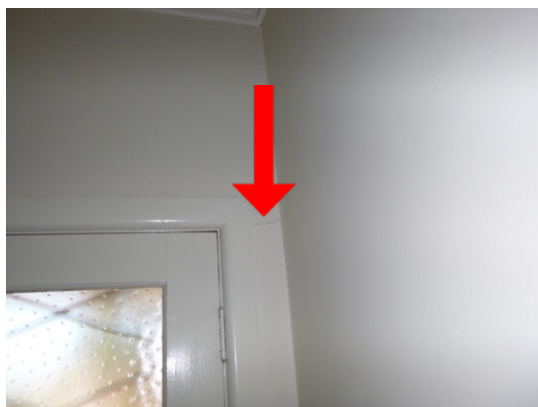
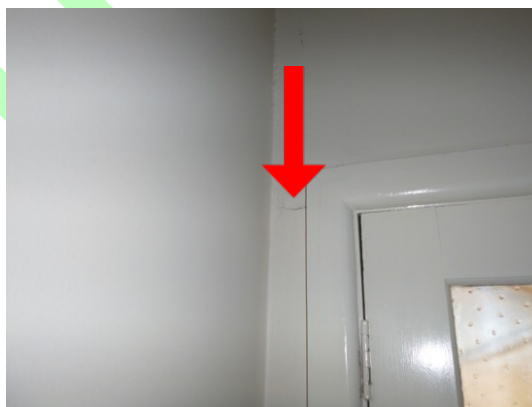
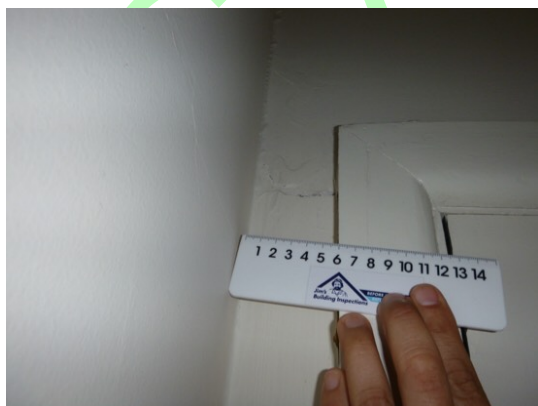
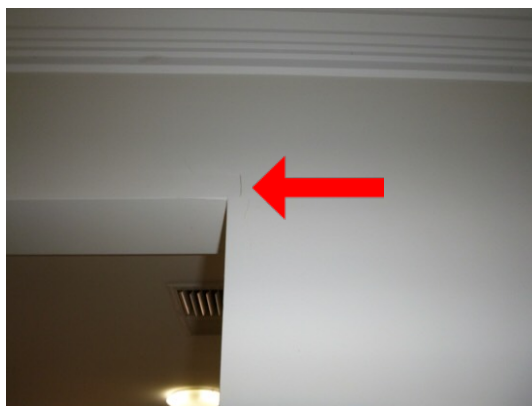
## Defects 3.02

Location: Hallway

Finding: Plaster - Cracking x3

Information: Cracking to the internal plaster was identified in this area at the time of inspection.

The plaster cracking is approximately up to 2mm wide by 60mm long at the time of inspection.

The plaster cracking is approximately up to 2mm wide by 50mm long at the time of inspection.

This cracking should be monitored frequently to identify whether further cracking results.

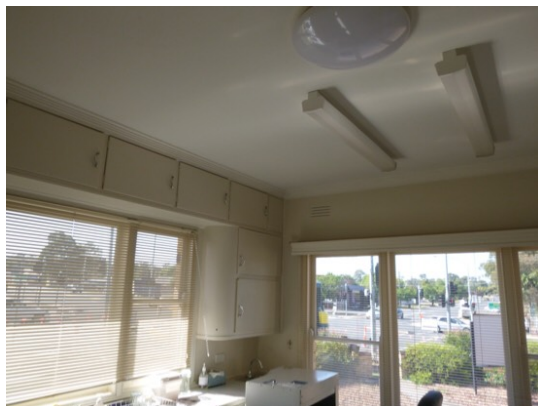
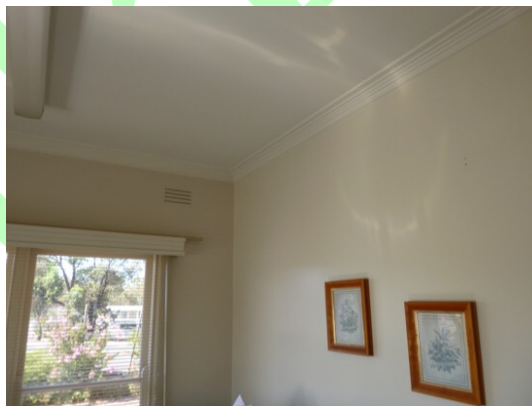
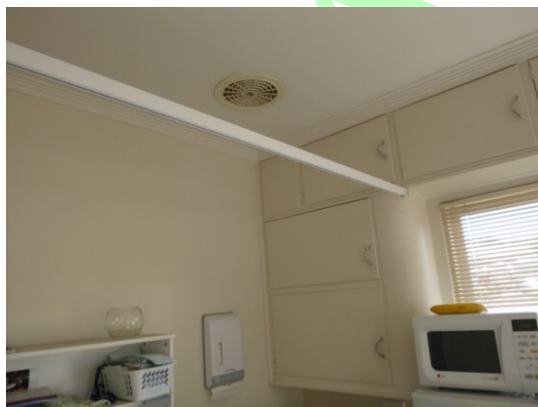
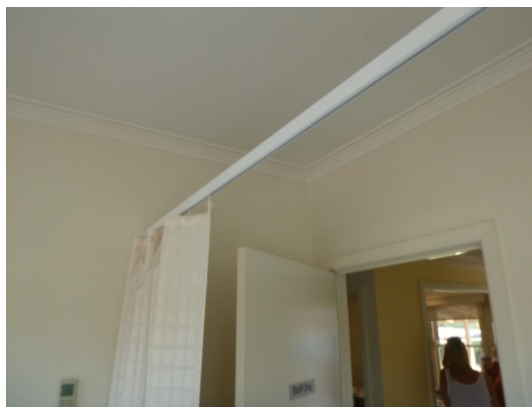
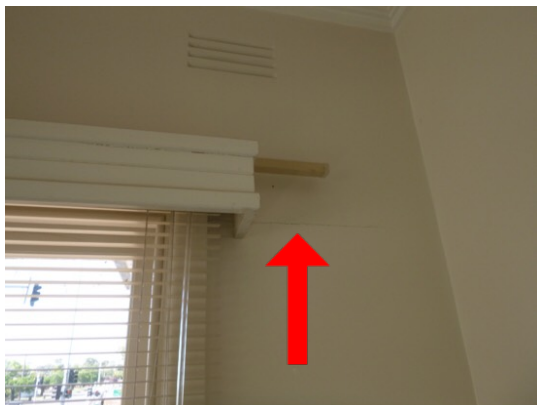
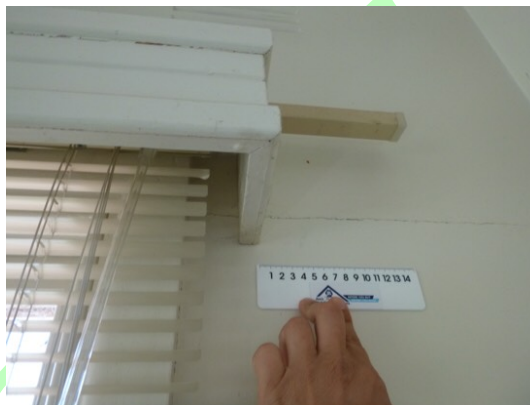
### Defects 3.03

Location: Kitchen

Finding: Plaster - Cracking

Information: Cracking to the internal plaster was identified in this area at the time of inspection.

The plaster cracking is approximately up to 1mm wide by 300mm long at the time of inspection.

This cracking should be monitored frequently to identify whether further cracking results.

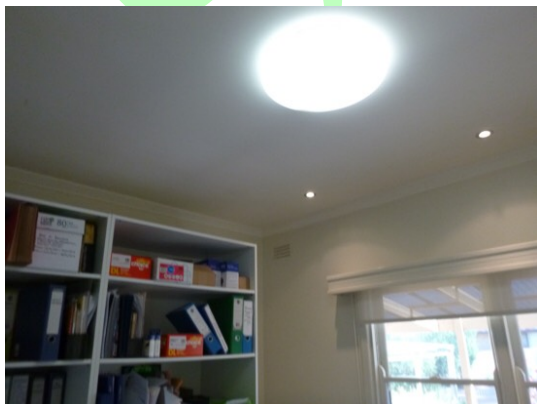
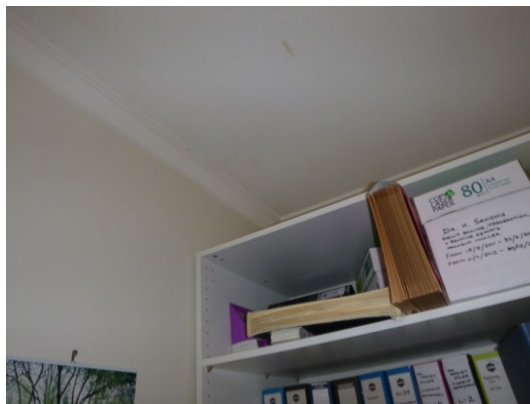
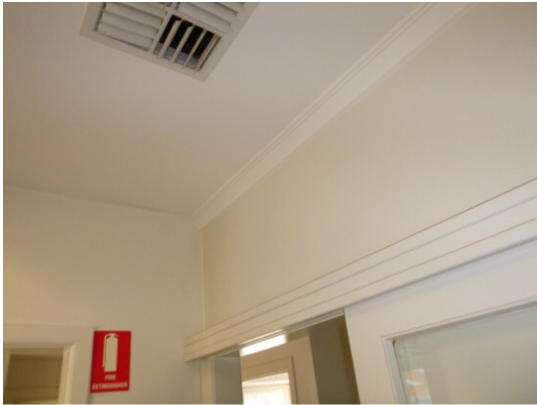
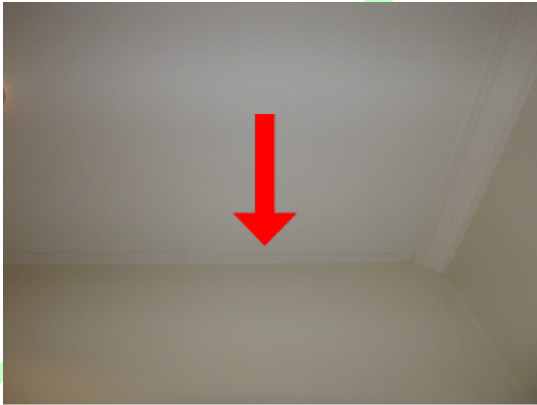
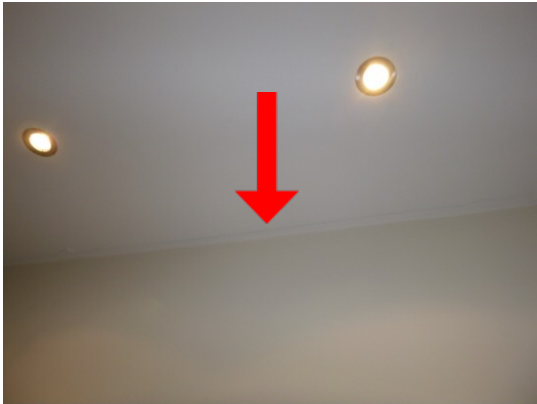
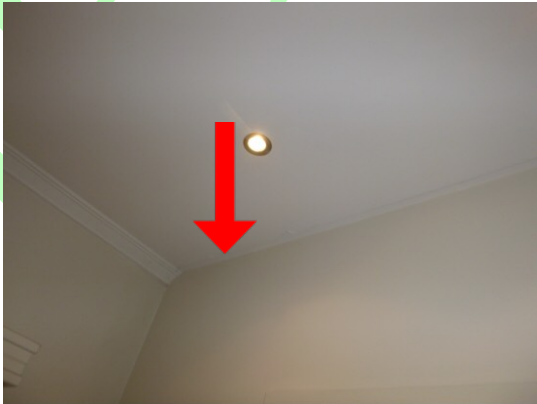
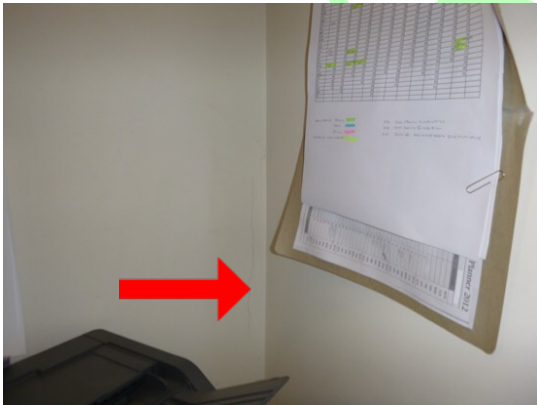
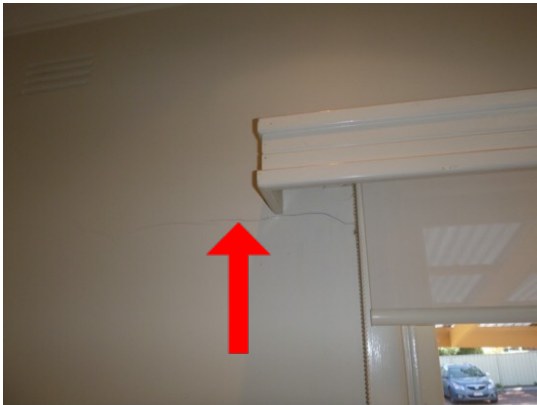
### Defects 3.04

Location: Reception Office

Finding: Plaster - Cracking x3

Information: Cracking to the internal plaster was identified in this area at the time of inspection.

The plaster cracking is approximately up to 1mm wide by 2500mm long at the time of inspection.

The plaster cracking is approximately up to 2mm wide by 400mm long at the time of inspection.

The plaster cracking is approximately up to 1mm wide by 600mm long at the time of inspection.

This cracking should be monitored frequently to identify whether further cracking results.

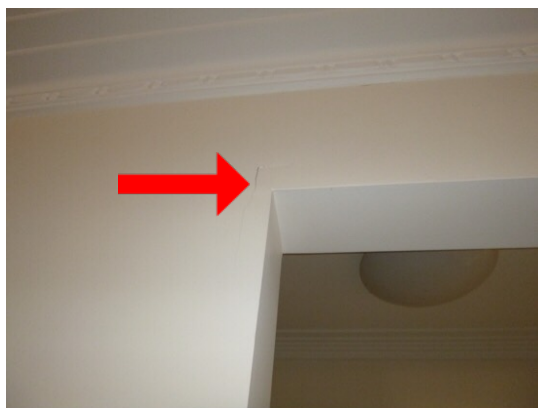
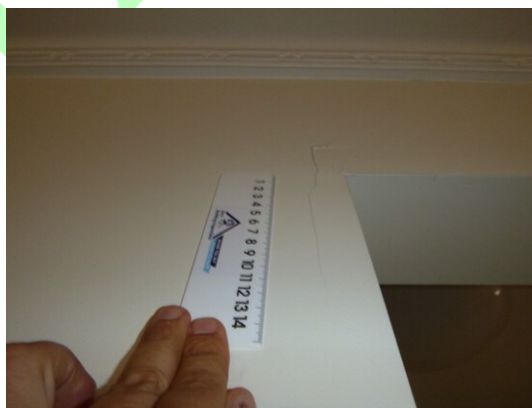
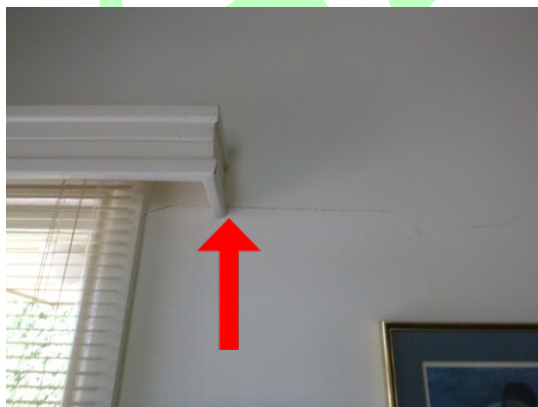
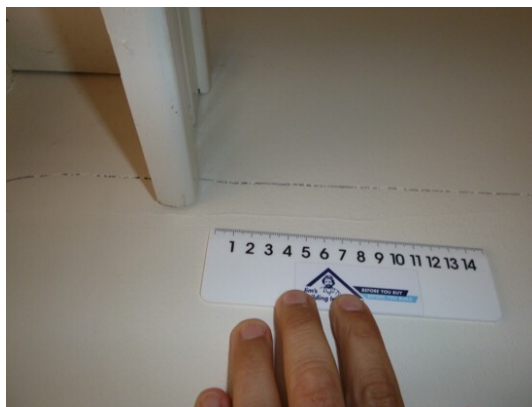
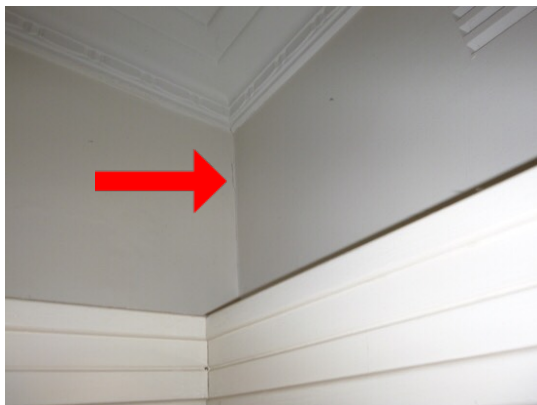
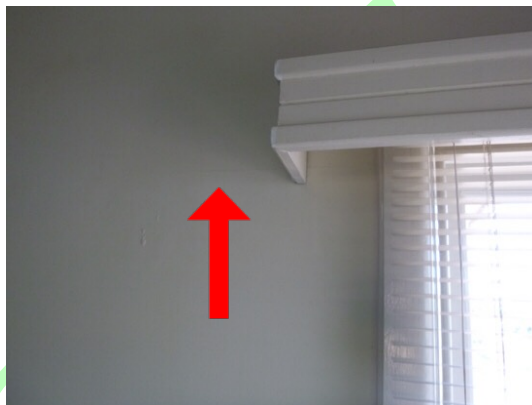
### Defects 3.05

Building: Main Building  
Location: Waiting Room  
Finding: Plaster - Cracking x4  
Information: Cracking to the internal plaster was identified in this area at the time of inspection.

The plaster cracking is approximately up to 1mm wide by 200mm long at the time of inspection.

The plaster cracking is approximately up to 1mm wide by 600mm long at the time of inspection.

The plaster cracking is approximately up to 1mm wide by 700mm long at the time of inspection.

The plaster cracking is approximately up to 1mm wide by 400mm long at the time of inspection.

This cracking should be monitored frequently to identify whether further cracking results.

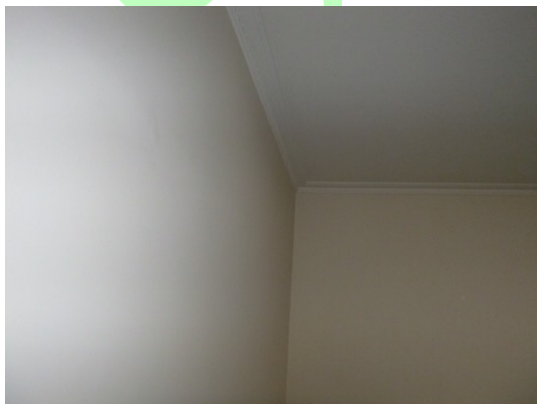
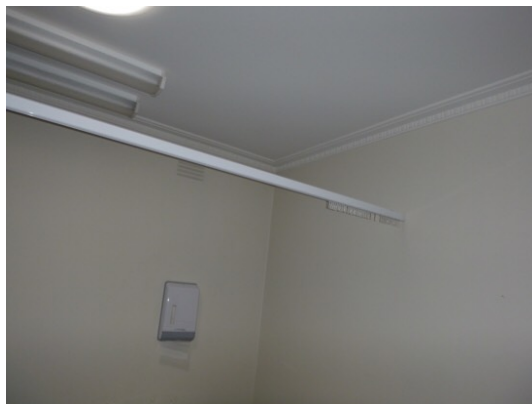
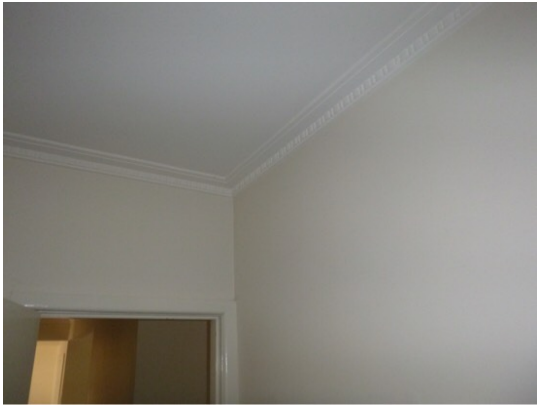
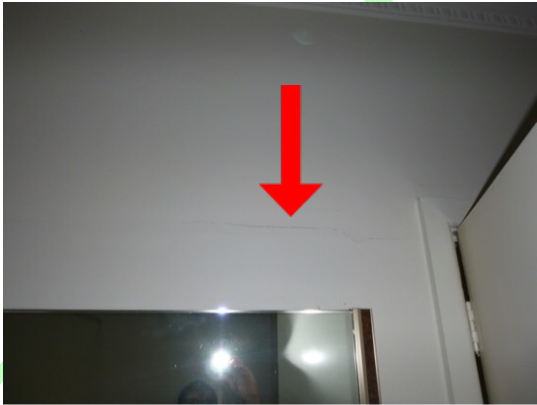
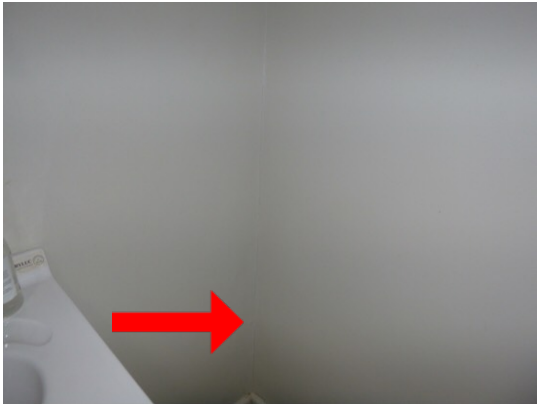
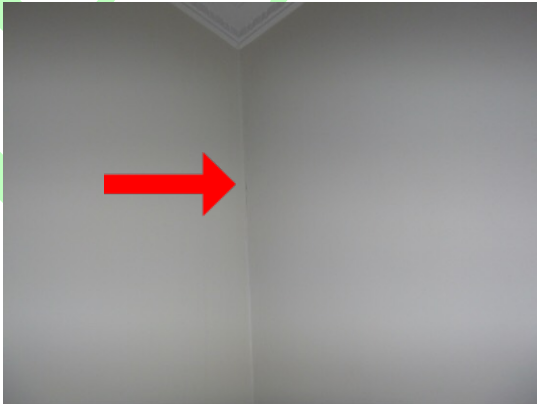
### Defects 3.06

Building: Main Building  
 Location: Consulting Room 2  
 Finding: Plaster - Cracking x3  
 Information: Cracking to the internal plaster was identified in this area at the time of inspection.

The plaster cracking is approximately up to 1mm wide by 700mm long at the time of inspection.

The plaster cracking is approximately up to 2mm wide by 1200mm long at the time of inspection.

The plaster cracking is approximately up to 1mm wide by 400mm long at the time of inspection.

This cracking should be monitored frequently to identify whether further cracking results.

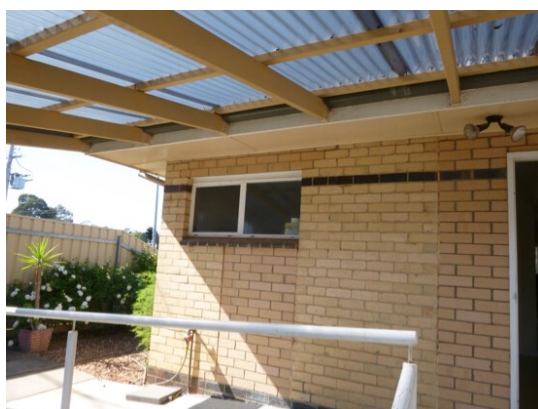
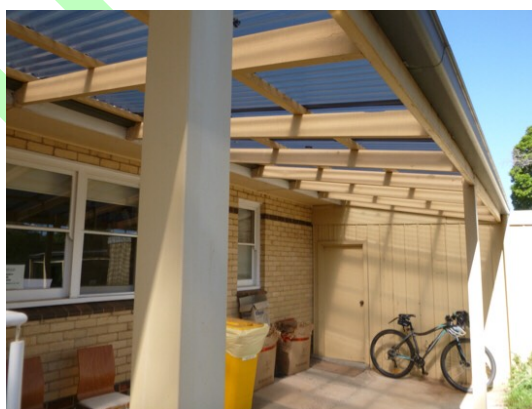
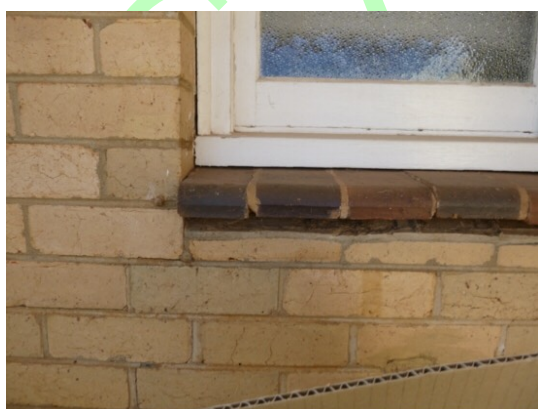
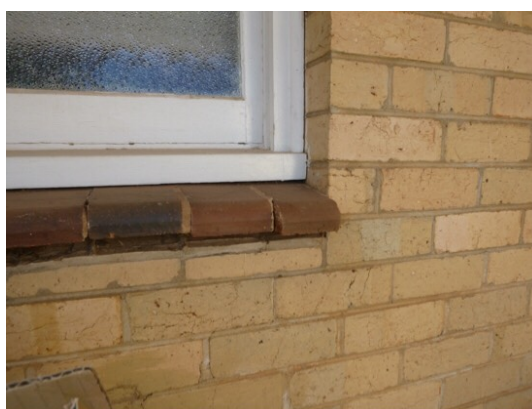
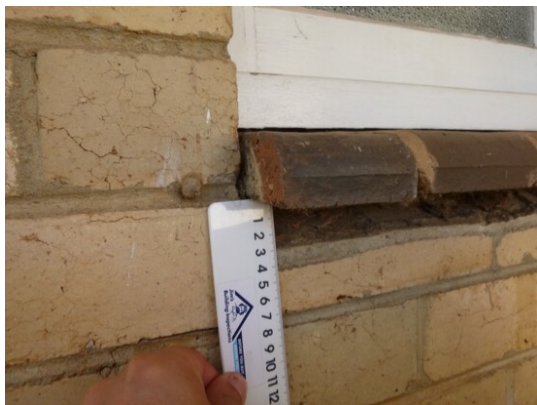
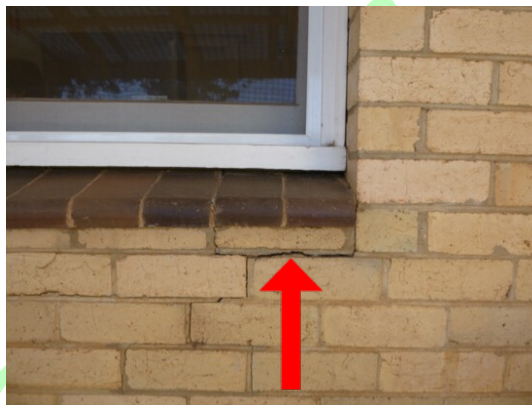
## Defects 3.07

Building: Main Building  
Location: Rear Elevation  
Finding: Brickwork - Sill Bricks Lifted/Mortar Cracking  
Information: Lifting of window sill bricks was identified in this area at the time of inspection.

Sill bricks were raised by approximately 30mm.

Mortar to one brick was cracked.

This should be carefully monitored to ensure that further lifting does not ensue as a result of further dilapidation.

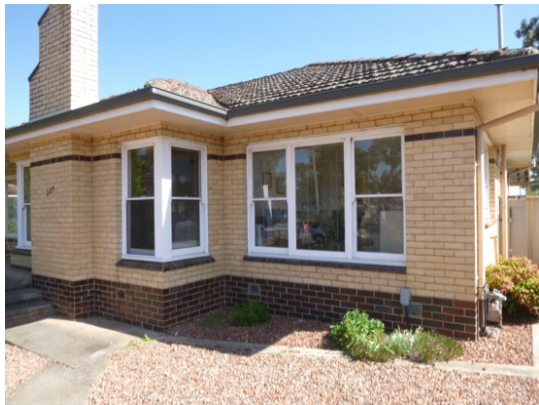
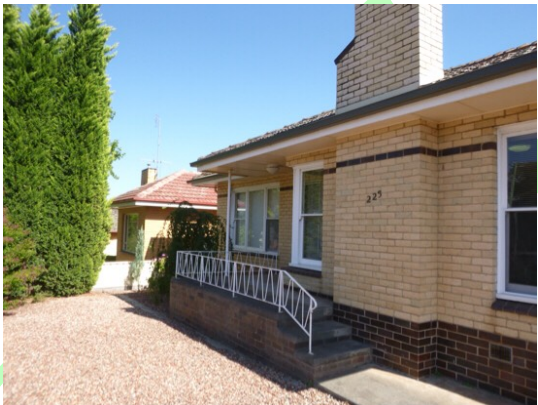
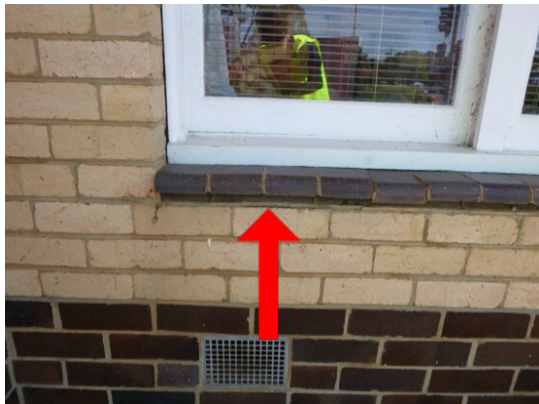
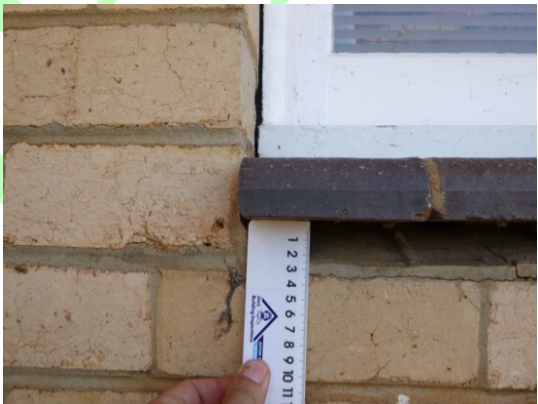
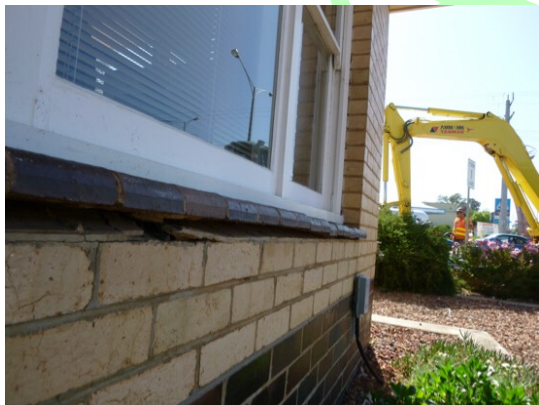
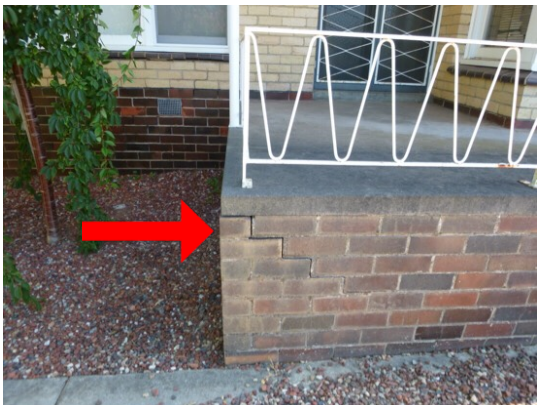
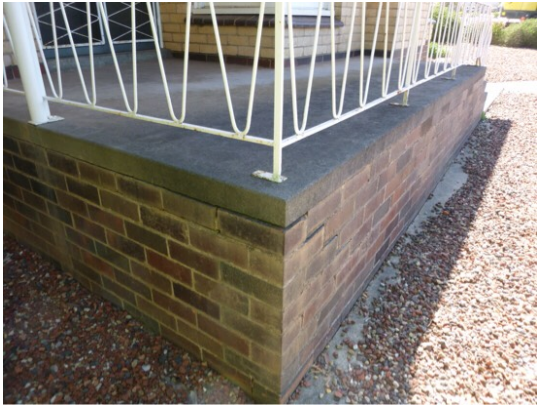
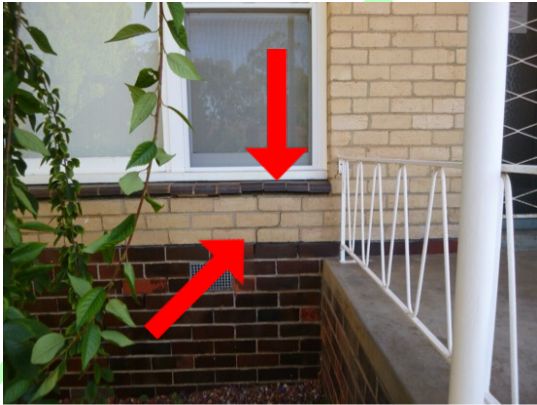
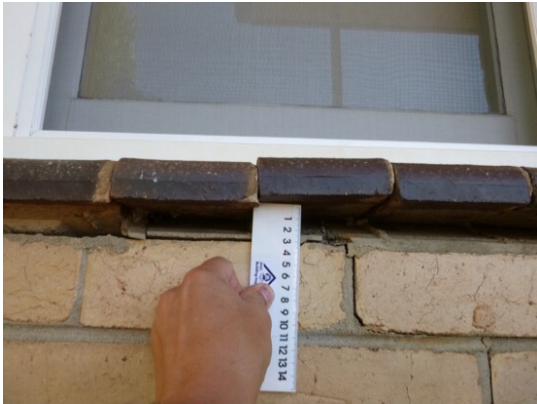
### Defects 3.08

| Location: | Front Elevation |
| Finding: | Brickwork - Sill Bricks Lifted x2/Step Cracking x2 |
| Information: | <p>Lifting of window sill bricks was identified in two areas at the time of inspection.</p> <p>This should be carefully monitored to ensure that further lifting does not ensue as a result of further dilapidation.</p> <p>Sill bricks were raised by approximately 30mm.</p> <p>Step cracking was identified to the brickwork in two areas at the time of inspection.</p> <p>Such cracking should be carefully inspected frequently to ensure that further cracking / deterioration does not ensue as a result of dilapidation.</p> <p>Please refer to associated photographs for further detail.</p> |

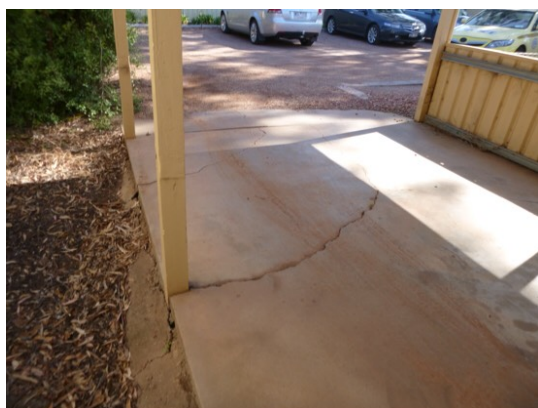
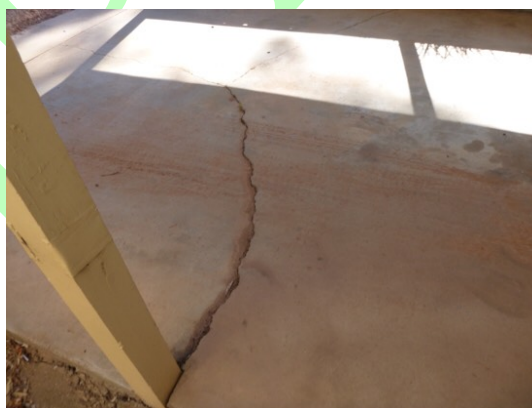
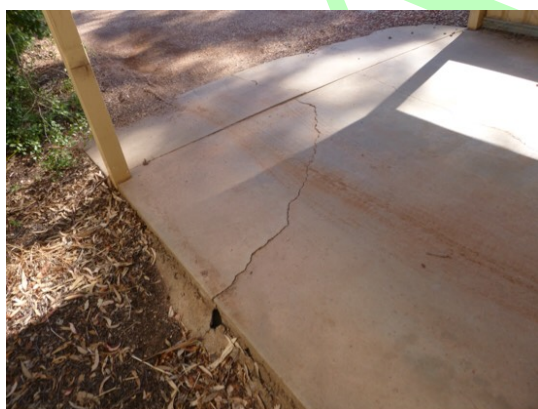
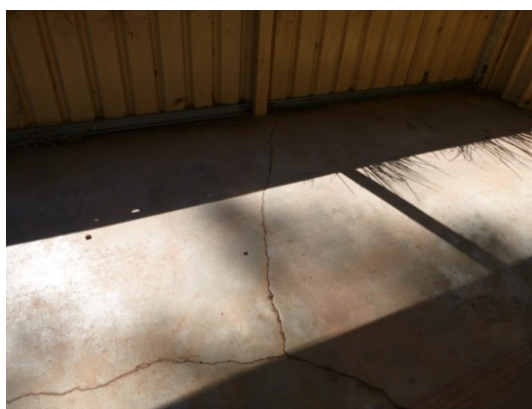
## Defects 3.09

Building: Yard  
Location: Yard - Rear Driveway to Garage  
Finding: Concrete Paving - Cracking & Subsiding  
Information: Cracking to the paving in this area was identified at the time of inspection.

This type of cracking is often consistent with general dilapidation of the property, and may continue to develop if left unmaintained.

Please refer to associated photographs for further detail. Frequent monitoring should be carried out to identify any further damage.

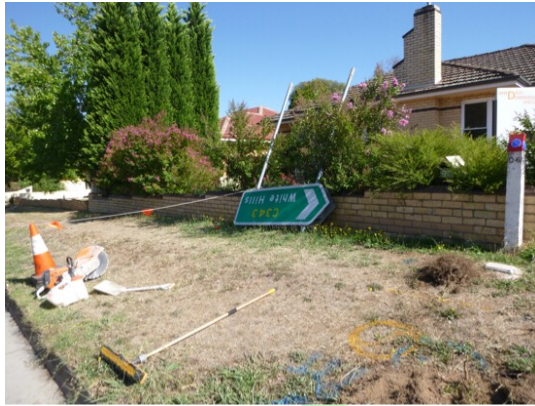
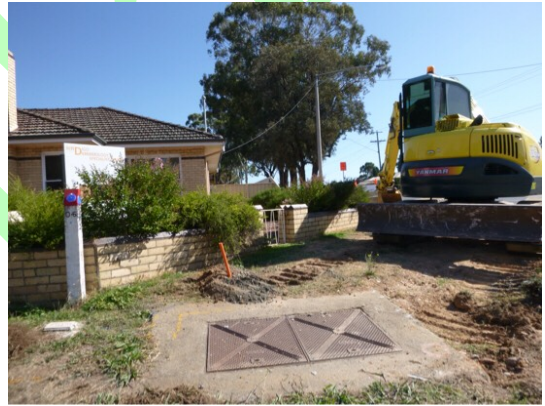
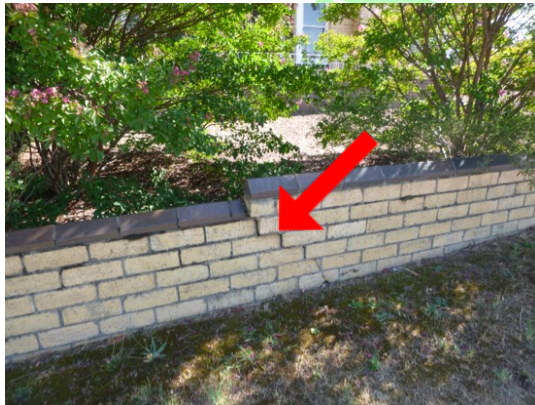
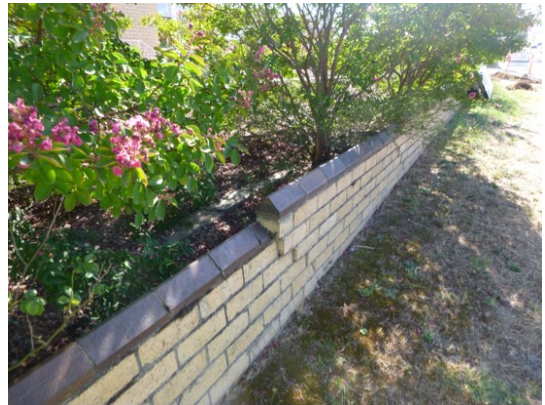
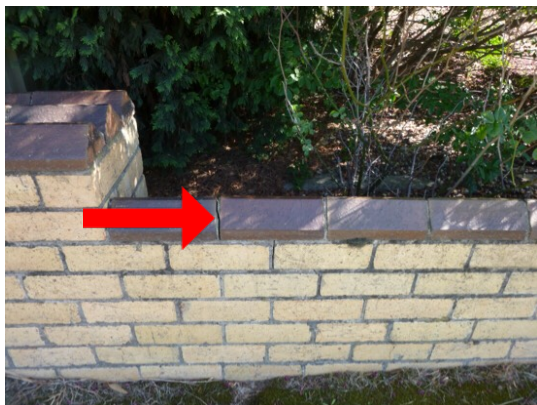
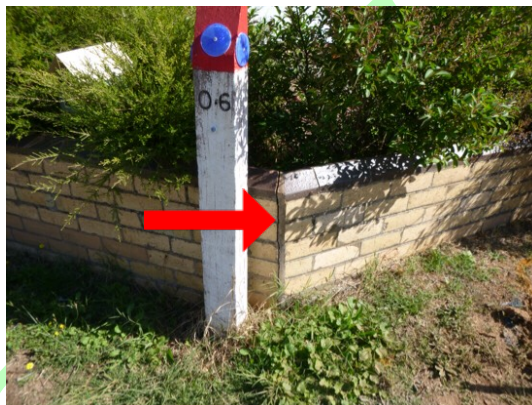
### Defects 3.1

Building: Yard  
Location: Front Brick Fencing  
Finding: Brickwork - Cracking x3  
Information: Cracking was identified to the brickwork in this area at the time of inspection.

This cracking should be carefully monitored to ensure that further cracking does not ensue as a result of further dilapidation.

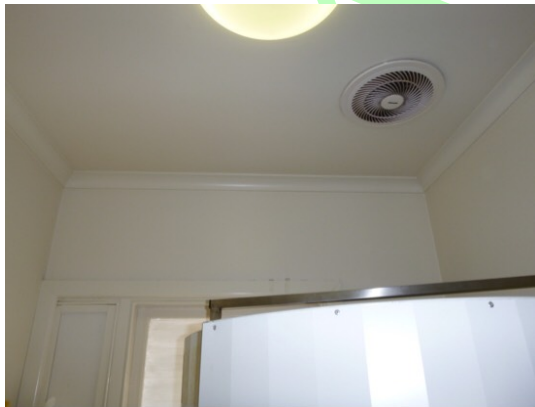
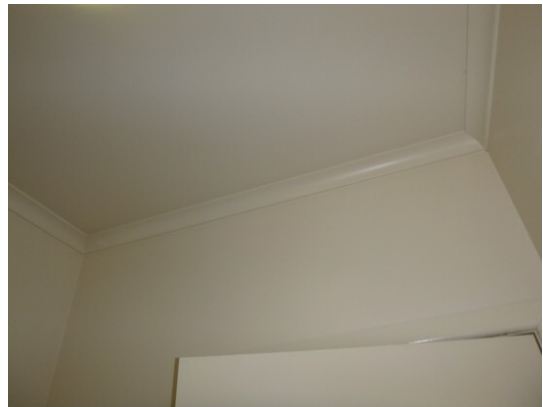
Building: Main Building  
Location: UVB Therapy Room  
Finding: No Visible Defects  
Information: At the time of inspection, no visible defects as a result of dilapidation were identified in this area.

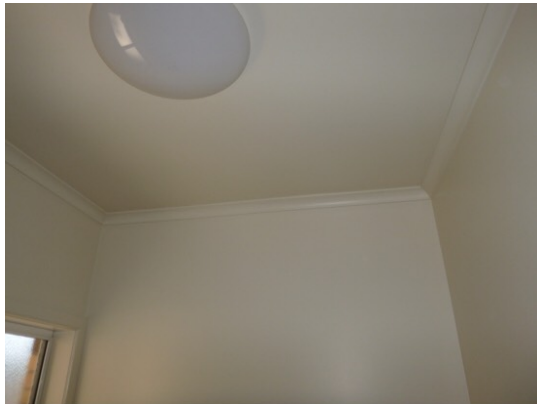
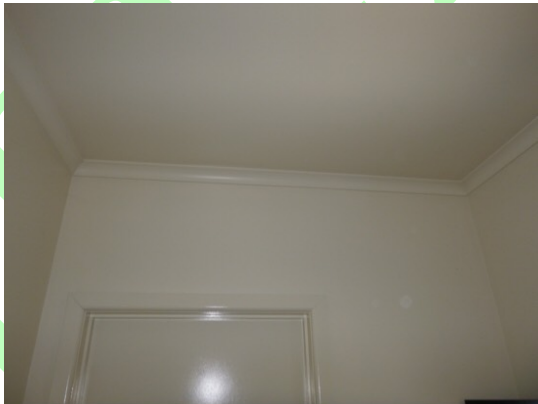
Building: Main Building  
Location: Toilet (WC)  
Finding: No Visible Defects  
Information: At the time of inspection, no visible defects as a result of dilapidation were identified in this area.

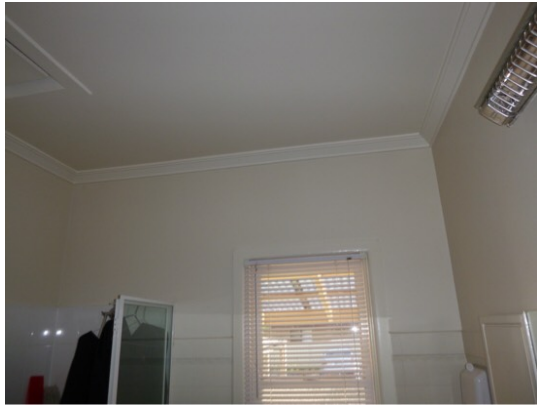
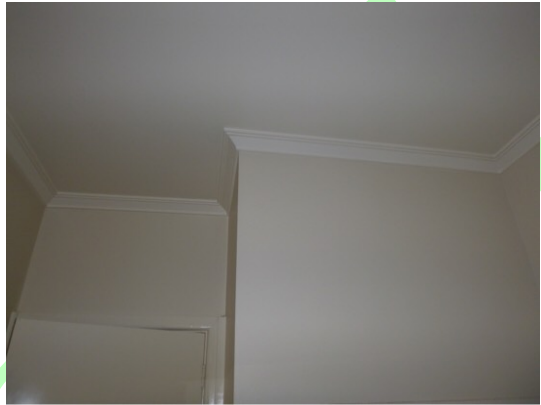
Building: Main Building  
Location: Bathroom  
Finding: No Visible Defects  
Information: At the time of inspection, no visible defects as a result of dilapidation were identified in this area.

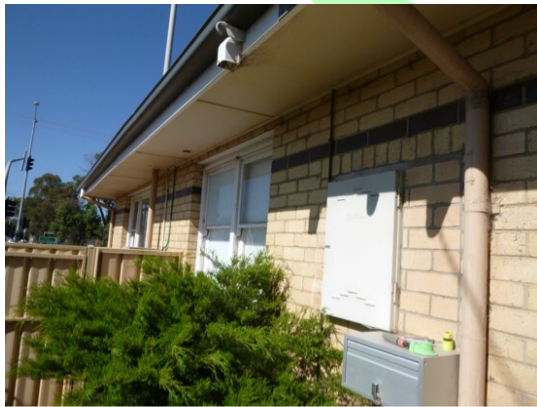
Building: Main Building  
Location: Right Elevation  
Finding: No Visible Defects  
Information: At the time of inspection, no visible defects as a result of dilapidation were identified in this area.

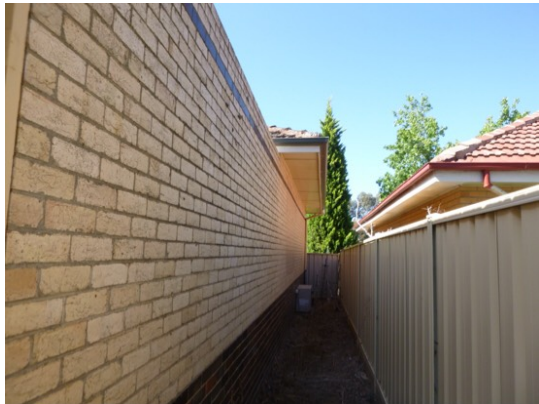
Building: Main Building  
Location: Left Elevation  
Finding: No Visible Defects  
Information: At the time of inspection, no visible defects as a result of dilapidation were identified in this area.
