Southern Queensland Correctional Precinct, Stage 2 or SQCP2

Site Works - Work list

May 16, 2025

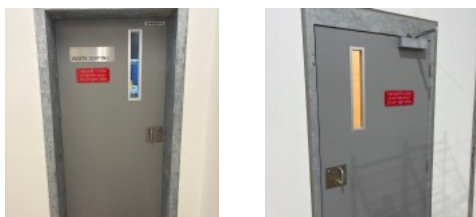
Apr 22, 2025 11:27 AM - Jim Bardsley (Lietzke Australia & Austral Monsoon Building Products): Work Completed  
Apr 14, 2025 11:40 AM - Matt Levitt (John Holland Delivery - Building): Assigned to Lietzke Australia & Austral Monsoon Building Products  
Apr 11, 2025 10:29 AM - Rod Bussing (DEPW): Assigned to John Holland Delivery - Building  
Apr 11, 2025 10:29 AM - Rod Bussing (DEPW): Updated  
Apr 11, 2025 10:29 AM - Rod Bussing (DEPW): Original defect not only included door closer and rectify hole in door frame head, but

also treatment of rust marks and damage to paintwork to both sides of door.

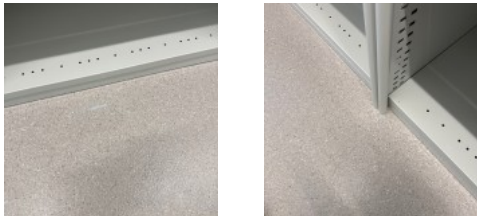
If further works are required all shelving would have to be removed and the whole floor replaced

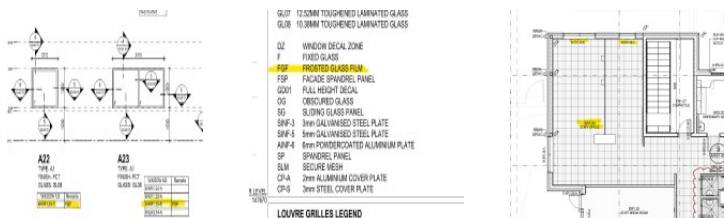
Jan 22, 2025 7:37 PM - Karl Ho (GBA - Guymer Bailey Architects): Updated  
Jan 22, 2025 7:37 PM - Karl Ho (GBA - Guymer Bailey Architects): There is sufficient information on AR-E1-701. See attachment.
