## **2 Palmview Forest Drive, Palmview PRE-CONSTRUCTION CONDITION SURVEY**

**Project: Caloundra Road to Sunshine Motorway Upgrade**

**Document No: BE150388-CS-001**

**Inspection Date: 18 May 2017**

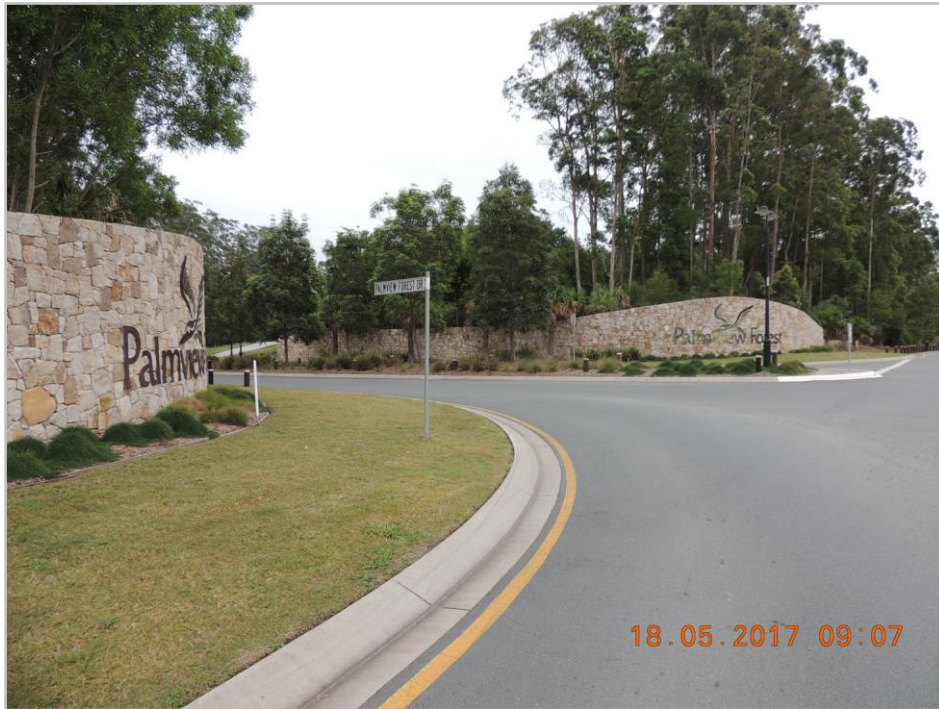
Photograph 1: Subject property viewed looking north west

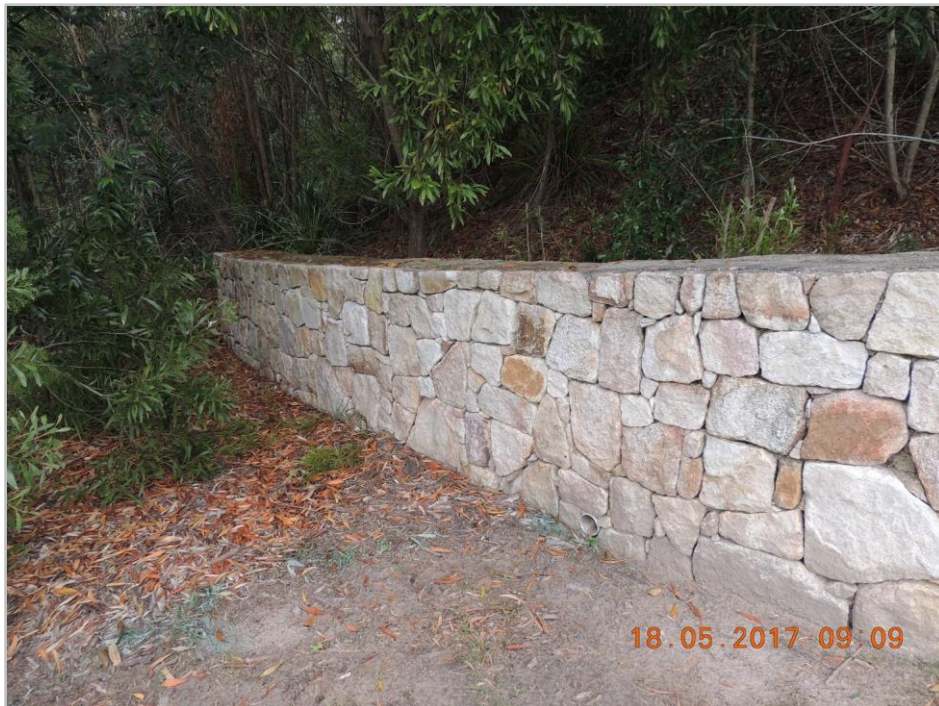
Photograph 2: General view, south east corner, south wall viewed looking south west  
Generally appears to be in fair condition

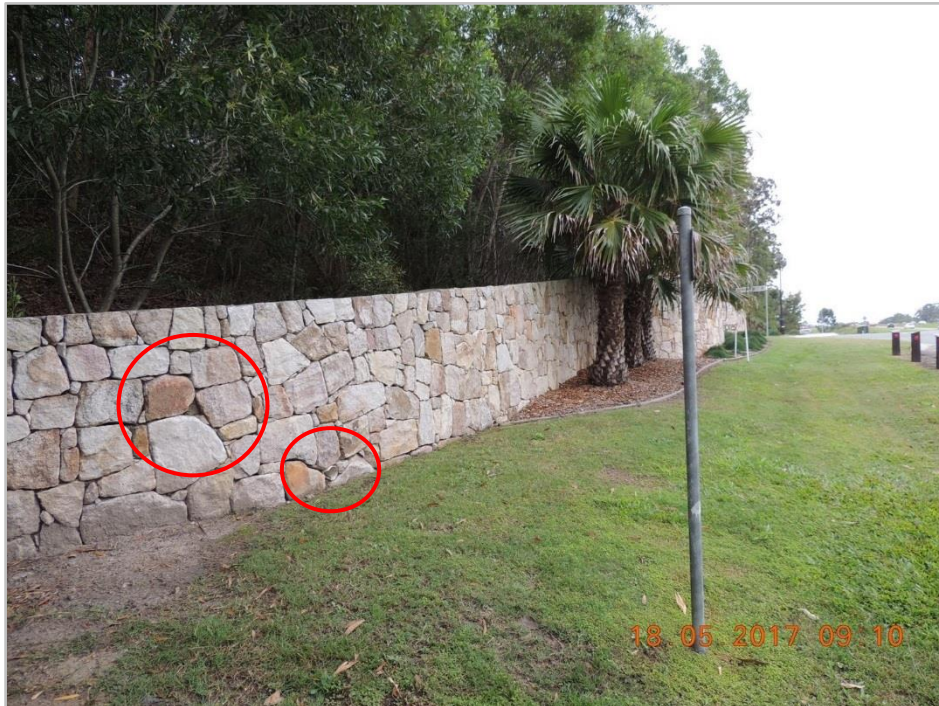
Photograph 3: General view, east side, south wall viewed looking north west  
Stone missing, damaged pipe

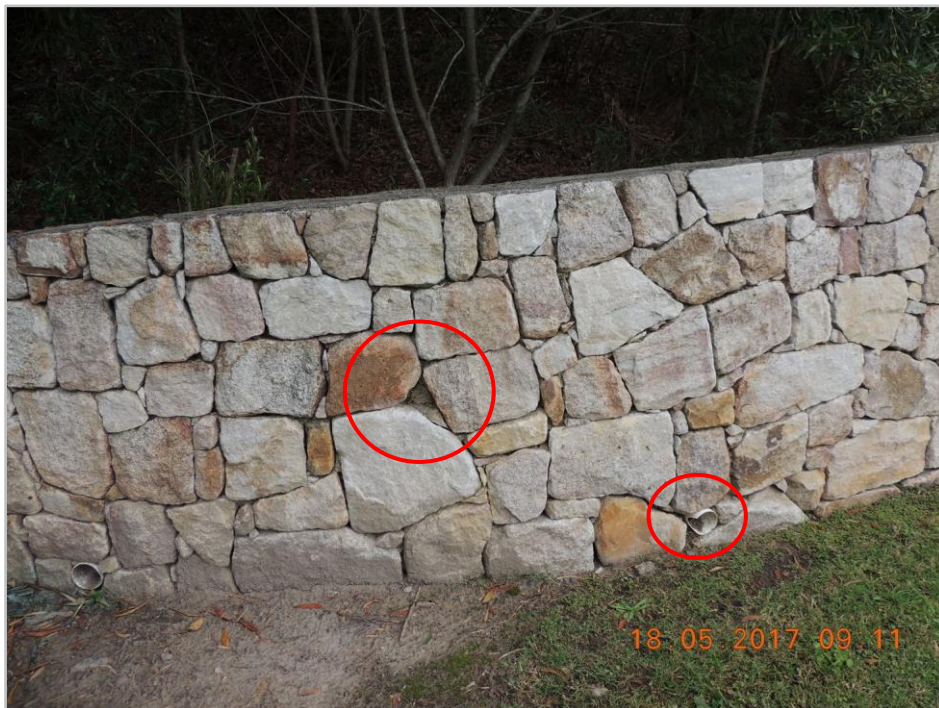
Photograph 4: East side, south wall viewed looking west  
Close view of Photograph 3 – stone missing, damaged pipe

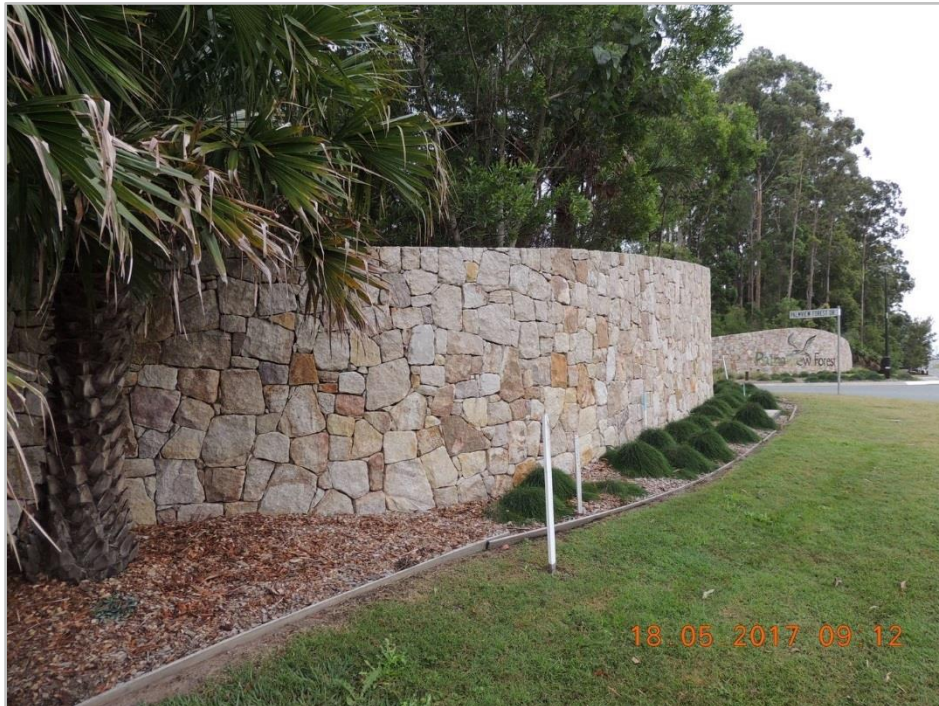
Photograph 5: General view, east side, south wall viewed looking north west  
Generally appears to be in fair condition

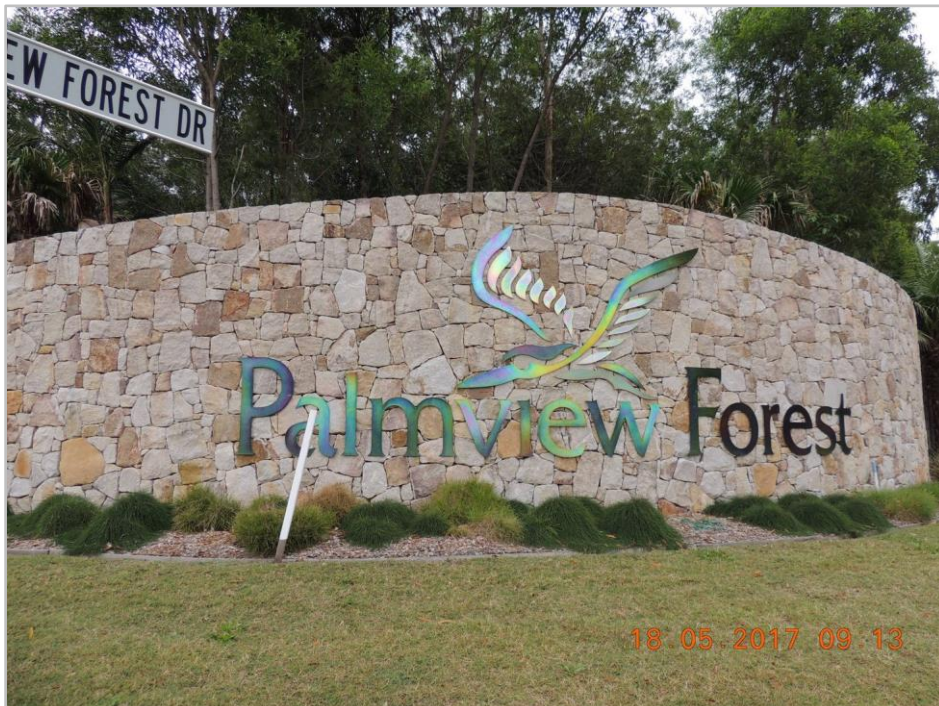
Photograph 6: General view, north east corner, south wall viewed looking south west  
Generally appears to be in fair condition

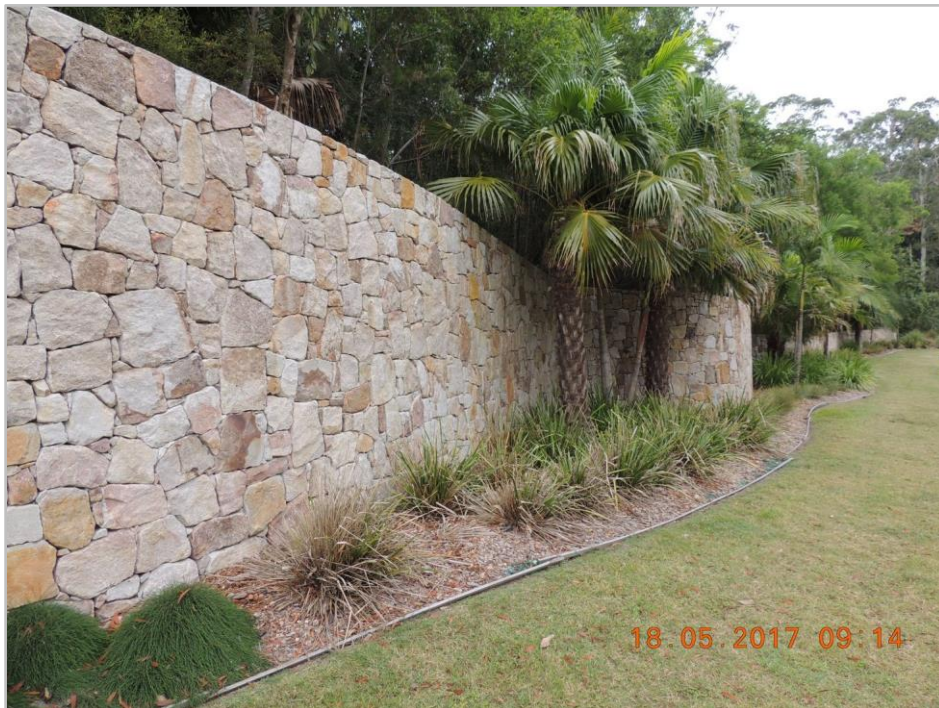
Photograph 7: General view, north side, south wall viewed looking south west  
Generally appears to be in fair condition

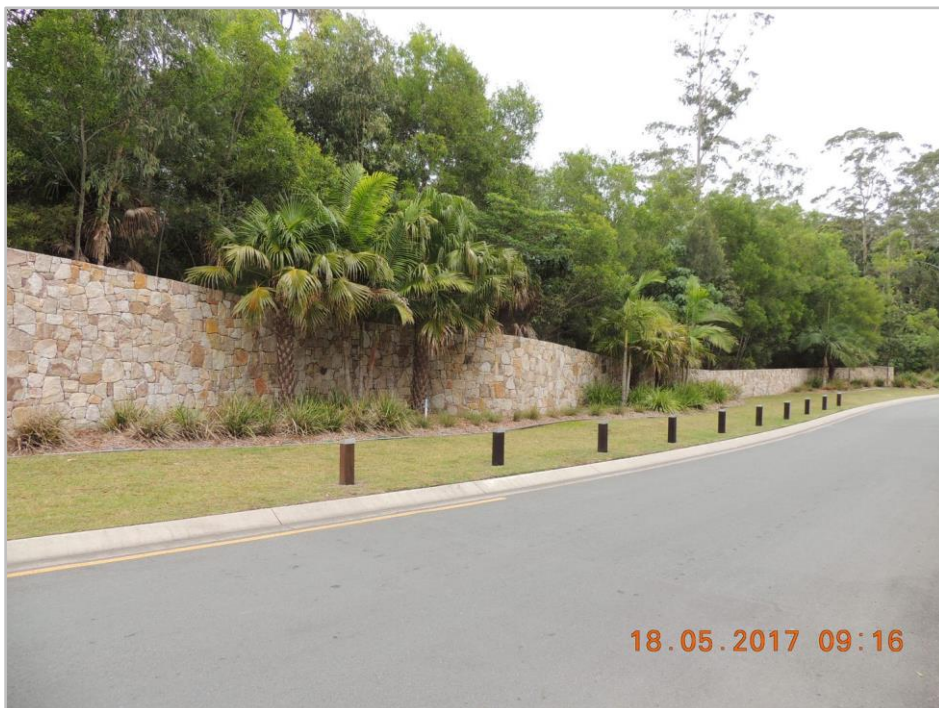
Photograph 8: General view, north side, south wall viewed looking south west

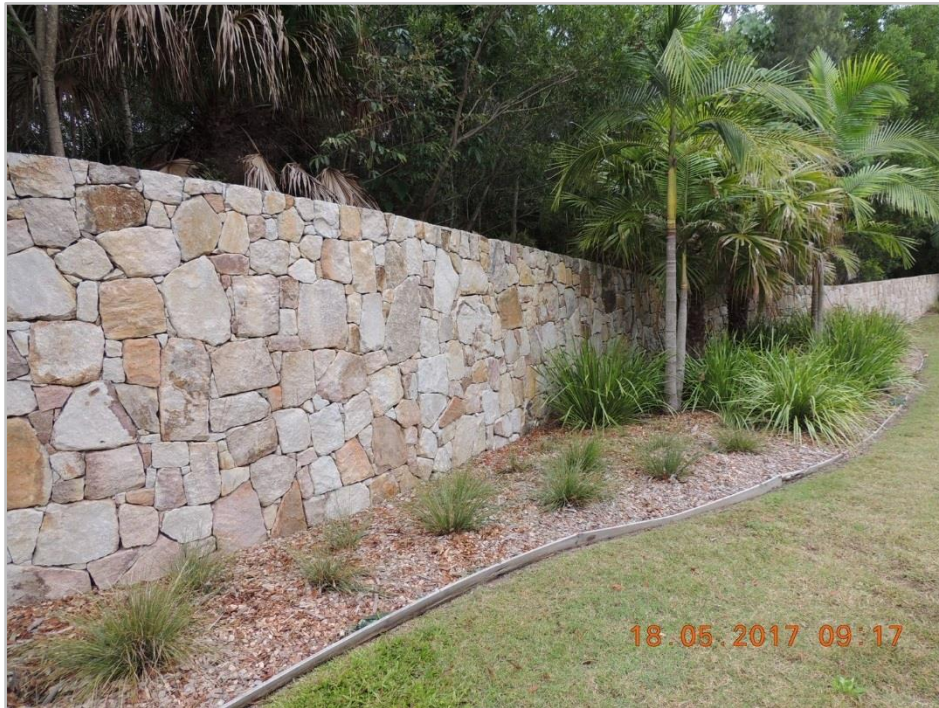
Photograph 9: General view, north side, south wall viewed looking south west  
Generally appears to be in fair condition

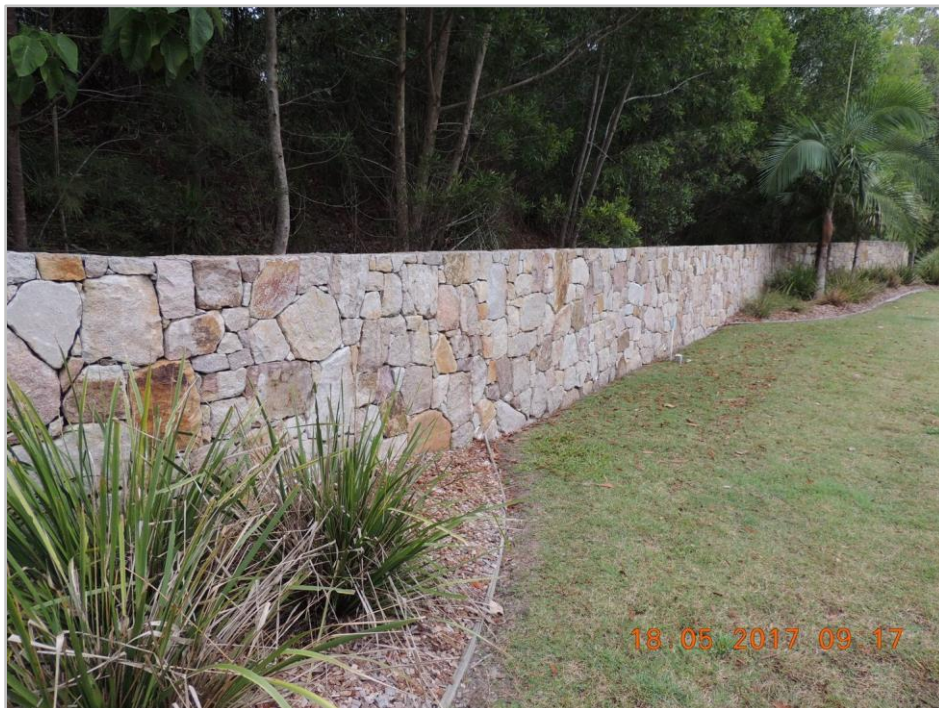
Photograph 10: General view, north side, south wall viewed looking south west  
Generally appears to be in fair condition

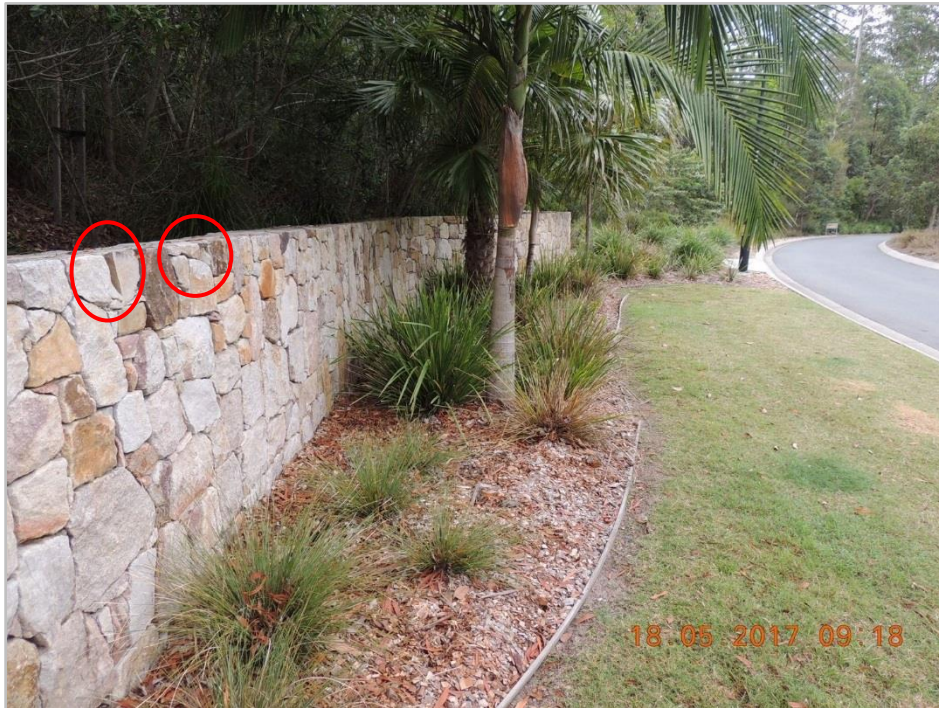
Photograph 11: General view, north side, south wall viewed looking west  
Cracked and damaged stone, missing stone

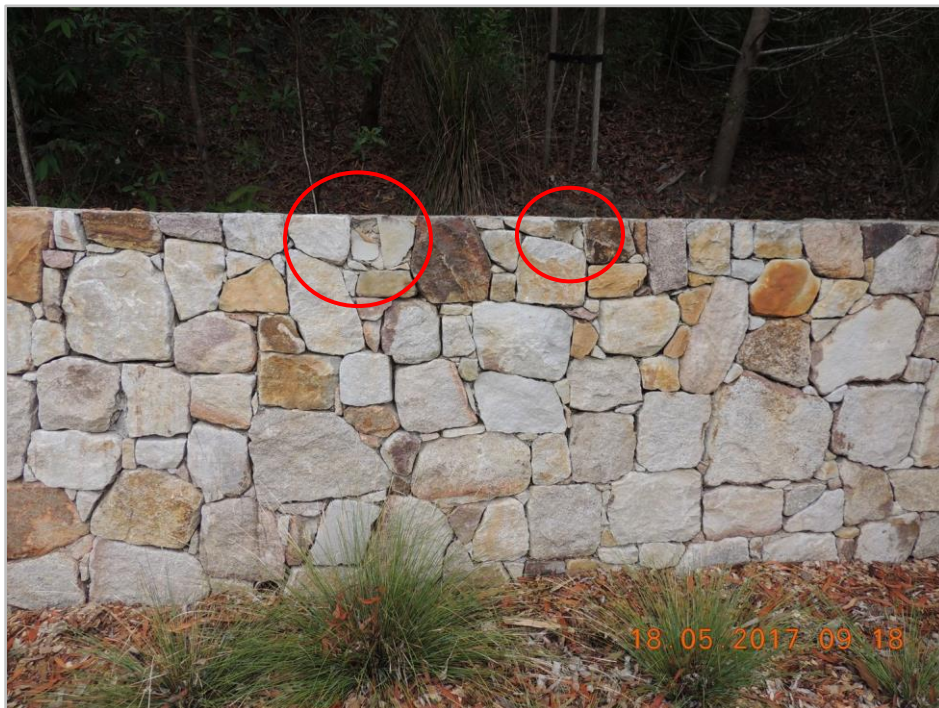
Photograph 12: North side, south wall viewed looking south  
Close view of Photograph 11 – cracked and damaged stone, missing stone

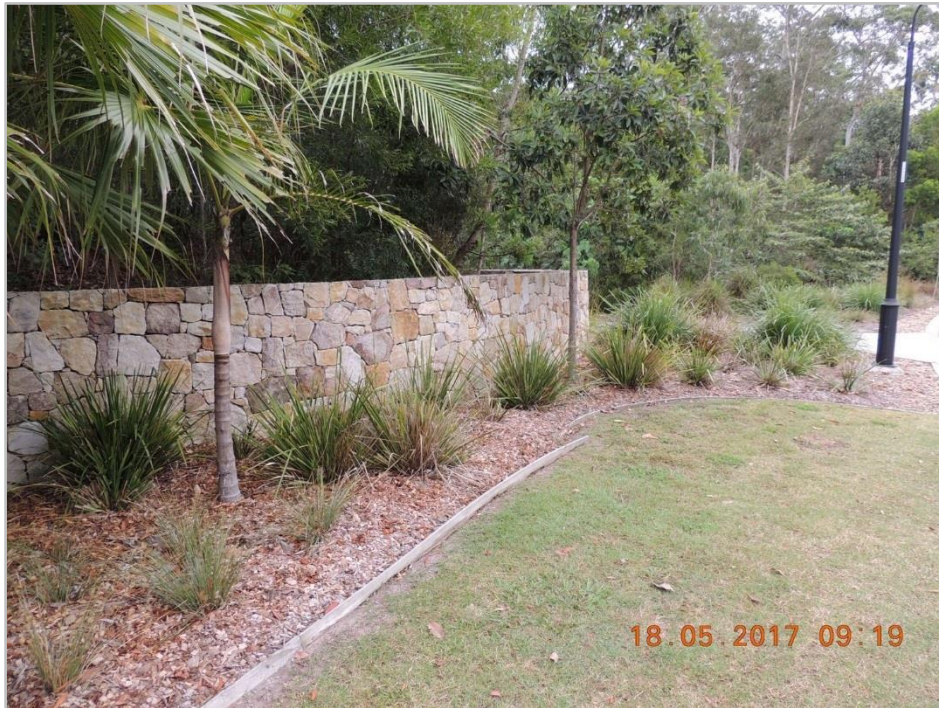
Photograph 13: General view, north side, south wall viewed looking south west  
Generally appears to be in fair condition

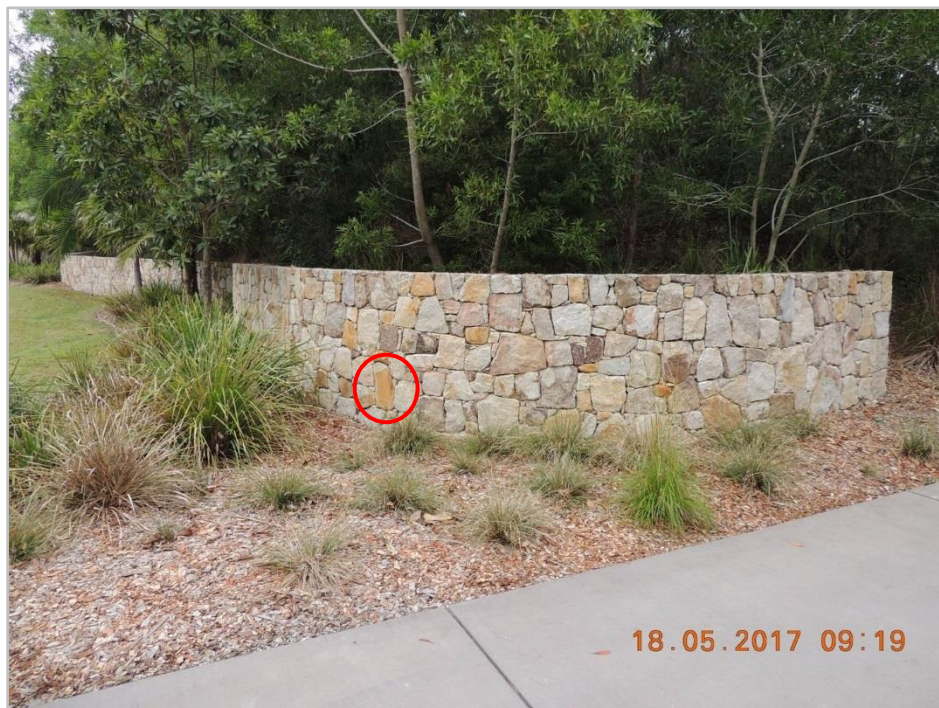
Photograph 14: General view, west corner, south wall viewed looking south east  
Cracked stone

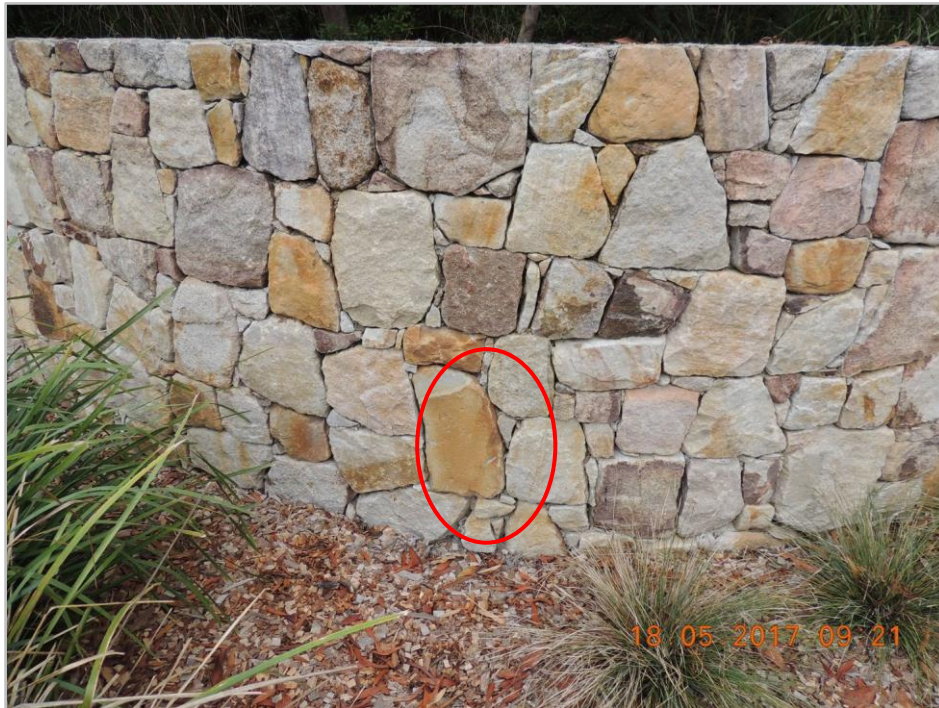
Photograph 15: West corner, south wall viewed looking south east  
Close view of Photograph 14 – cracked stone

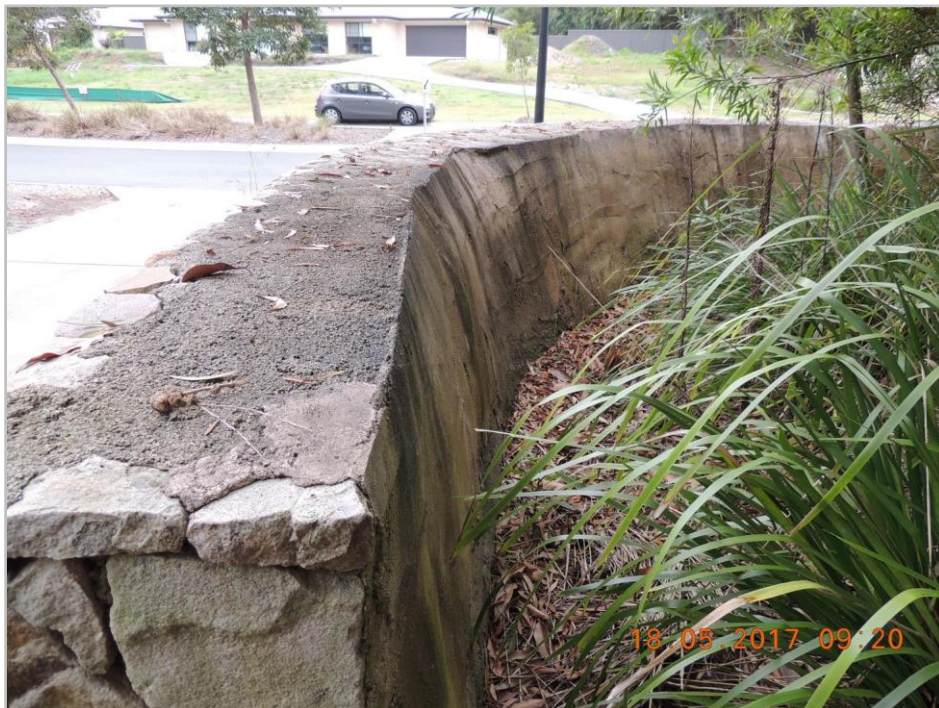
Photograph 16: General view, west corner, south wall viewed looking north  
Restricted visibility due to vegetation, generally appears to be in fair condition

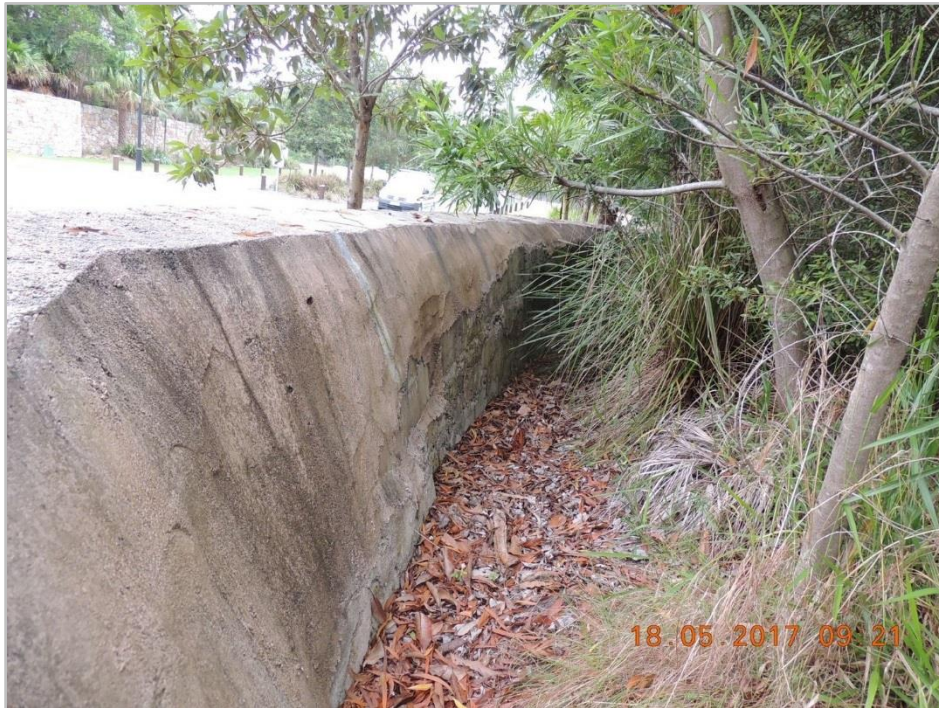
Photograph 17: General view, west corner, south wall viewed looking north east  
Restricted visibility due to vegetation, generally appears to be in fair condition

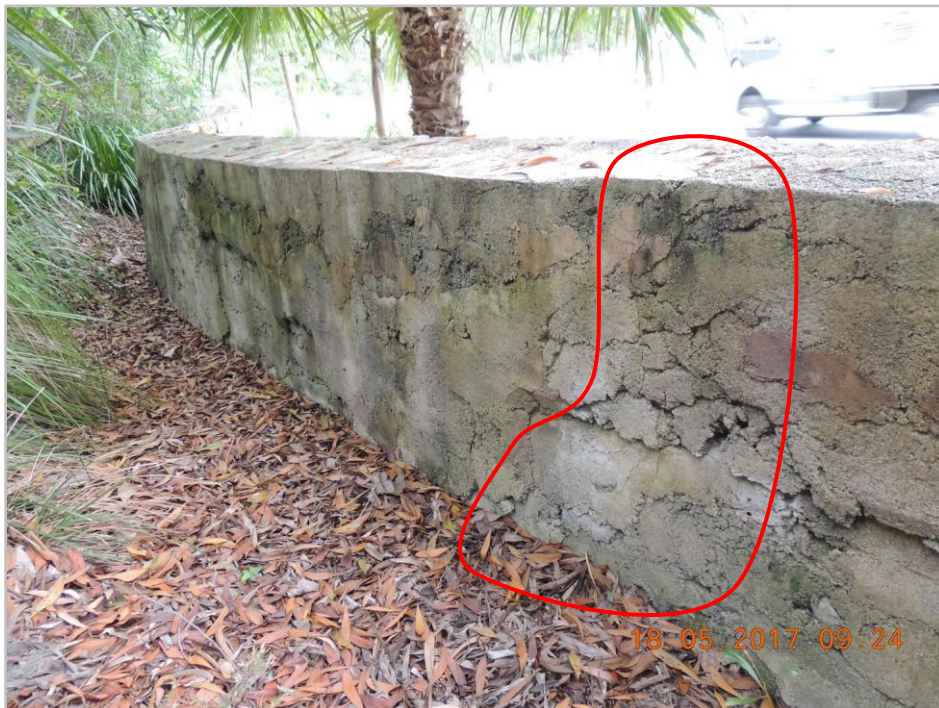
Photograph 18: General view, north side, south wall viewed looking north west  
Cracked concrete

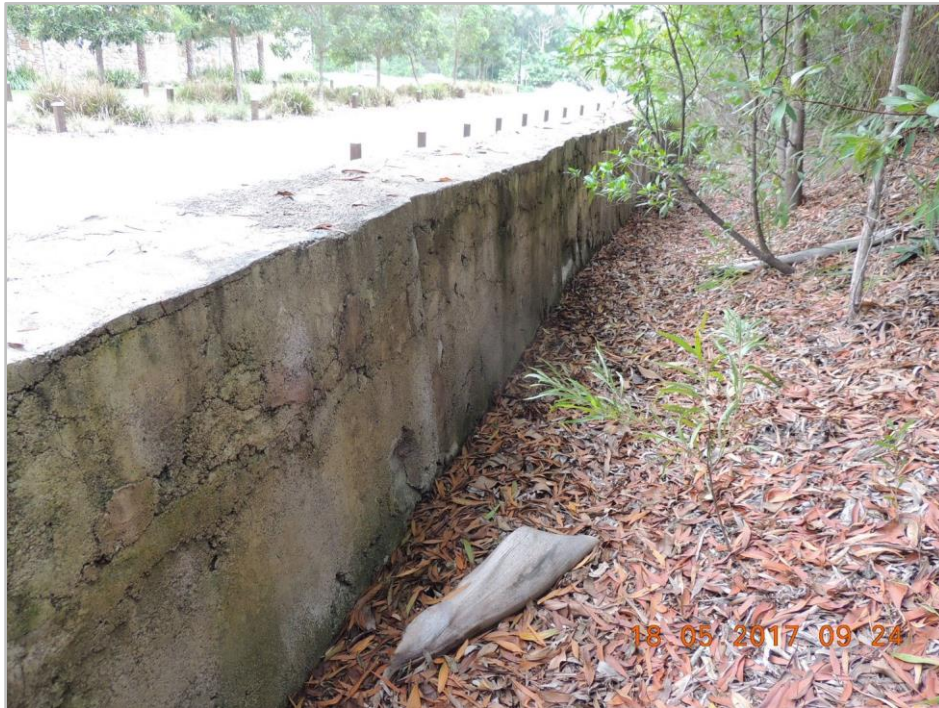
Photograph 19: General view, north side, south wall viewed looking east  
Generally appears to be in fair condition

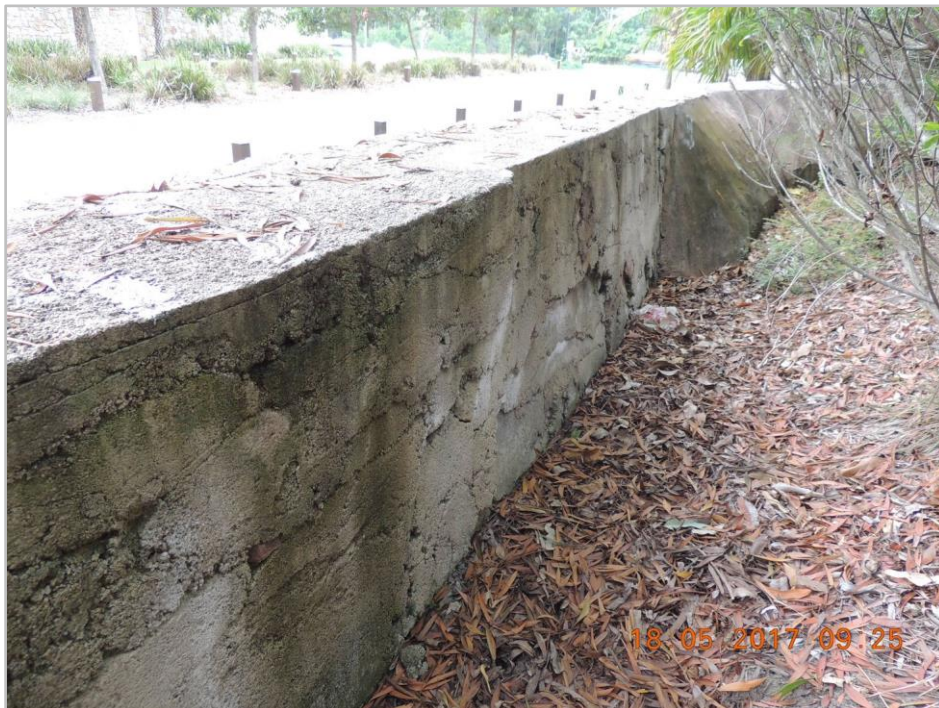
Photograph 20: General view, north side, south wall viewed looking east  
Generally appears to be in fair condition

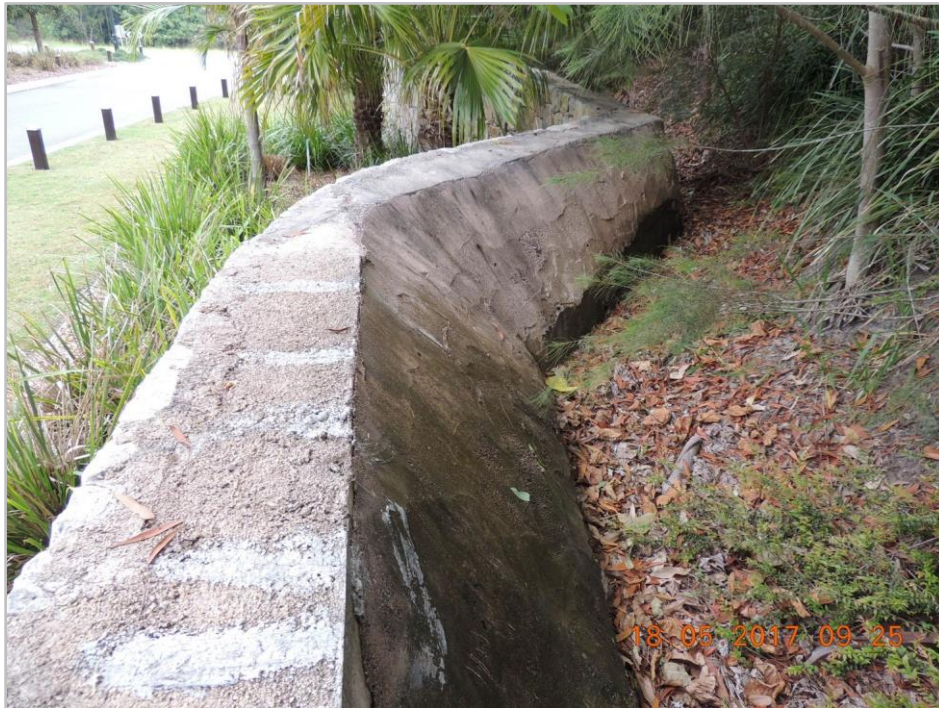
Photograph 21: General view, north side, south wall viewed looking east  
Generally appears to be in fair condition

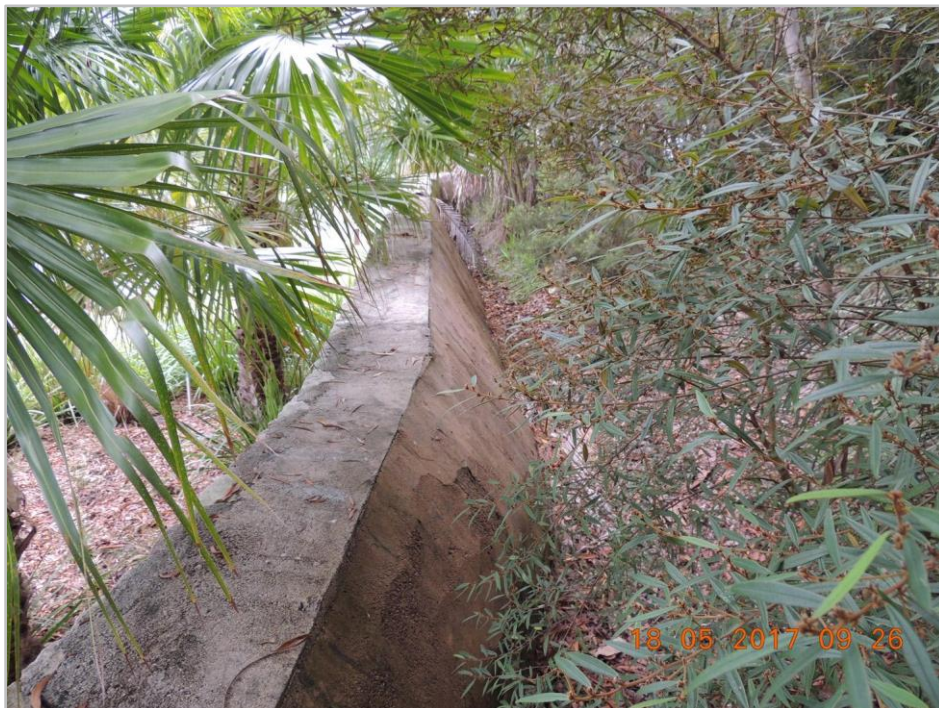
Photograph 22: General view, north side, south wall viewed looking east  
Restricted access and visibility due to vegetation

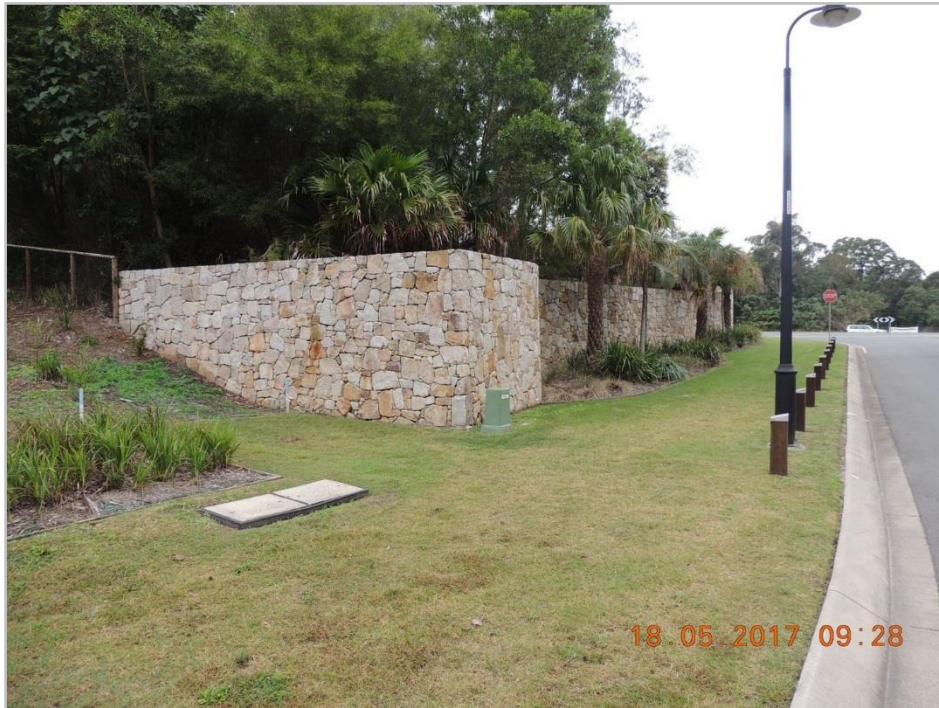
Photograph 23: General view, west corner, north wall viewed looking north east

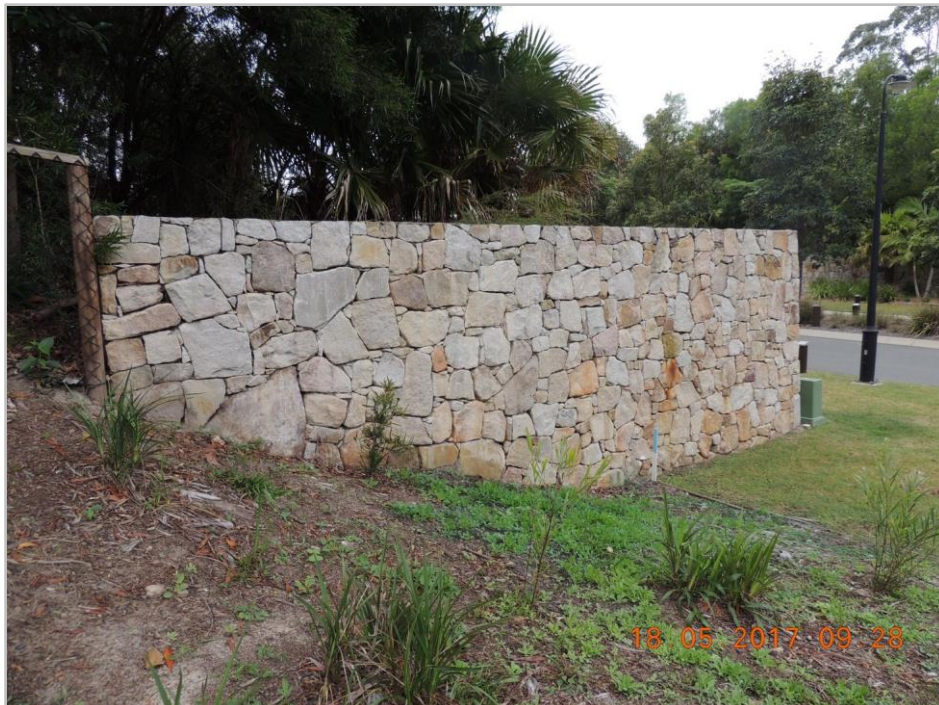
Photograph 24: General view, west side, north wall viewed looking south east

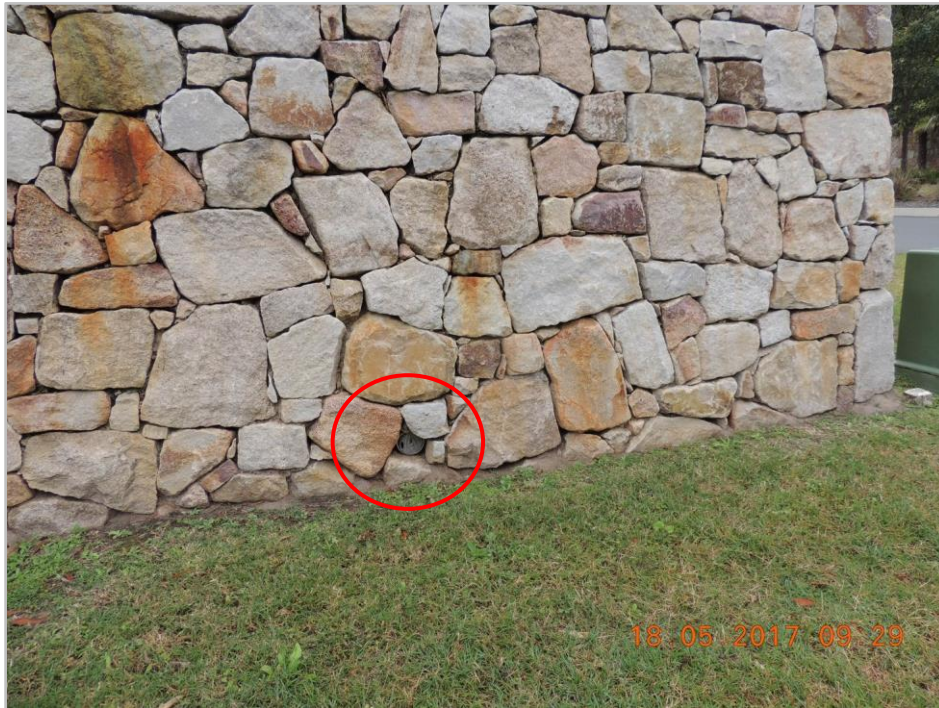
Photograph 25: General view, west side, north wall viewed looking east  
Blocked pipe

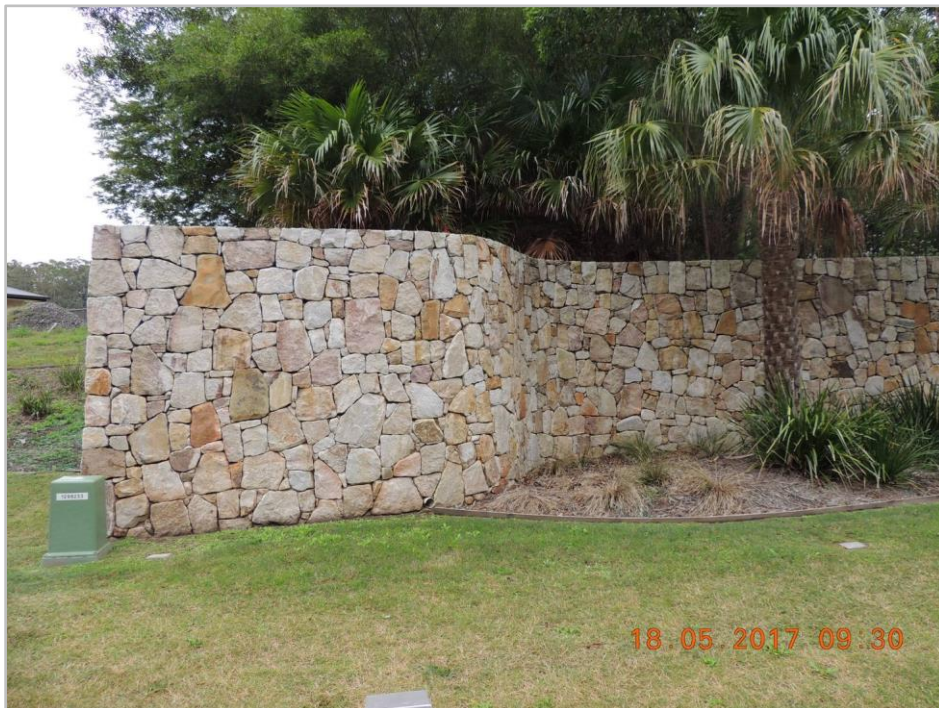
Photograph 26: General view, south side, north wall viewed looking north  
Generally appears to be in fair condition

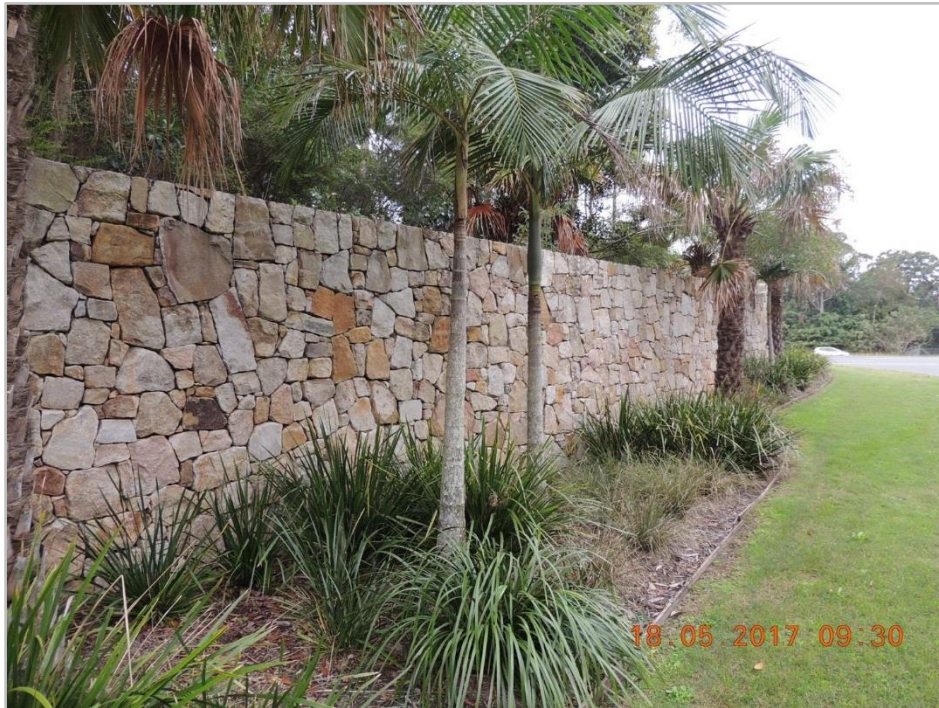
Photograph 27: General view, south side, north wall viewed looking north east  
Generally appears to be in fair condition

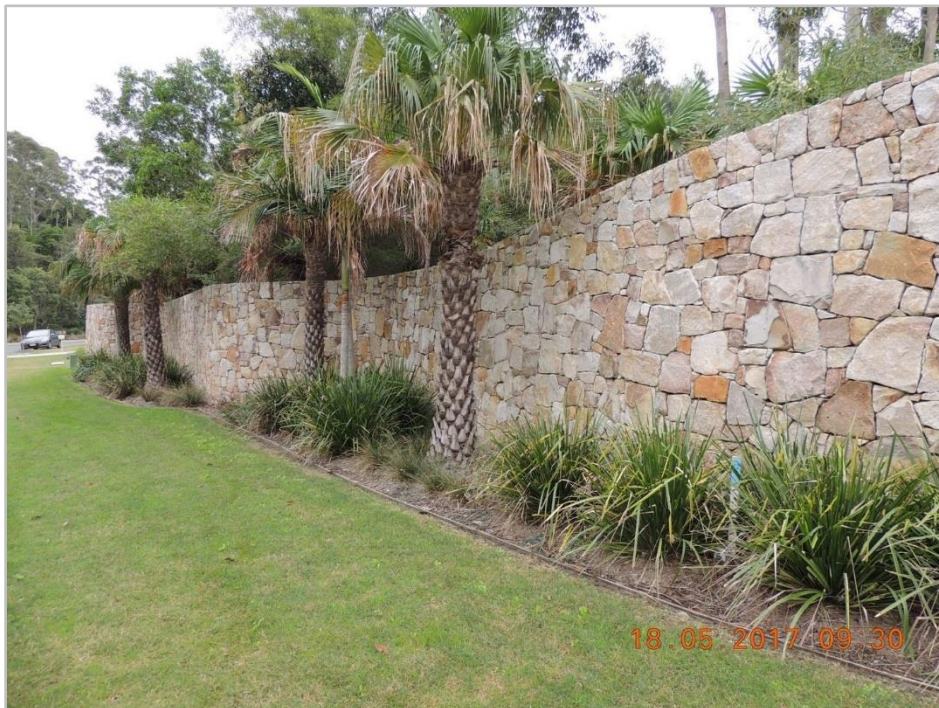
Photograph 28: General view, south side, north wall viewed looking north west  
Generally appears to be in fair condition

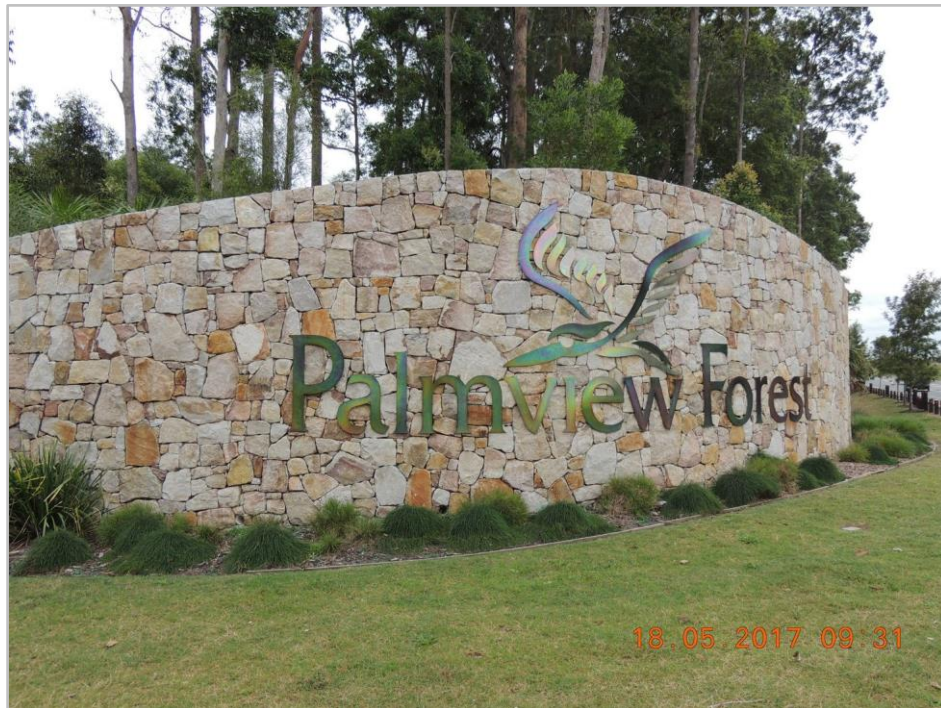
Photograph 29: General view, south east corner, north wall viewed looking north  
Generally appears to be in fair condition

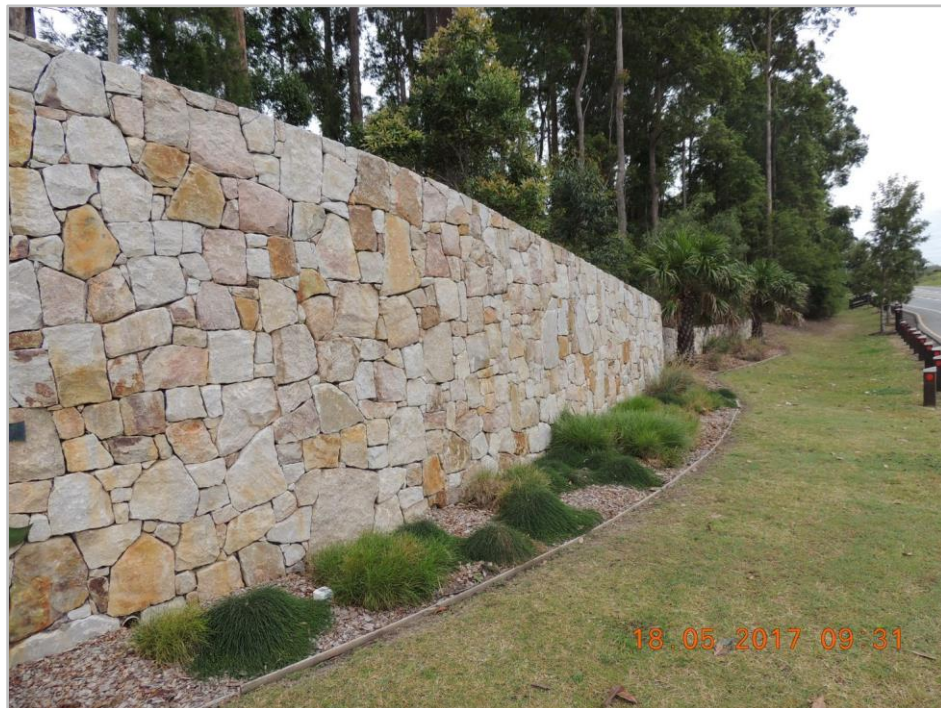
Photograph 30: General view, east side, north wall viewed looking north  
Generally appears to be in fair condition

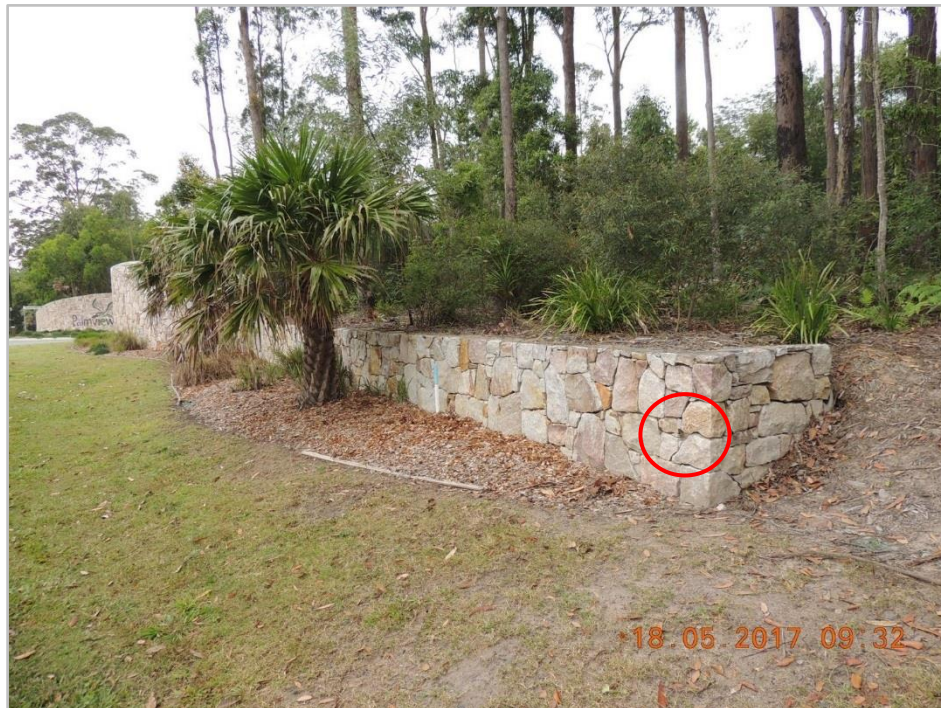
Photograph 31: General view, north east corner, north wall viewed looking south west  
Missing stone

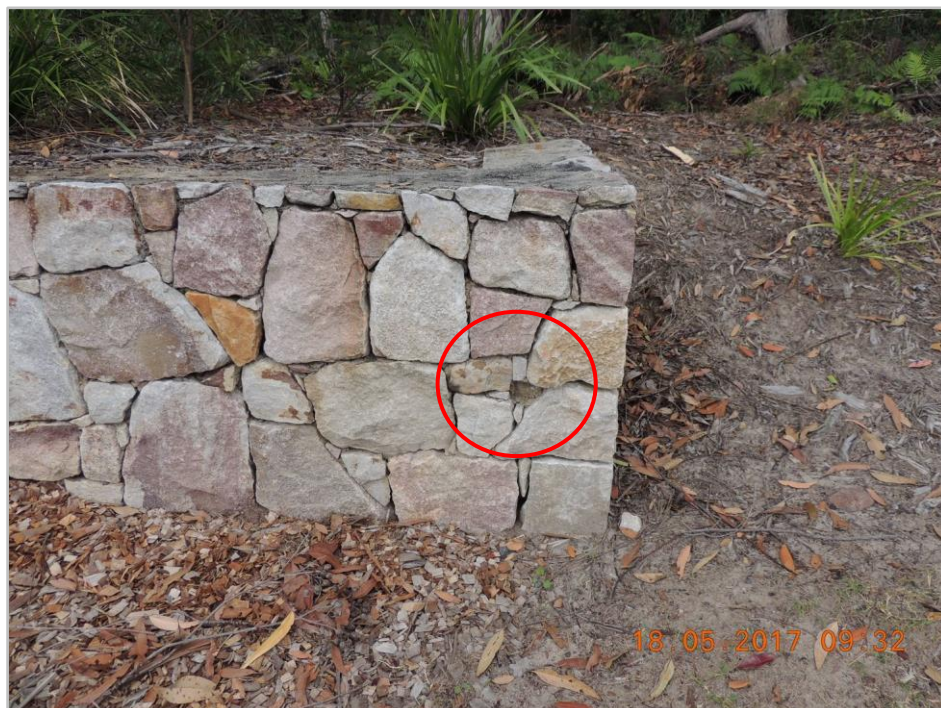
Photograph 32: North east corner, north wall viewed looking west  
Close view of Photograph 31 – missing stone

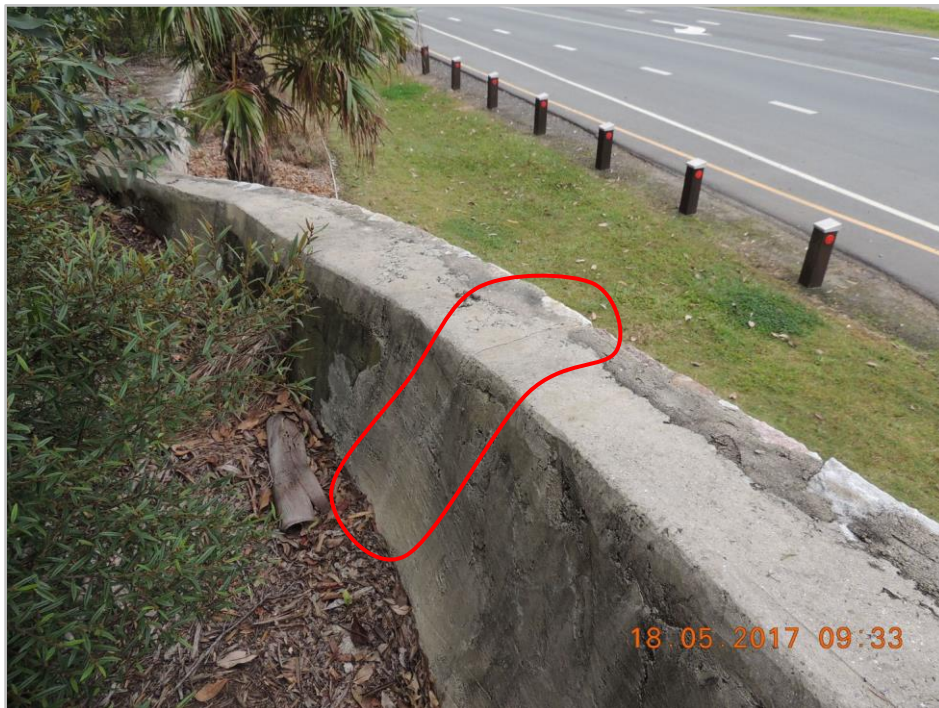
Photograph 33: East side, north east wall viewed looking north east  
Cracked concrete
