## **2 Palmview Forest Drive, Palmview PRE-CONSTRUCTION CONDITION SURVEY**

**Project: Caloundra Road to Sunshine Motorway Upgrade**

**Document No: BE150388-CS-001**

**Inspection Date: 18 May 2017**

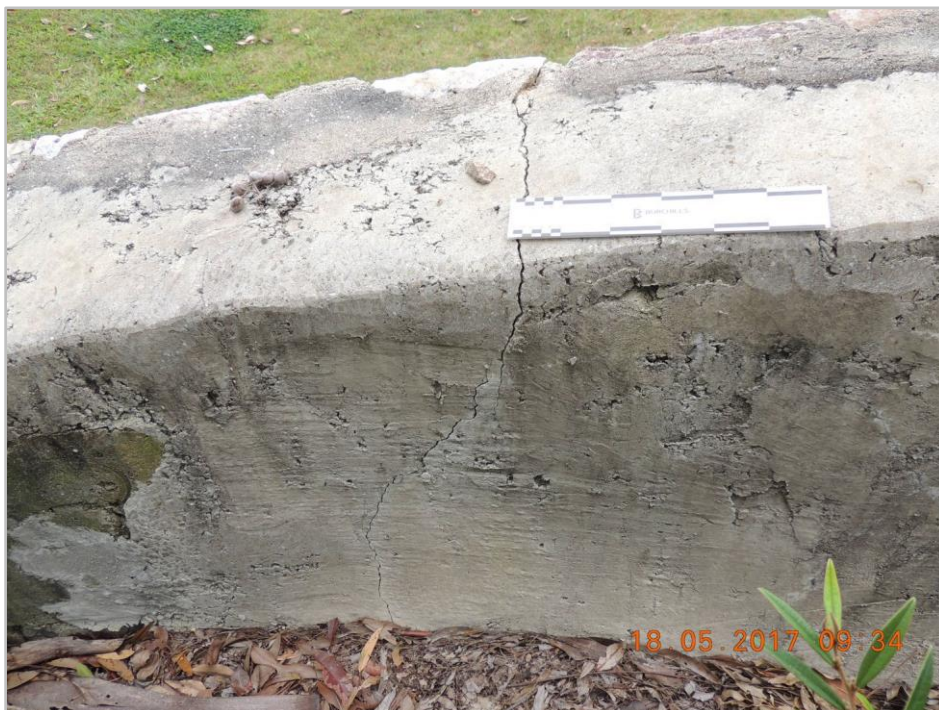
Photograph 34: East side, north east wall viewed looking north east  
Cracked concrete

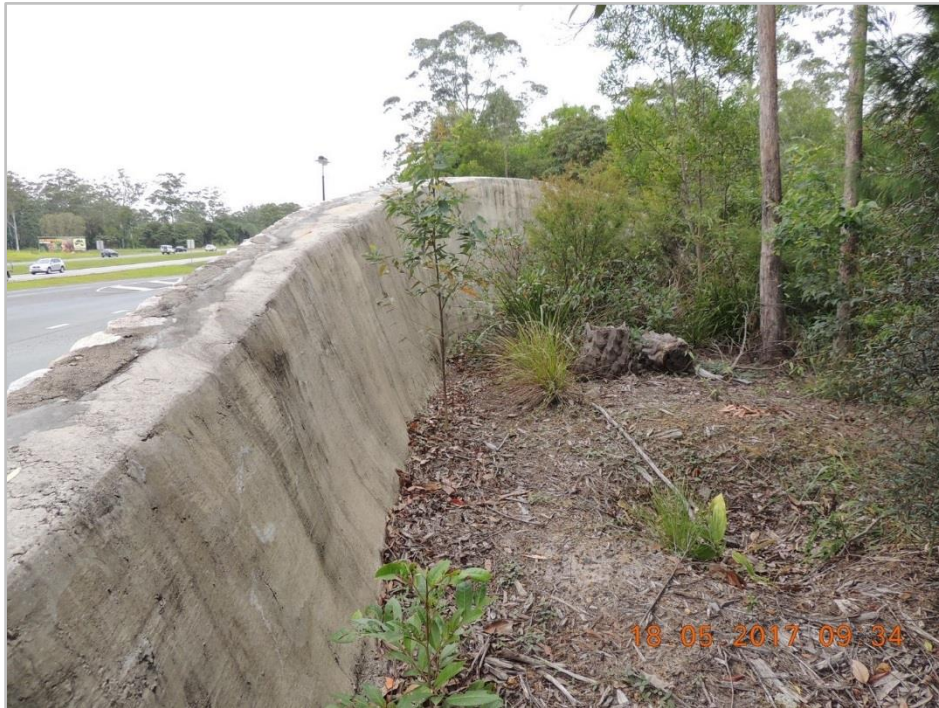
Photograph 35: General view, south east corner, north wall viewed looking south  
Restricted visibility and access due to vegetation
