# INCIDENT REPORT & INVESTIGATION

| Project: (inc. Job No.) | | Mayfair Stormwater and Reconstruction Project 0807a | | | | | Date: | | 14/02/24 | | |
| Location: | | Mayfair Drive Emerald. | | | | | | | | | |

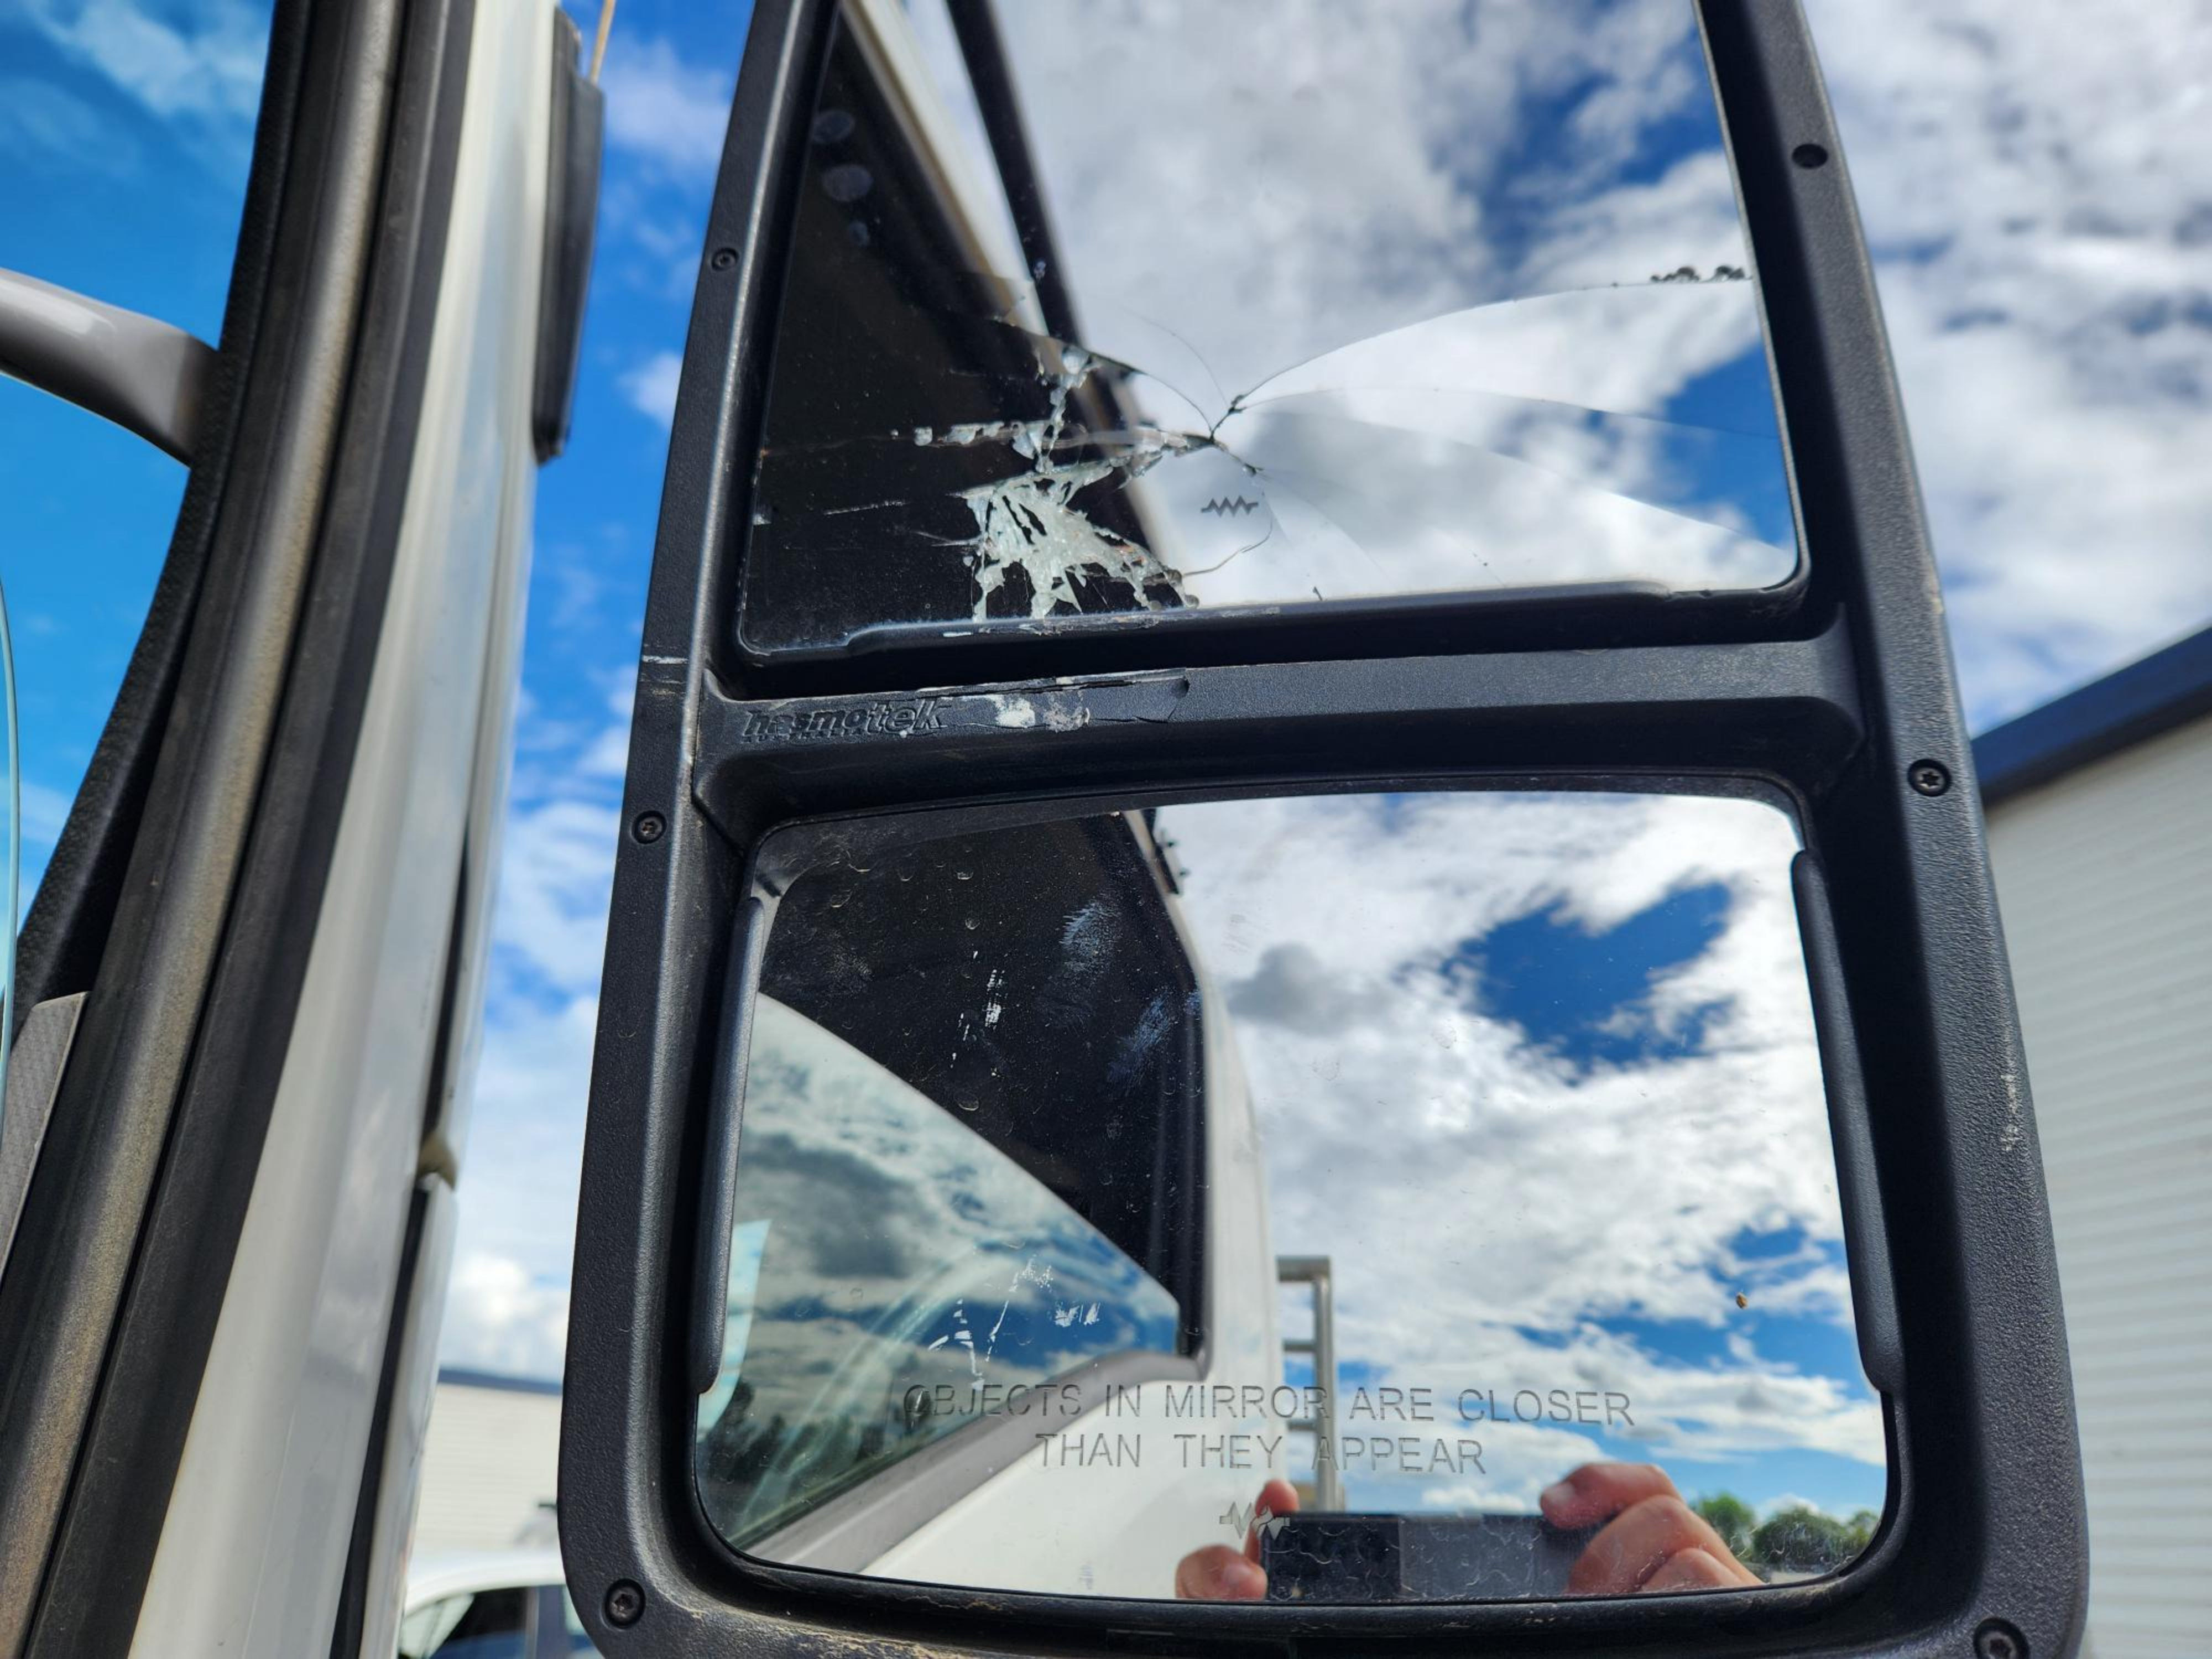
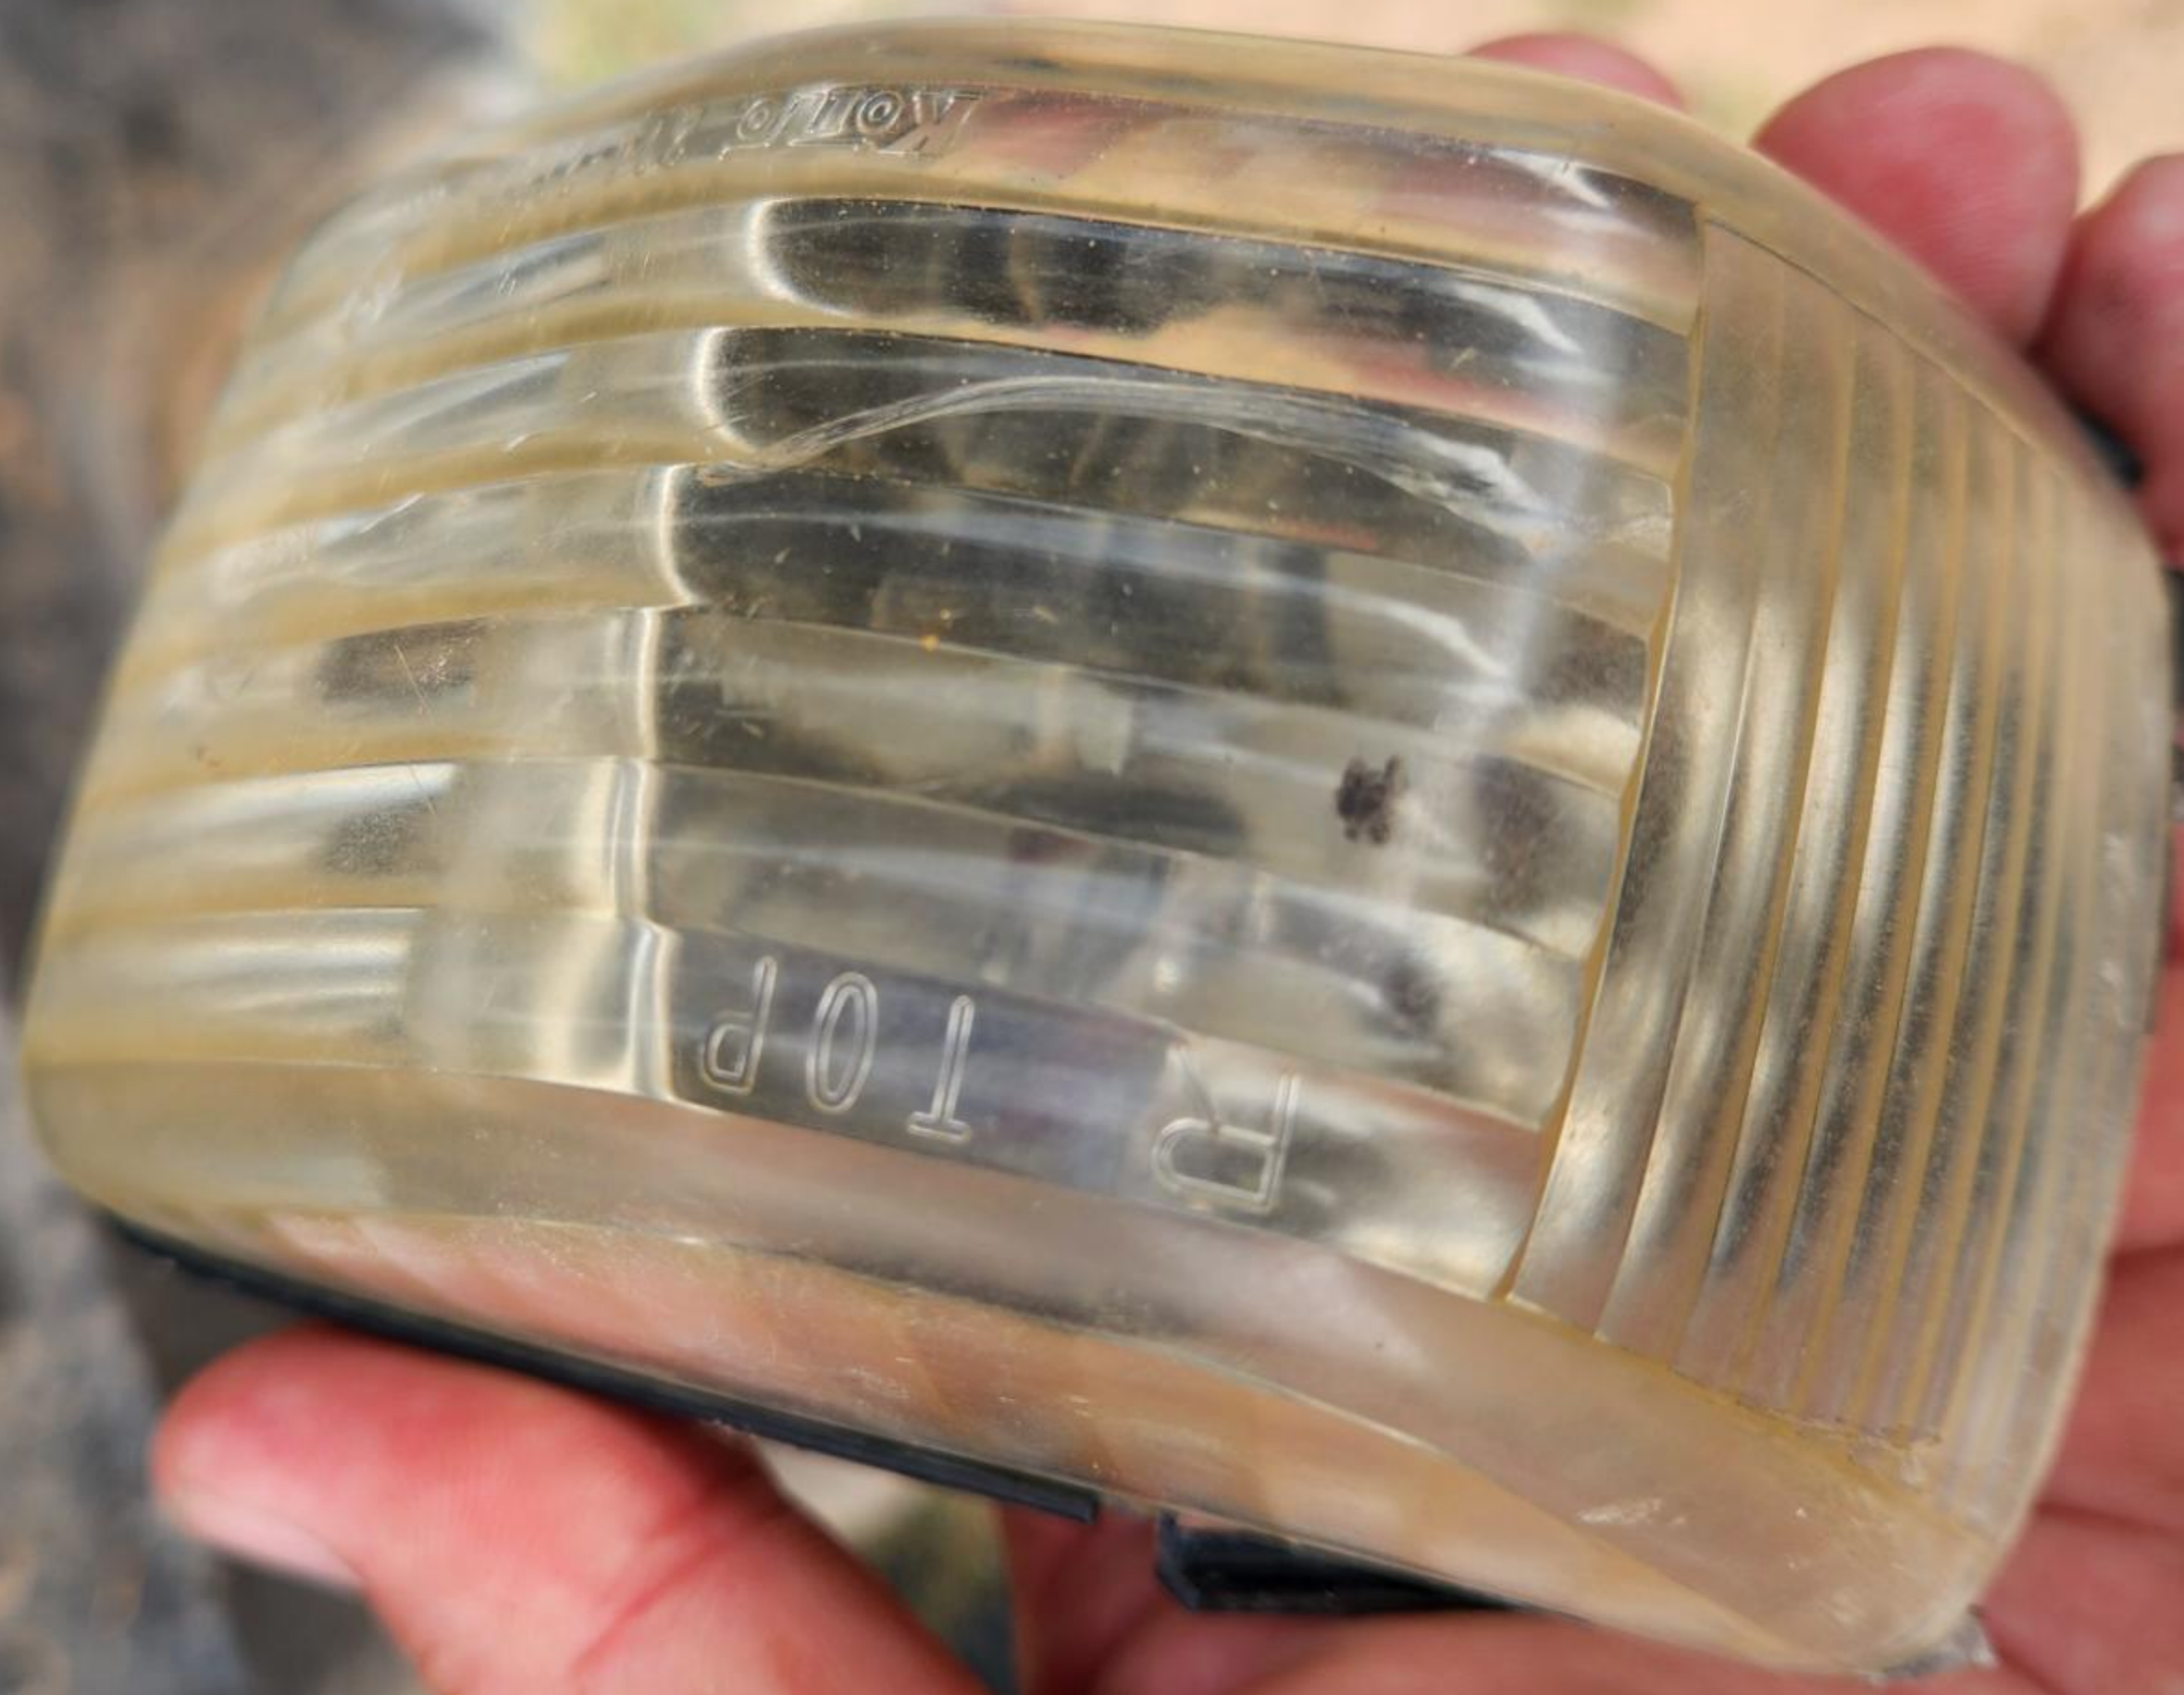
| Damage: (What was damaged?) | | - Cracked Side Mirror Drivers side<br>- Indicator Cover Broken + Popped off.<br>- front Quarter Panel Popped + clip broken, No damage to Panel | | | | | | | | | |

| | Description of how incident happened: <i>Provide sketch and photos if possible</i><br>Was Reversing back had to go left hand down to ground corner<br>Clipped back of life<br>- SC80 Was Reversing in to be loaded with Material, SC92 was parked on the side of the corner in the work area.<br>SC80's mirror clipped the steel rack on SC92 and also the side indicator resulting in the indicator cover popping off and front Quarter panel popping a plastic clip.<br>Nil Damage to SC92 | | | | |
| | Describe all contributing factors (environment / task / experience):<br>Not much Space Small area light vehicle parked in area<br>- tight work area, multiple crews working concurrently in a small area. | | | | |
