## Defect Inspection

Completed by Michael Trott

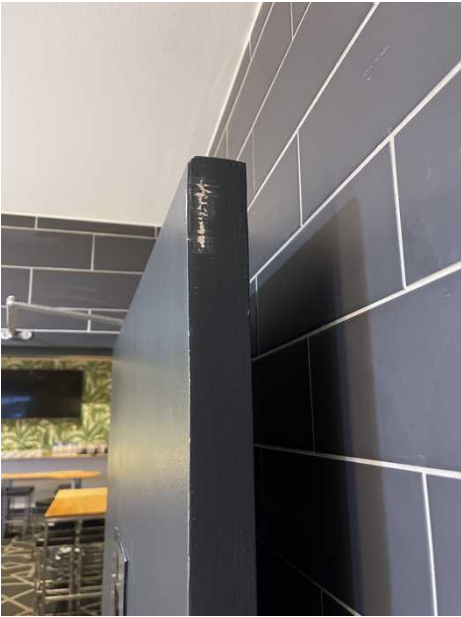
**Photo 1**

Door rubbing on frame causing paint to come off  
Plain then paint again

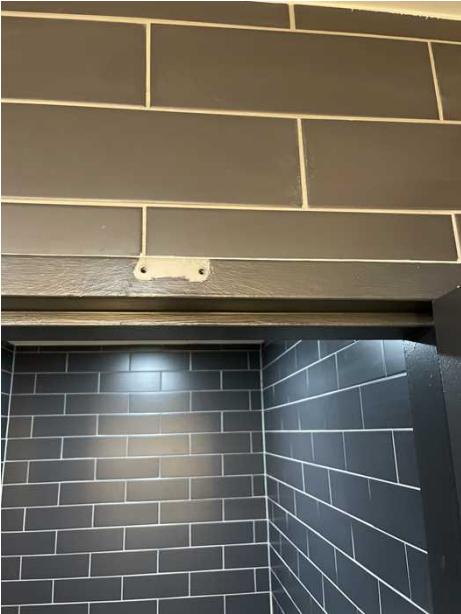
**Photo 2**

**Photo 2 - Details**  
Need door closer on middle door

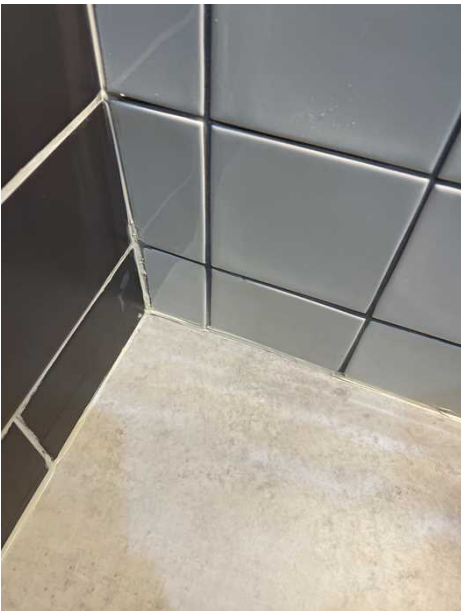
**Photo 3**

**Photo 3 - Details**  
All silicone work needs to be done again

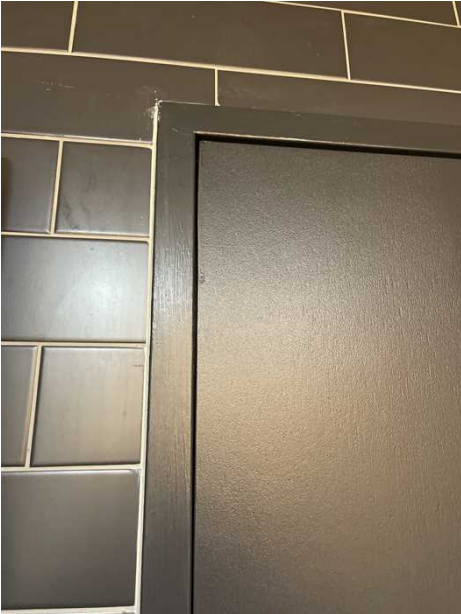
**Photo 4**

Middle door needs plaining as is rubbing then needs to be painting again

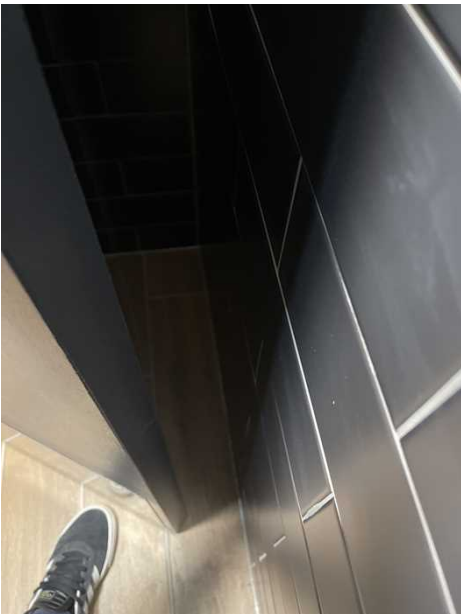
**Photo 5**

Two door stops to install

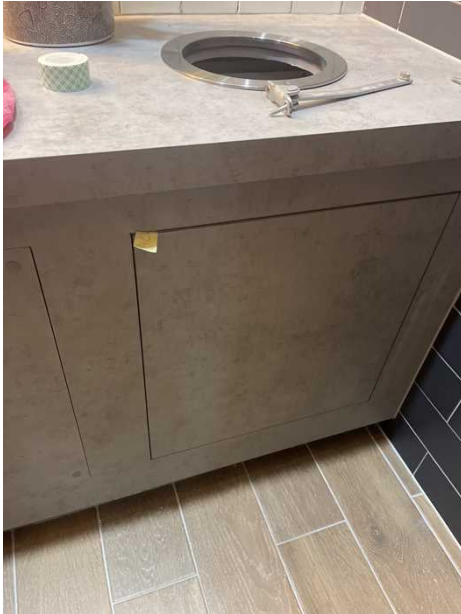
**Photo 6**

**Photo 6 - Details**  
Handle or push cap to install on door
