## Scanning Report

20 May 2024

| Address | 85 Deakin St, Kangaroo Point QLD |
| Scope of Works | *Imaging of structural beam for the presents of concrete cancer/spalling.<br>*Provide information pertaining to reinforcement depth and spacings.<br>* Imaging of reinforcement condition. |

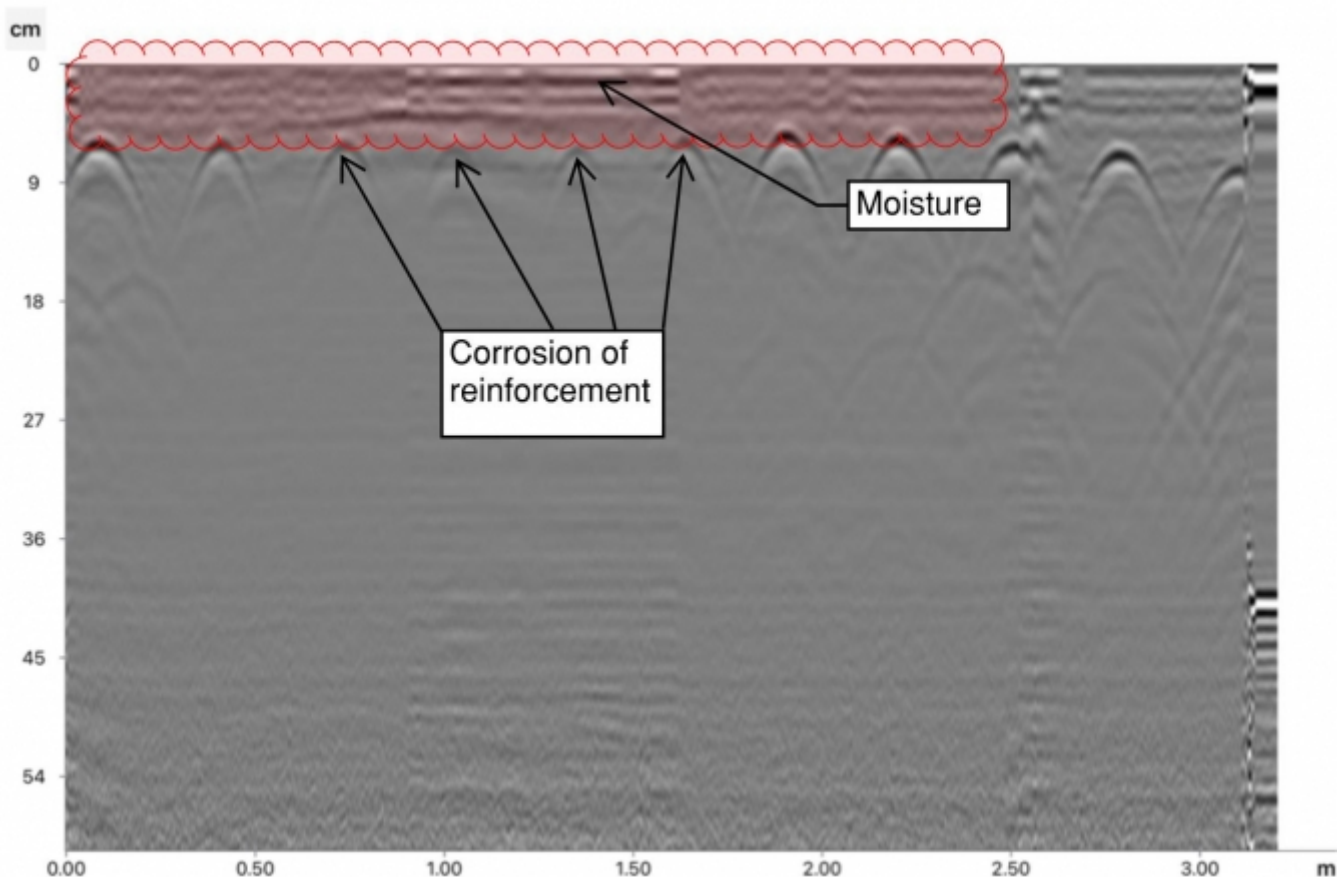
Location: Soffit

| Job Notes | As can be seen in the image attached, weak amplitude signals indicate corrosion of the reinforcement. Also highlighted in the image is high levels of moisture present. |

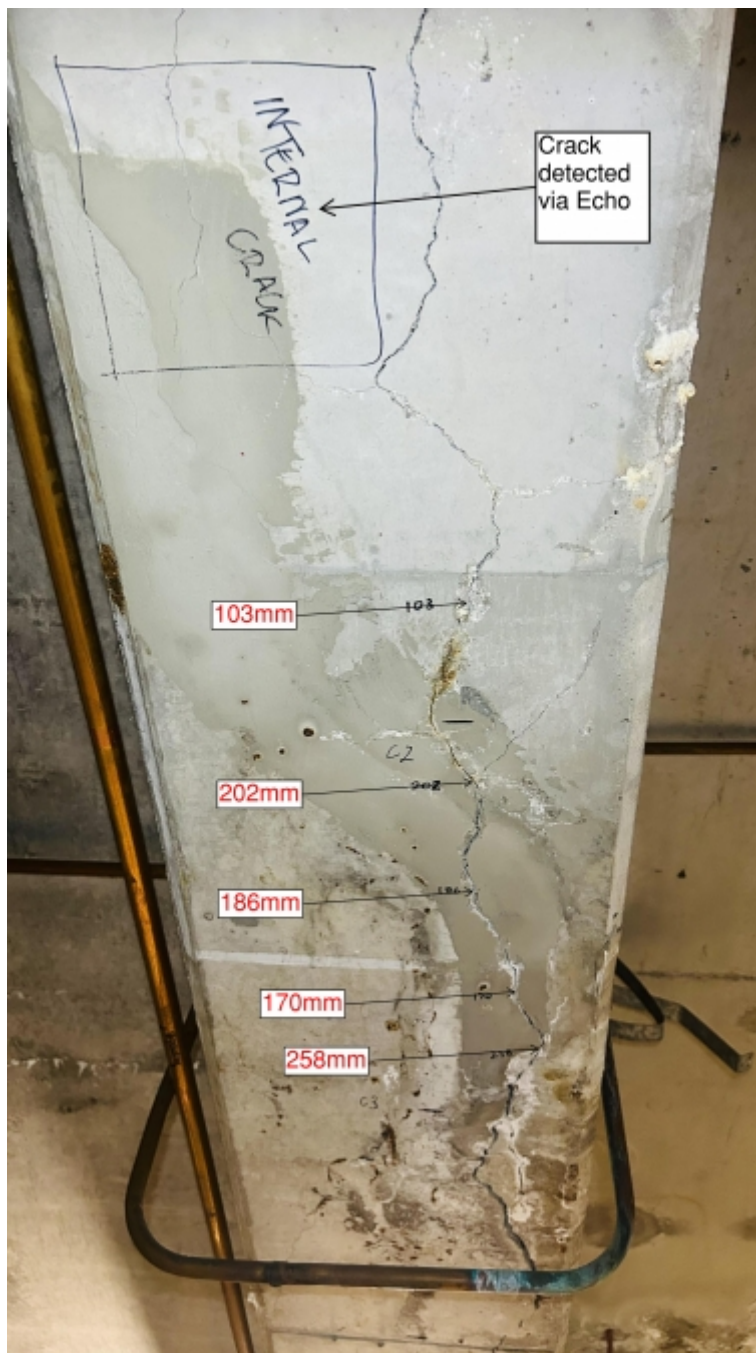
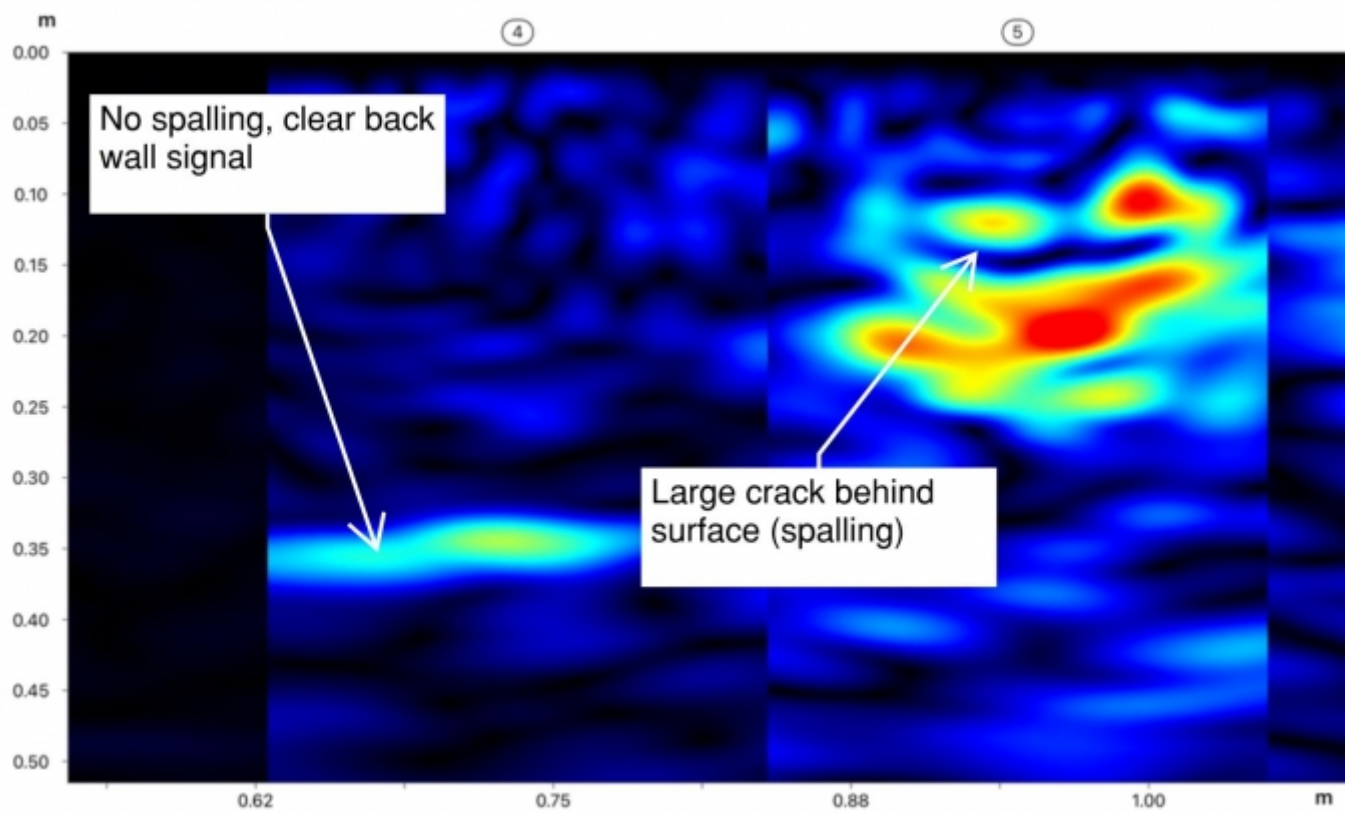
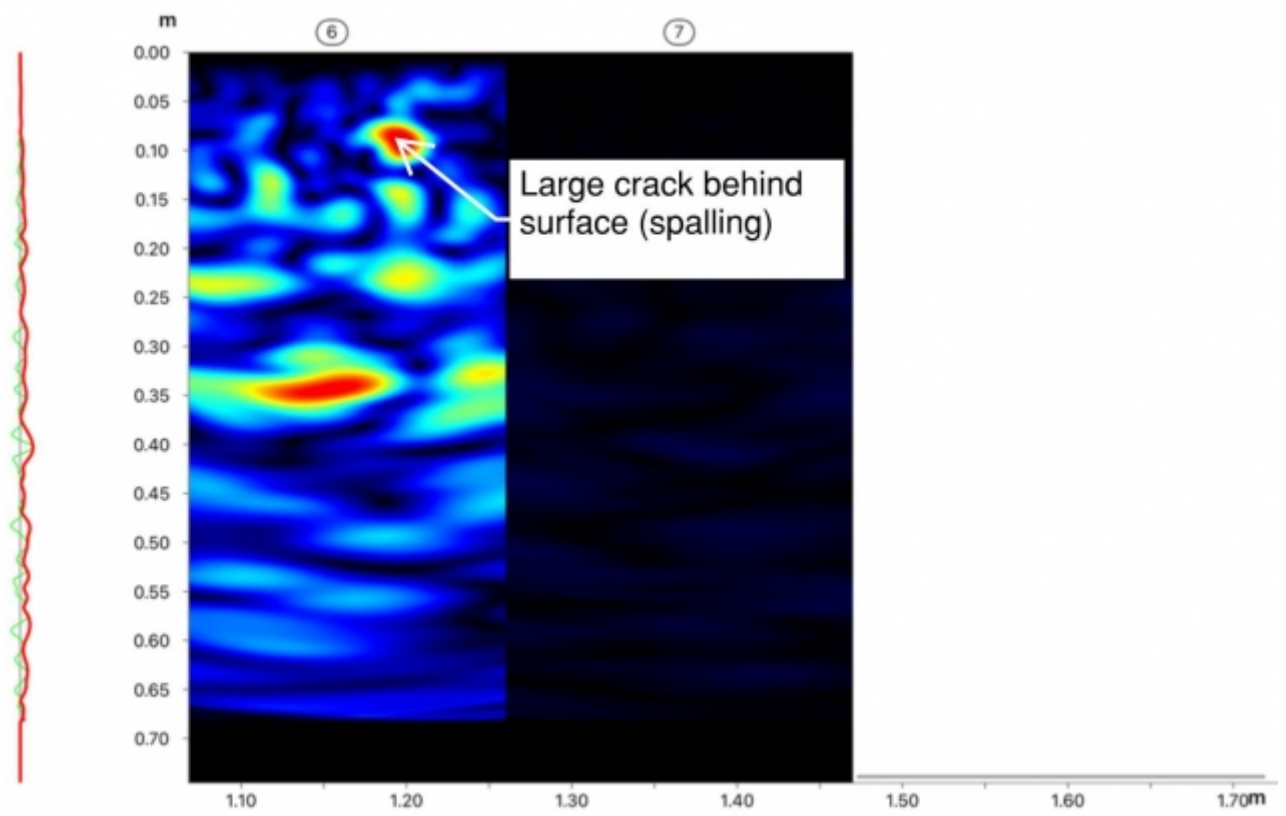
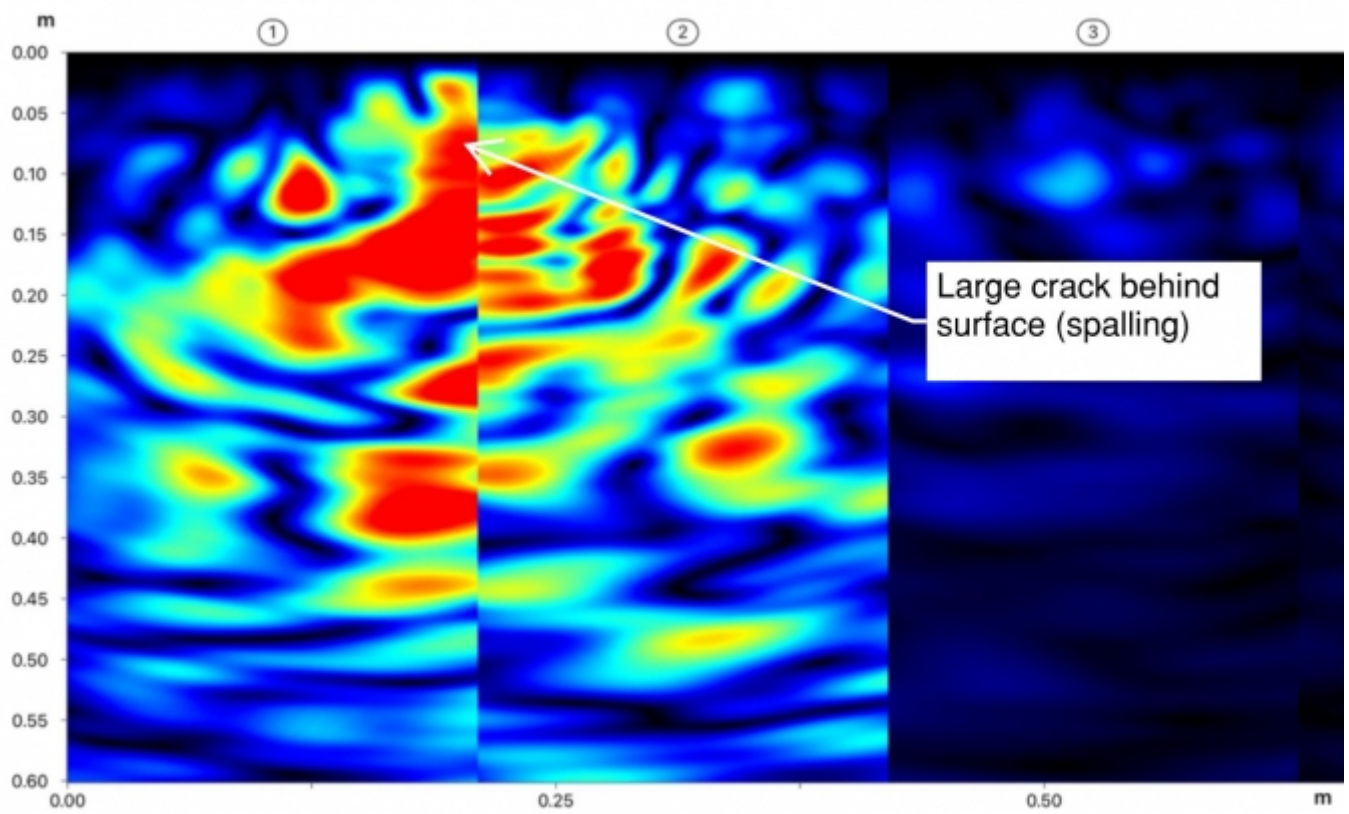
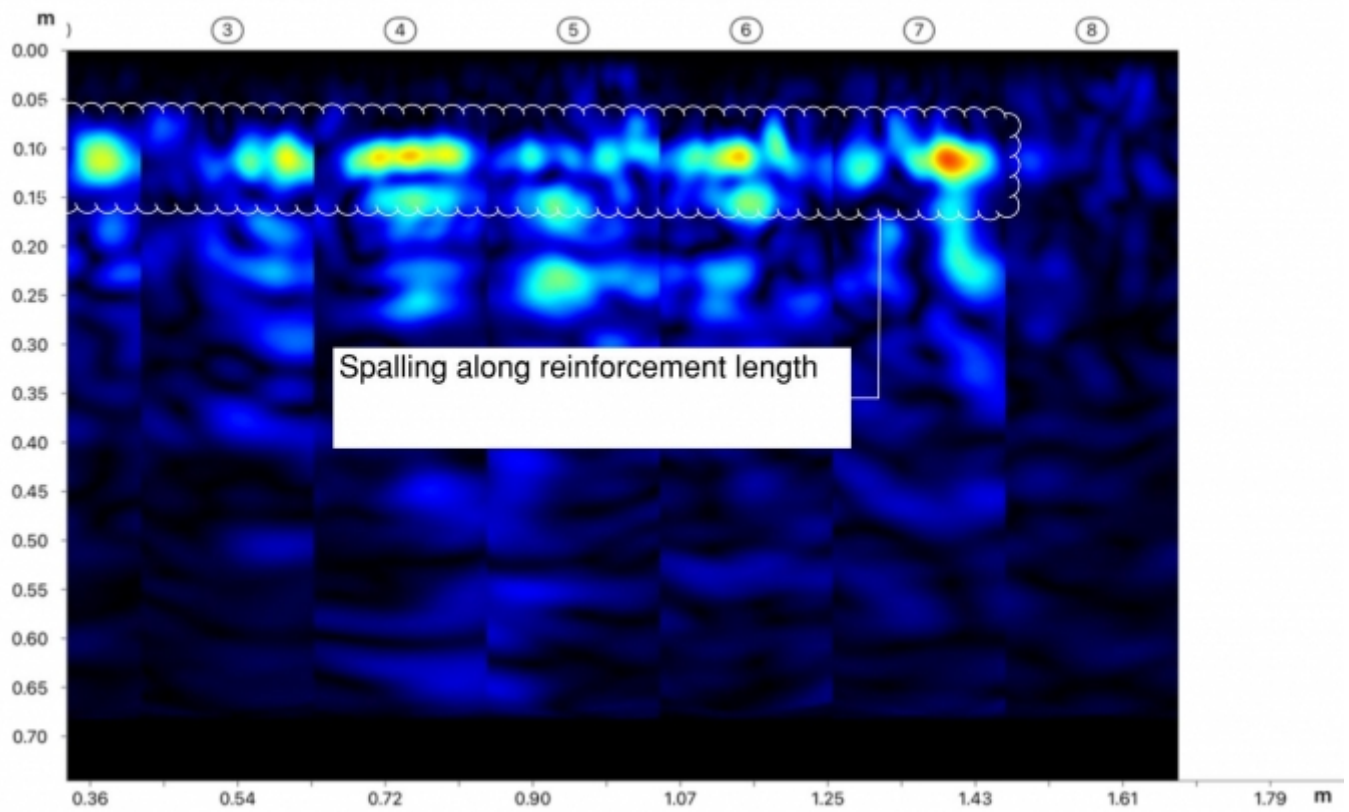
## Location: Beam

Ultra sonic pulse velocity was conducted to determine the depth of cracking, these results have been provided on the attached. Some crack depths unknown as cracking is beyond the machine's depth range.

Ultra sonic pulse echo was used to locate horizontal cracking along with spalling. Large amounts of concrete cancer can be found throughout the beam length as highlighted in the images provided. (bright reflections)

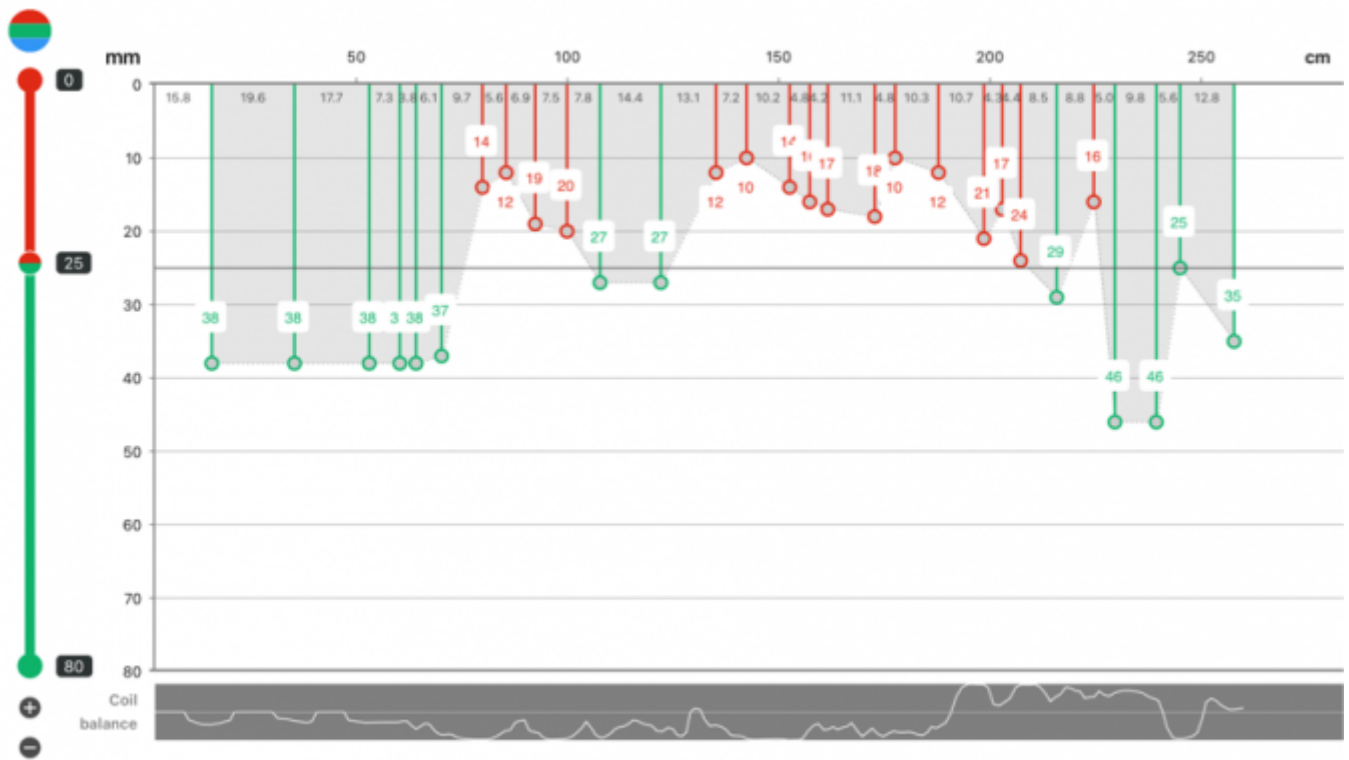
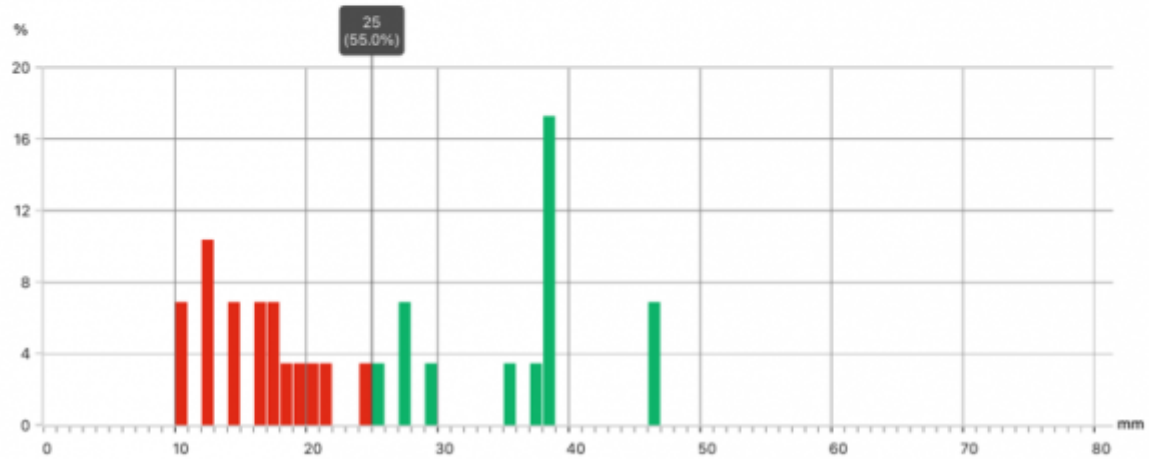
## Location: Reinforcement cover & spacing (length)

Covermeter readings obtained over an unobstructed length of 2.5meters.  
Minimum depth preset was set to 25mm

| n | $\bar{x}$ | $\bar{x}$ | stdev | Lowest | Highest |
|---|---|---|---|---|---|
| 29 | 24.6 | 21.0 | 11.2 | 10 | 46 |

| n | $\bar{x}$ | $\bar{x}$ | stdev | Lowest | Highest |
|---|---|---|---|---|---|
| 28 | 8.6 | 7.7 | 4.0 | 3.8 | 19.6 |

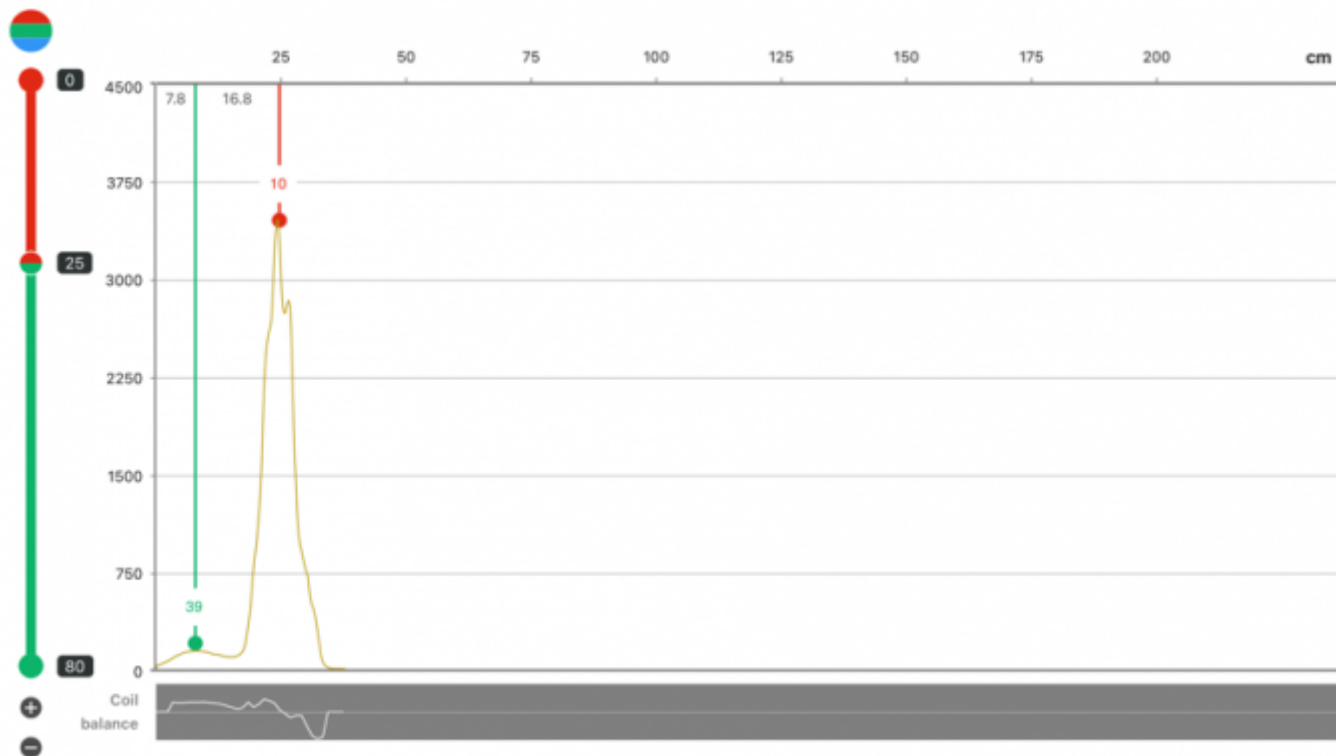
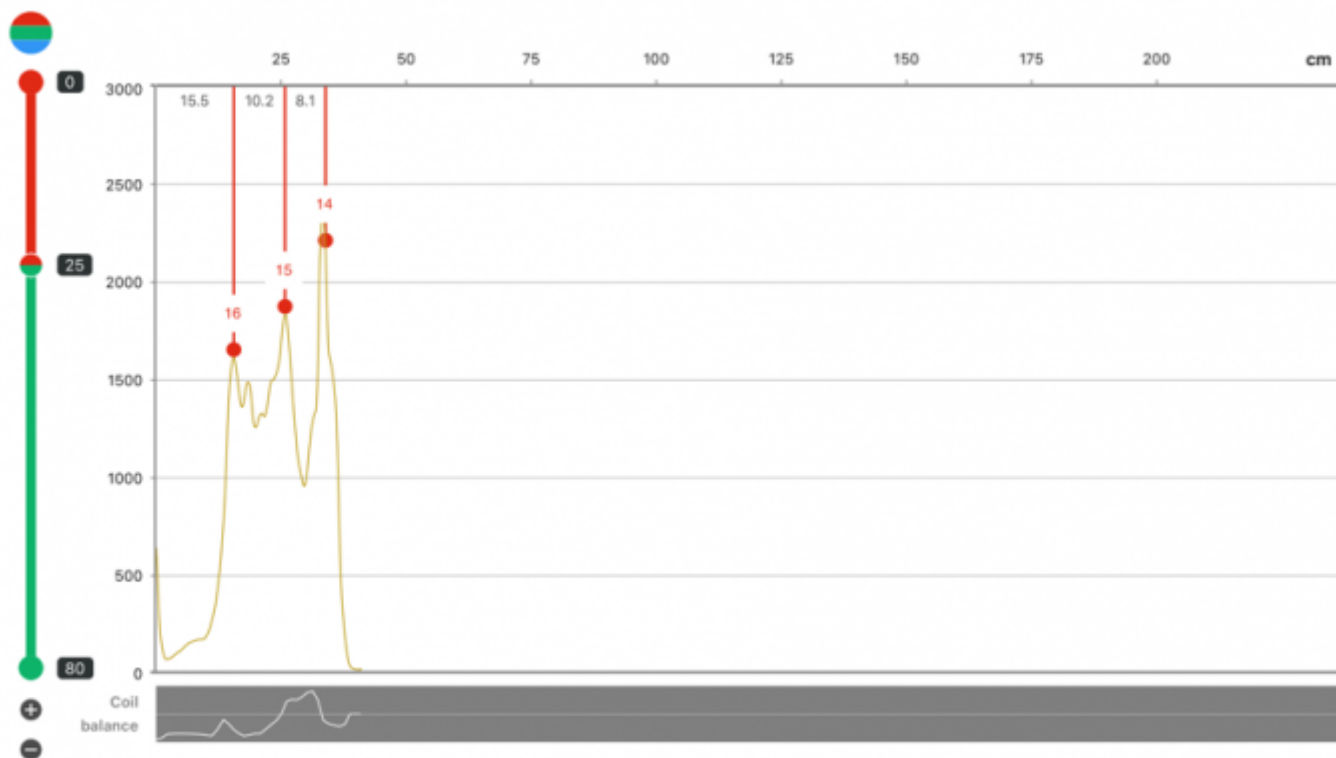
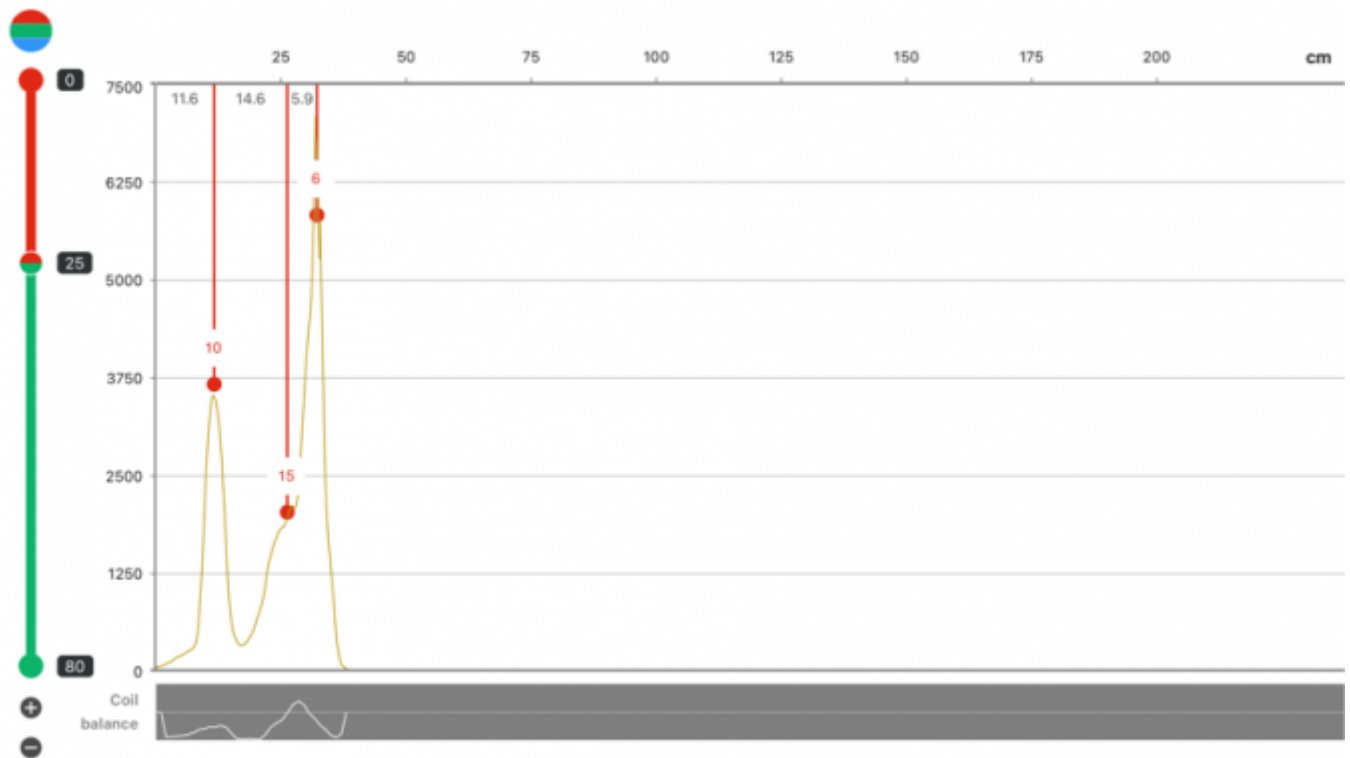
## Location: Reinforcement cover &amp; spacing (width)

Covermeter readings obtained over an unobstructed width of 30cm.  
Minimum depth preset was set to 25mm

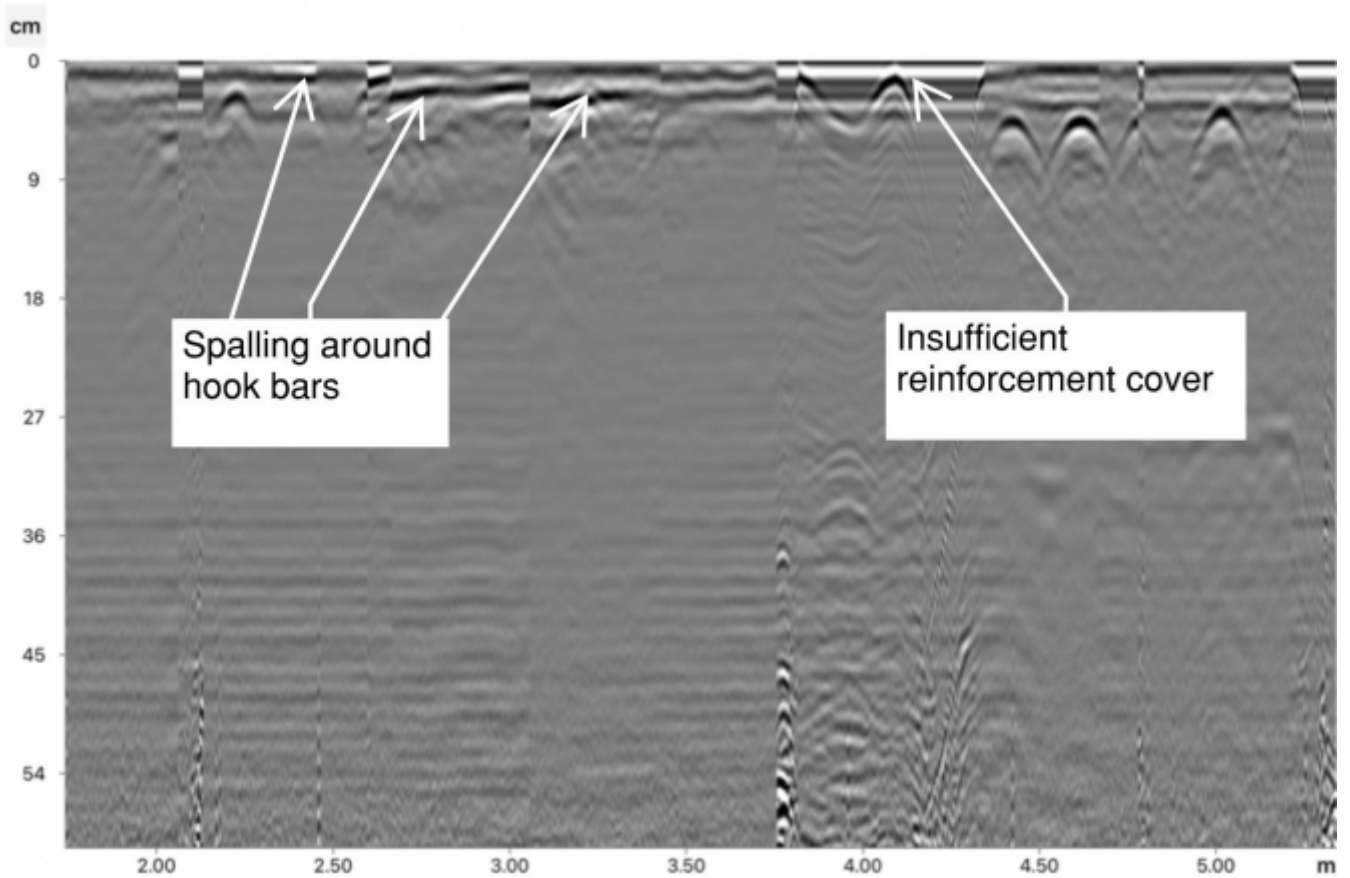
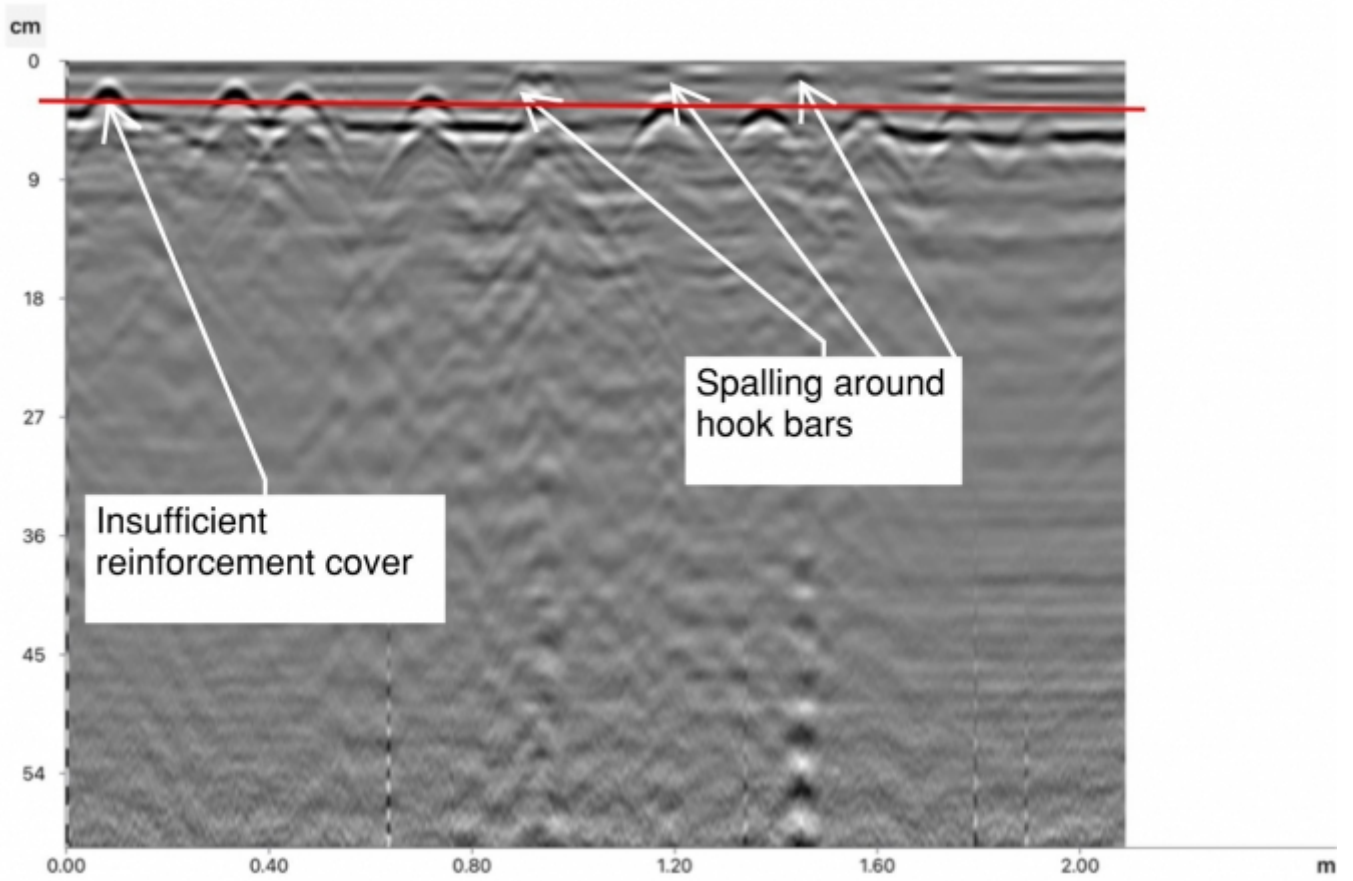
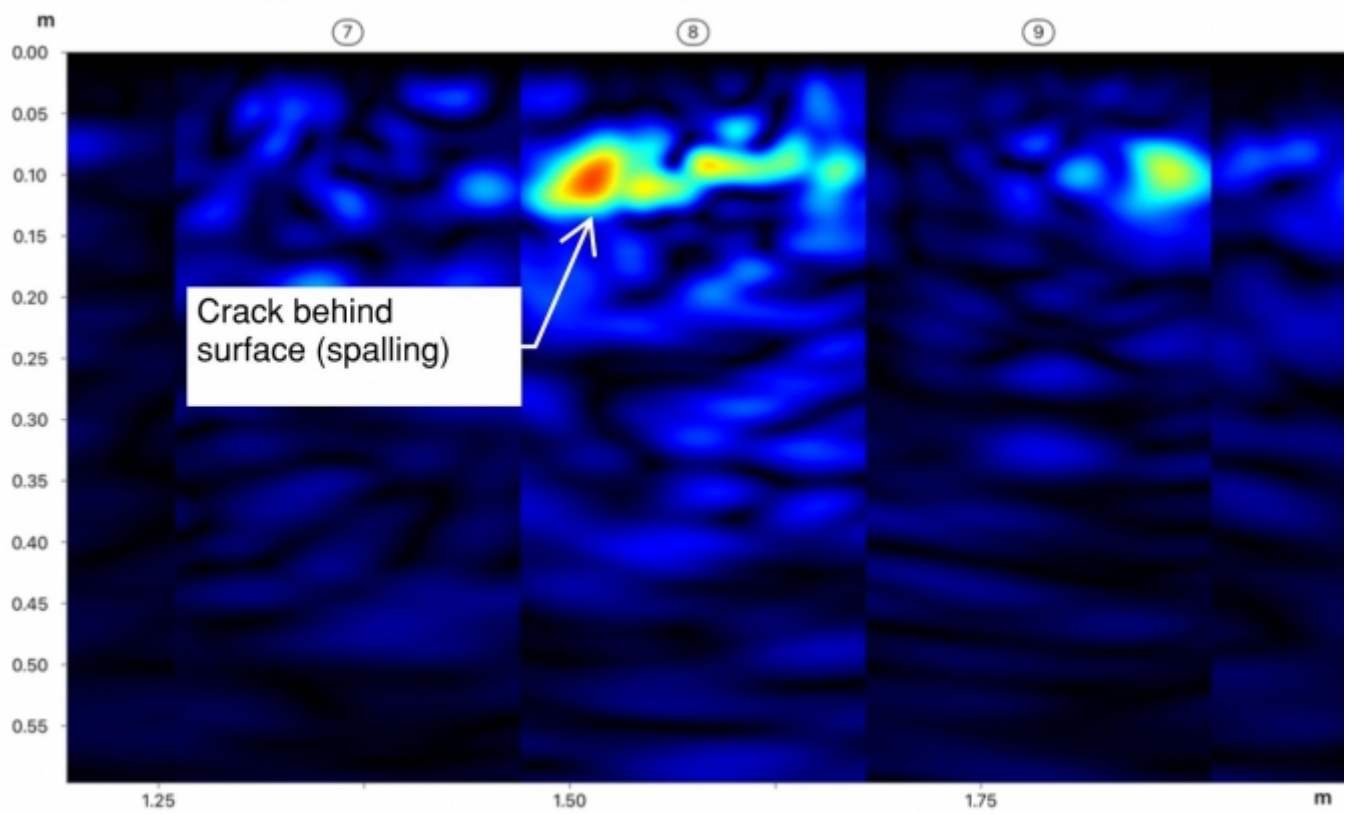
## Location: Z beam

Imaging of Z beam reinforcement cover and spalling.  
Minimal access due to vehicle and motorcycle within area.
