# K73 - E-T-8-0905 Management Site Safety & Environment Inspection

| Date | 10/08/2022 11:43:33 |
| Project Name | K73 - ASMTI |

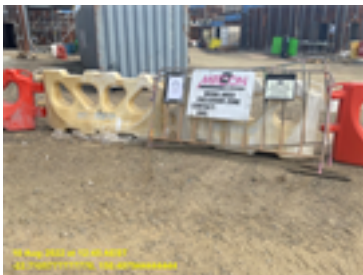
#9

| # | Comments | Created By | Date |
|---|---|---|---|
| 9 | <p>Inspected a Australis work area, and noticed there safety barricades are being correctly managed and utilised creating a well delineated exclusion zone.</p> <p>Safety committee noticed that across the general site various subcontractors safety barricades are being unused to left around. Committee agreed that they either need to be utilised or stored away in the correct areas.</p> | Rhys Yasso (LORA Construction Victoria/SA Region/Queensland) | 11/08/2022 08:01:17 |

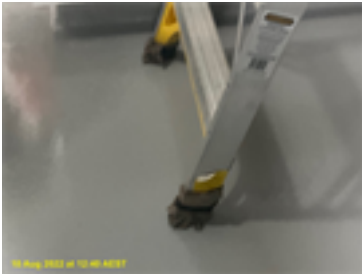
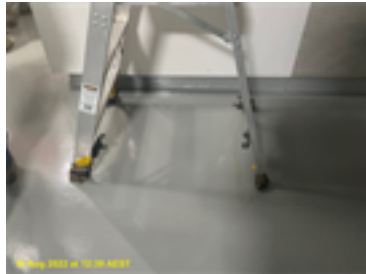
#17

| H&S | | | | |
|---|---|---|---|---|
| 17 | Ladders | Yes | 3 | Buildings 66.6, 57.6 & 56.5 |

| # | Comments | Created By | Date |
|---|---|---|---|
| 17 | <p>All usage of ladders within the buildings after floor finishing works have been conducted have had there feet wrapped and protected thanks to the AE Smith crew setting that standard for the rest of the subcontractors.</p> <p>Due to subcontractors switching between buildings and leaving/finishing works, equipment was found by a member of the committee I.e LinkeD that was no longer being used.</p> | Rhys Yasso (LORA Construction Victoria/SA Region/Queensland) | 11/08/2022 08:35:40 |
