## DARNLEY ISLAND FREEZER ELECTRICAL AND MECHANICAL REPORT

## INSPECTION SITE DETAILS

The details contained in this report relate to the freezer and sorting/filleting area and associated rooms and equipment of the Darnley Island Freezer, located at Lot 92 Darnley Island QLD 4875.

Site inspection took place on Friday 13 March 2020.

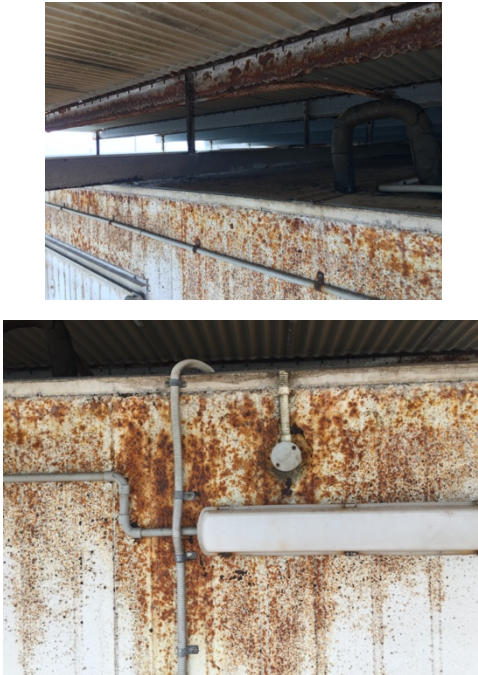
| <b>Freezer Room</b> | <p>The rooms are constructed out of coolroom panel which is at the end of its serviceable life. The ceilings top colourbond layer has rusted away and there has been a layer of composite aluminum sheet placed over most of the top of the ceiling to stop water ingress. There has been multiple penetrations from previous refrigeration unit which have since been removed. A prop has also been installed due to the poor roof condition.</p> <p>There is 5kw air conditioning unit in the filleting room, which acts to cool the room and remove excess moisture. This isn't designed for the conditions or application but works at present.</p> <p>There is 2 x sliding chiller doors for entry to the filleting room and 2 x doors to both freezer rooms. These doors use tracks and roller wheels that may need to be replaced.</p> <p>Due to the location and the prevailing SE breeze, the cool room exterior panels are in poor condition.</p> <p>The floor of the rooms is a concrete slab poured after the rooms have been erected. Filleting room is in good condition. In the snap room, some of the concrete is breaking up and may need replacing or re-sealing</p> | |

| <b>Short term recommendations</b> | <b>Cool panels</b> | Some of the existing panel sheets need external sheets to be installed over existing sheets. |
| | <b>Ceiling</b> | Re-sealing of silicone on all joints. |
| | <b>Doors</b> | Replacement of door seals, rollers and heater on trim. |
| | <b>Floor</b> | Re-seal of concrete. |
| | <b>External panels</b> | Some of the existing panel sheets need external sheets to be installed over existing sheets. |
| <b>Long term recommendations</b> | Coolroom panels, ceiling, doors-panels are reaching the at the end of their workable life and need to be replaced. | |

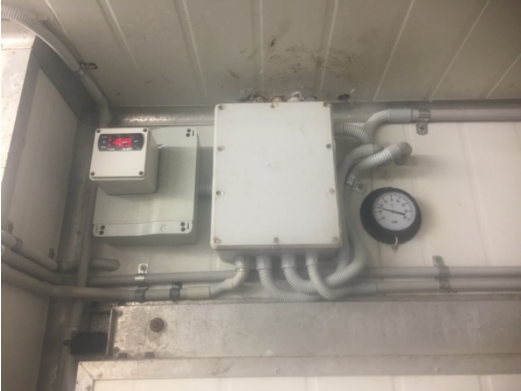
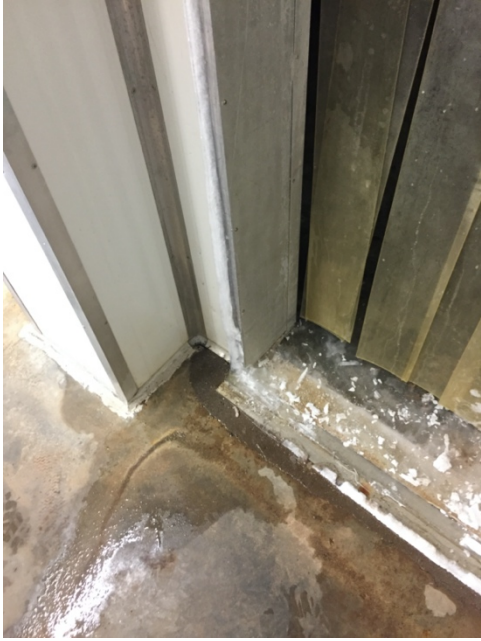
| <b>Refrigeration Units</b> | <p><b>Snap Freezer Unit:</b><br/>When running is able to maintain -20 degrees. Outdoor condensing unit and snap evaporator is approximately 12 months old. The snap condensing unit has 3 x condenser fans which sit horizontally making them prone to seizing up and failing.</p> <p>The snap has had previous rodent damage and had to be raised to try and prevent further damage.</p> <p>Inside the snap condensing unit, there is a refrigerant pipe mount which needs to be replaced.</p> <p><b>Large Freezer Unit:</b><br/>Outdoor condensing unit is approximately 12 months old and when running is able to maintain -20 degrees. Large freezer evaporator is an older unit and has (repairable) heater faults.</p> | |

| <b>Short term recommendations</b> | <b>Snap Freezer Unit:</b> | Regular maintenance is recommended. |
| | <b>Large Freezer Unit:</b> | Spare fans should be kept on site. |
| <b>Long term recommendations</b> | <b>Snap Freezer Unit:</b> | Replacement of unit recommended if building is replaced. |
| | <b>Large Freezer Unit:</b> | Replacement of units recommended if building is replaced. |

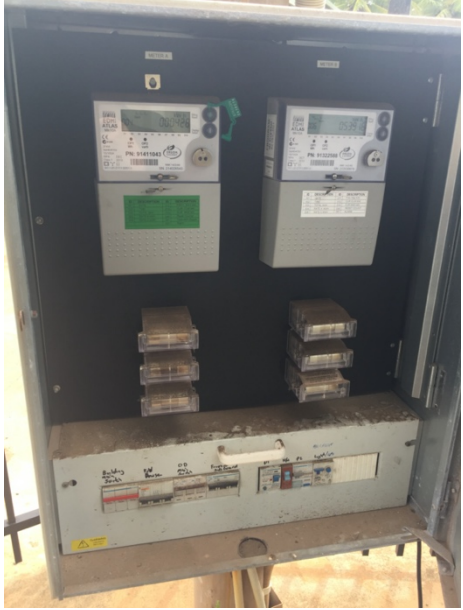
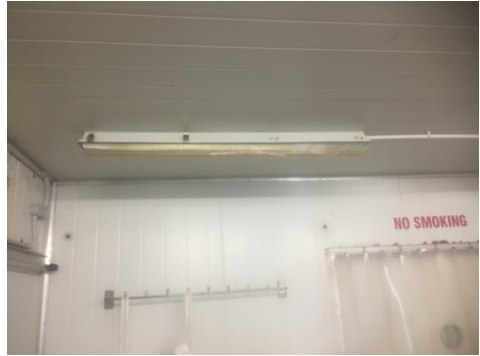
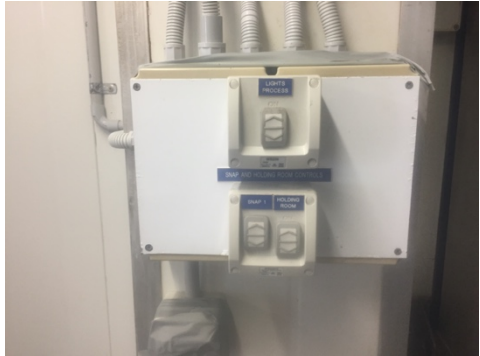
| <p><b>Electrical</b></p> | <p>There is a main switchboard on a pole, which has 2 x Ergon meters in it. One meter is for the freezer room and associated room/office. The other meter is for the fuel bowser on the other side of the road.</p> <p>There is also a distribution board on the side of the freezer room and another distribution board inside the office. Most of the electrical conduits have been re-run on the external wall once the aluminum sheets were placed.</p> <p>Inside, there are 2 x refrigeration controls placed above the door of the corresponding rooms. There is electrical cable running to both doors for heaters and two heated explosion ports. Both explosion ports and door trim heater are in poor electrical condition and should be replaced ASAP.</p> <p>Lighting is achieved by x 6 fluorescent lights in the filleting room, x2 fluorescent in each freezer room and LED battens on the exterior of the building.</p> <p>Inside lights are controlled by weatherproof switches between the freezer doors. Outside a weatherproof switch next to the entry sliding door controls the exterior lights.</p> <p>There is an electrical junction box between the door, which is broken and needs to be replaced. Of the 6 lights on the filleting room, 2 x aren't working and some have evidence of water ingress. The light switch for the freezer room is taped off as it trips the lighting circuit if turned on.</p> <p>On the junction box between the doors there is weatherproof switches which turn off the controls for each freezer room. This has the potential to be confused with light switches and may be mistakenly turned off.</p> <p>Ideally all the lights should be LED battens and should be fully sealed with silicon to reduce the chance of water ingress. Sometimes this is hard to achieve due to the conditions the lights are used in. Also running multiple circuits can reduce one light tripping all lights in an area.</p> <p>In the office, the distribution has previously been changed and all circuits have been put onto RCD safety switches. – office electrical units were in better order with all circuits operational.</p> | |

| <p><b>Short term recommendations</b></p> | <p>Replacement of junction box between rooms, removal of control switches on junction box</p> <p>More circuits should be installed to separate circuits and reduce nuisance tripping of lights</p> | |
| <p><b>Long term recommendations</b></p> | <p>As above, however is building is replaced, new electrical should be installed.</p> | |
