Core4 Services  
9a/62 Bishop St,  
Kelvin Grove QLD 4059

13<sup>th</sup> Jun 2024  
Job No. S5466

## Concrete Remedial Works - 85 Deakin St, Kangaroo Point

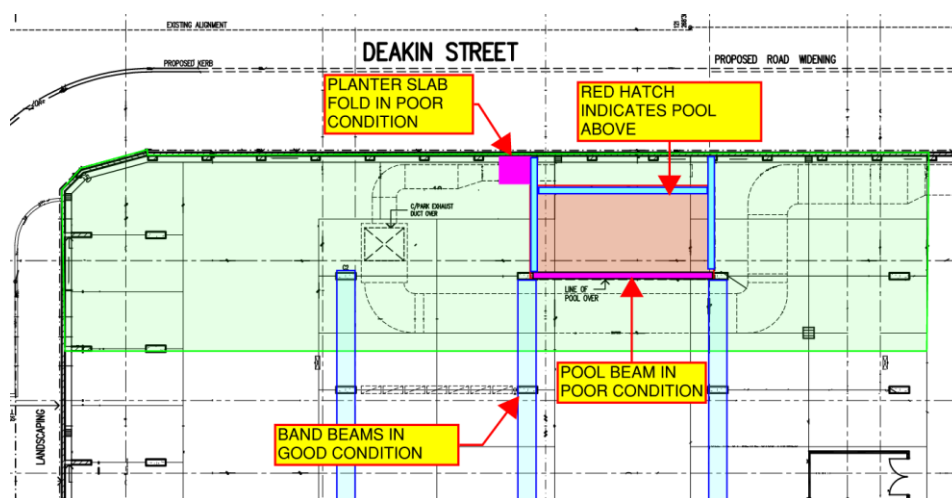
Figure 1 - Area of investigation shown in green.

The pool on the ground floor above is supported by a concrete beam on each side, the concrete beam as indicated in figure 1, has sever concrete cancer. Large cracks approx. 3-5mm in width can be seen along the length of the beam, refer photo 17-20

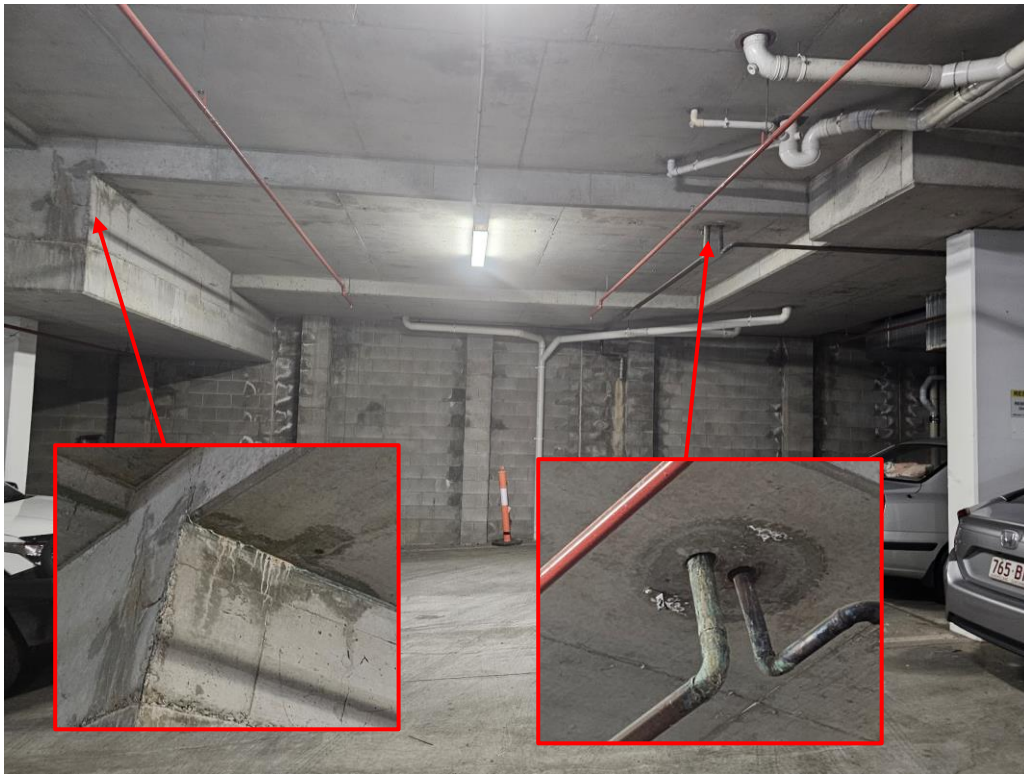
The slab within the shaded green area was found to be in a condition appropriate for its age, however there were scattered area of staining and water ingress to the concrete slab, refer photos 1-4. These areas of minor staining were primarily located around pipe penetrations & the area of slab with garden beds above.

**PHOTOGRAPH 1.:** Defect Class A: Visible staining of concrete, some efflorescence visible

Class A repairs may be considered optional, but if not repair will require yearly monitoring

- Scabble back surface concrete until all stained concrete is removed. Up to the depth of reinforcement if necessary
- Any reinforcement that is exposed shall be wired brushed clean of any rust & painted with SikaTop Armatec -110 EpoCem
- Repair concrete with Sika MonoTop -352 NFG concrete repair mortar

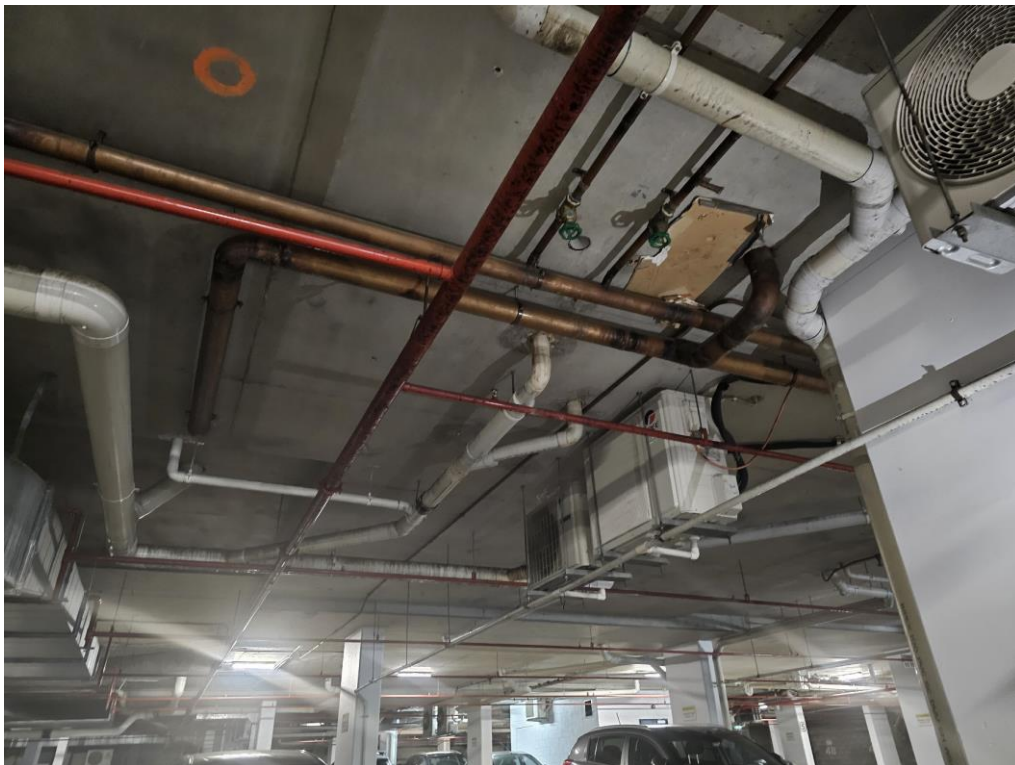
**PHOTOGRAPH 2.:** Defect Class A: Visible staining of concrete, located around pipe penetration

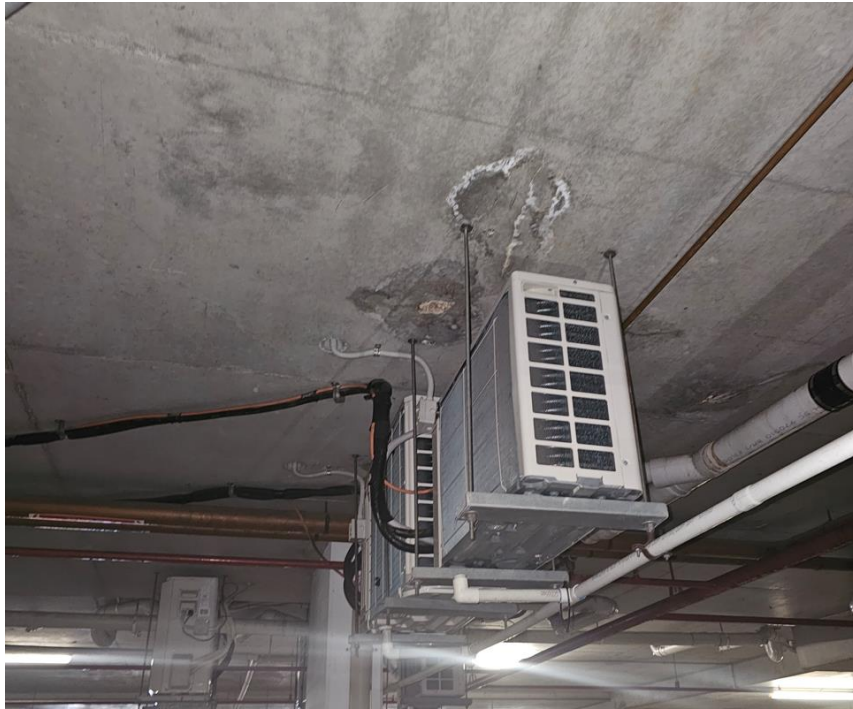
**PHOTOGRAPH 3.:** Defect Class A: Visible staining of concrete, located around air con

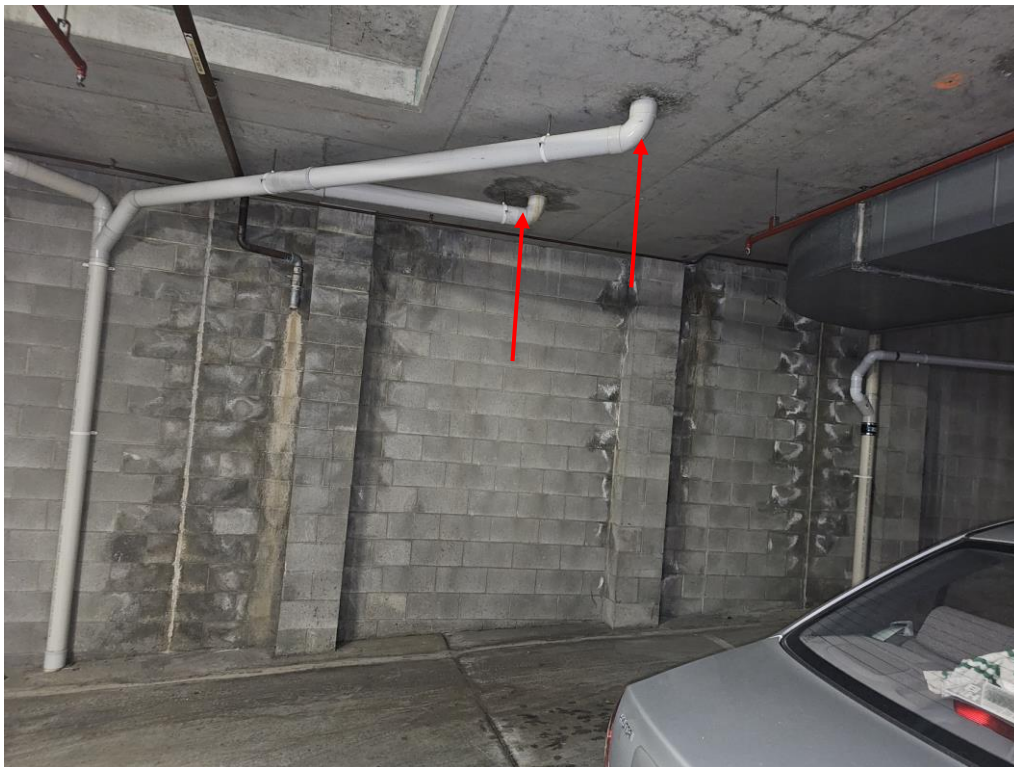
**PHOTOGRAPH 4.:** Defect Class A: Staining to concrete around pipe penetrations. Wall also indicates water penetration with notable efflorescence to the block wall

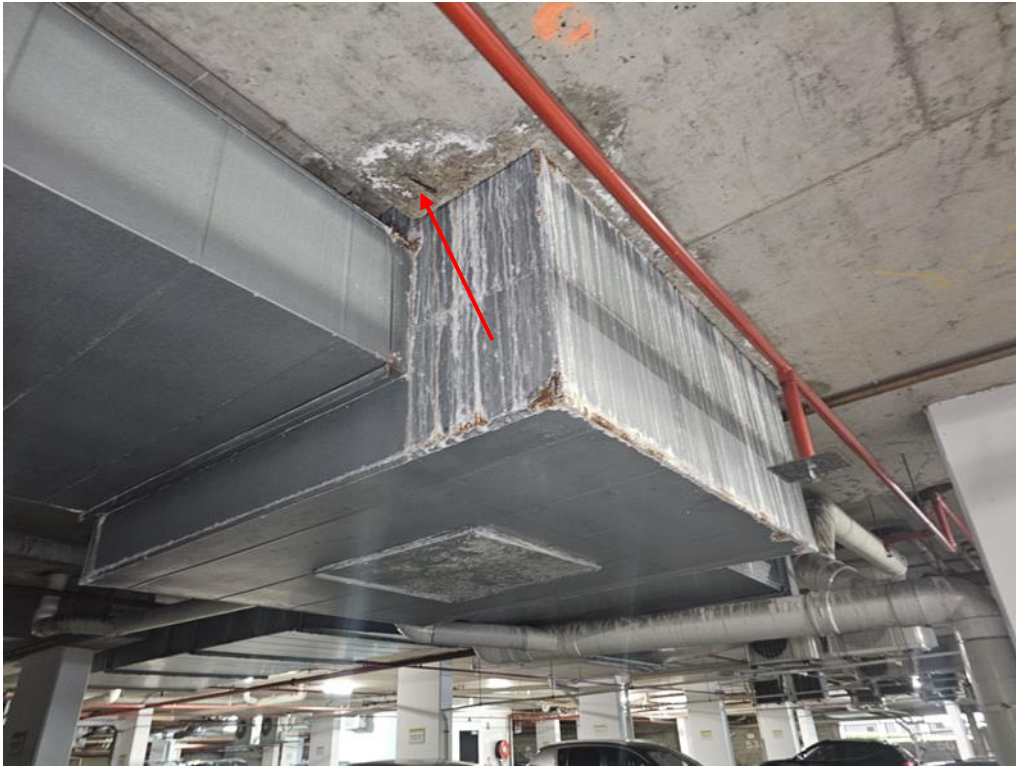
**PHOTOGRAPH 5.:** Defect Class B: Reinforcement exposed due to concrete spalling

- Prop each side of region to be repaired, props shall be spaced at 1.5m centres max.
- Clean area & remove any loose concrete from area.
- Scrabble back/ hammer out 50mm each end along exposed reinforcement min. or until clean reinforcement clean of rust is found
- Confirm extent of corrosion and wire brush clean steel reinforcement
- Paint steel reinforcement in SikaTop Armatec -110 EpoCem
- Repair concrete with Sika MonoTop -352 NFG concrete repair mortar

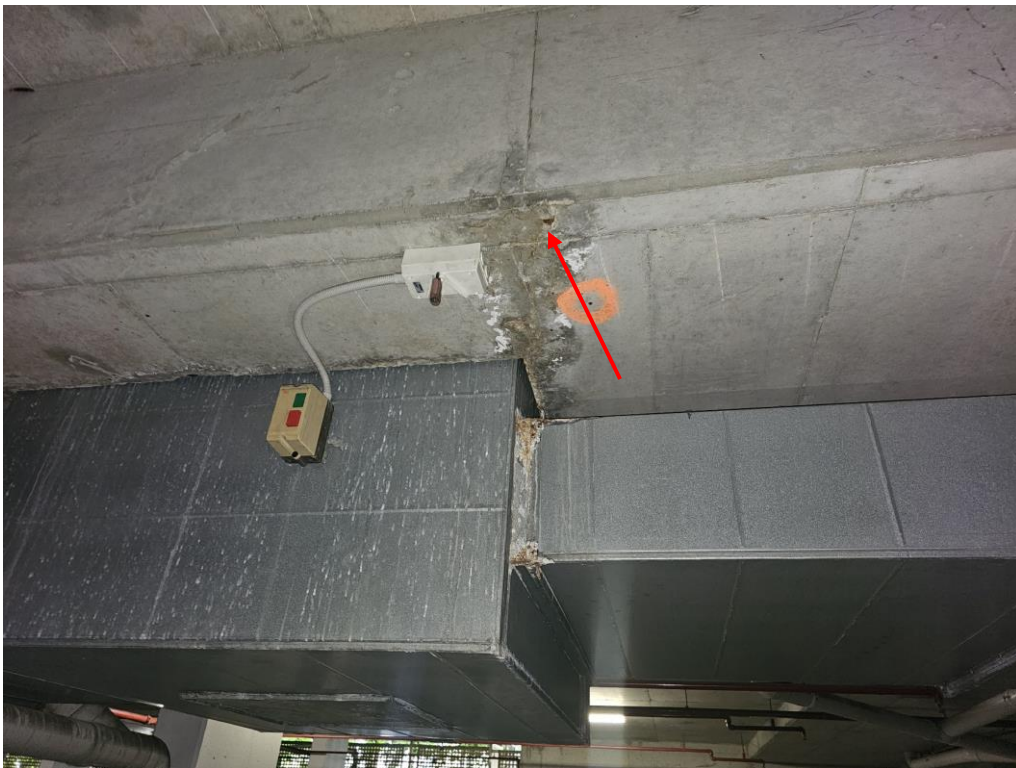
**PHOTOGRAPH 6.:** Defect Class B: Reinforcement exposed due to concrete spalling

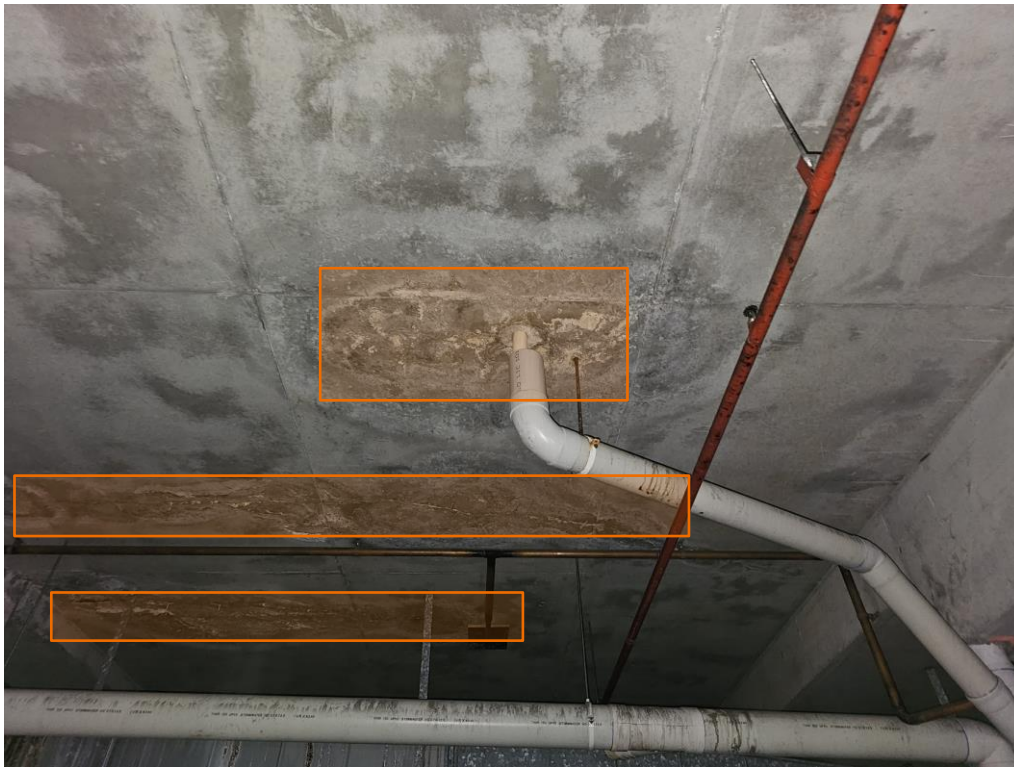
**PHOTOGRAPH 7.:** Defect Class B: Large area of straining, early stage of steel corrosion

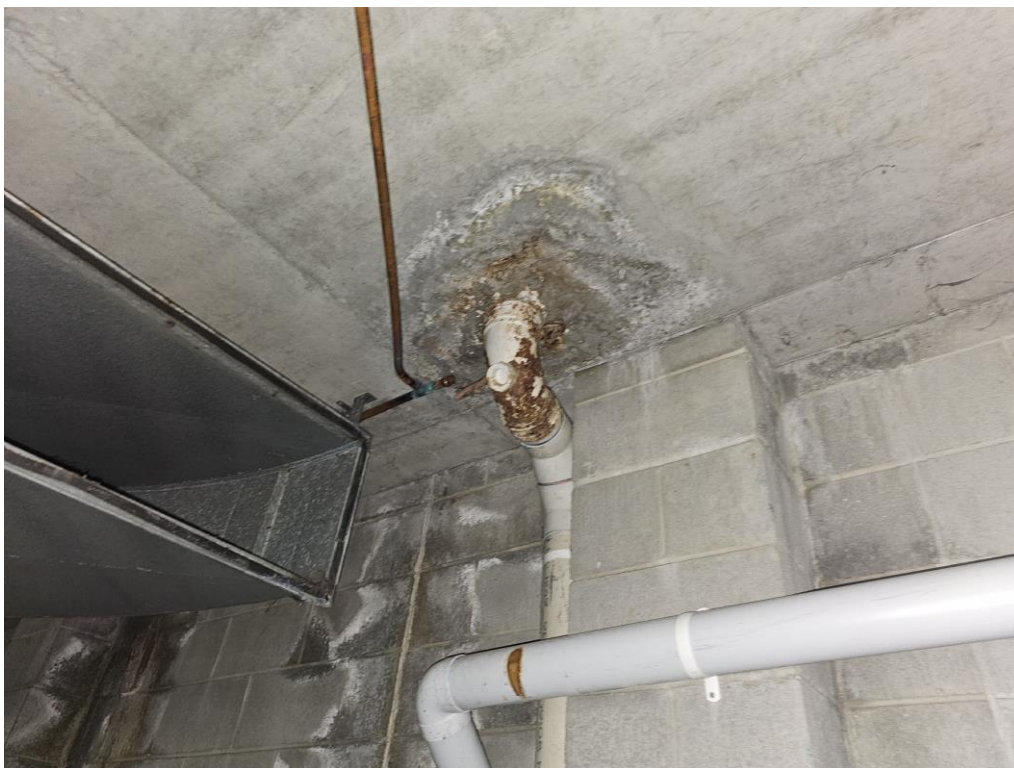
**PHOTOGRAPH 8.:** Defect Class A: Staining & material deposits to concrete around pipe penetration

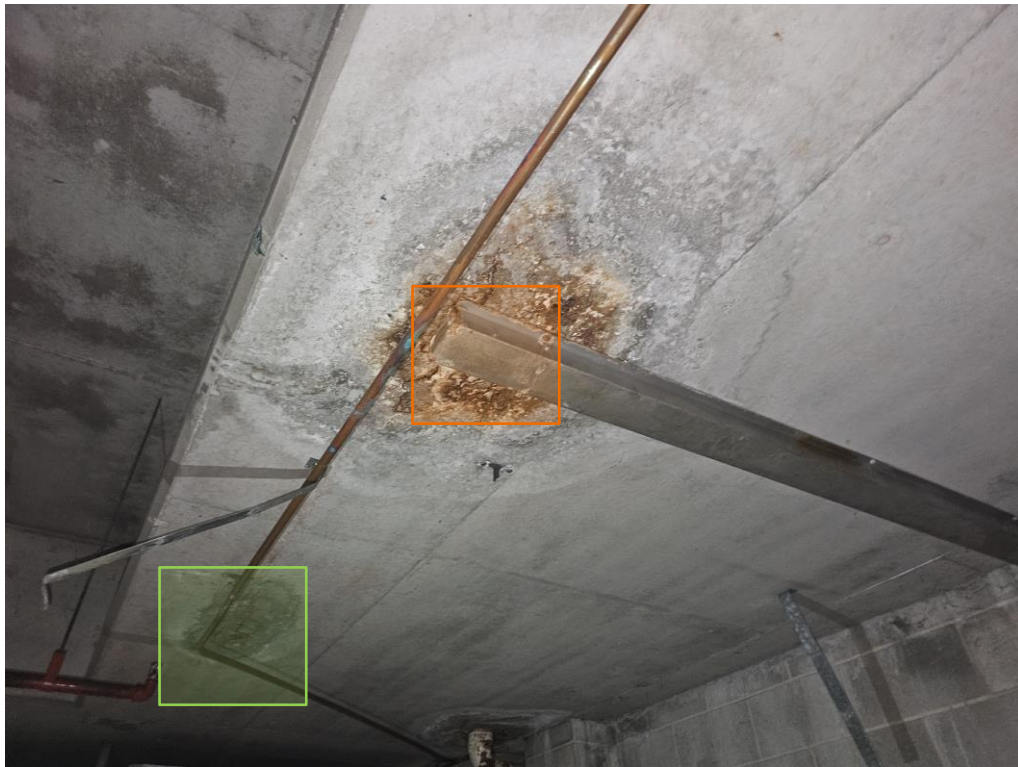
**PHOTOGRAPH 9.:** Defect Class B: Moderate strain to concrete, large crack at drip tray join

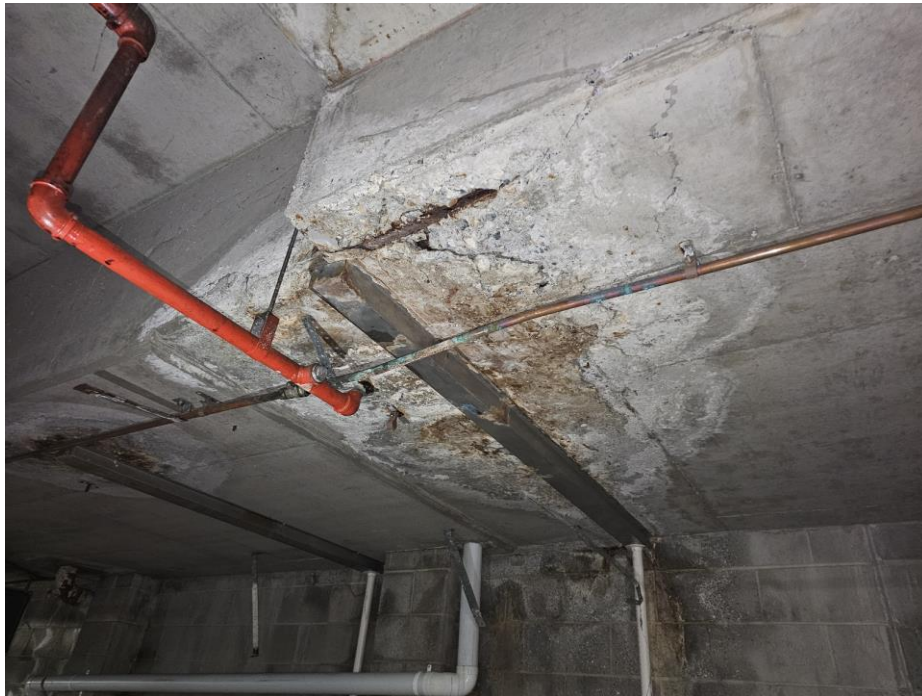
A section of slab supporting the front planter box has large vertical cracks along the surface & areas of spalling, refer photo 10

**PHOTOGRAPH 10.:** Defect Class C: large cracks across concrete face, large are of spalling with multiple chunks of concrete falling away to expose aggregate

- PROP SECTION AS NOTED ON DETAIL, PROPS SHALL BE RATED FOR 100kN EACH (10 TONNE)
- REMOVE EXISTING DRIP TRAY FOR REPAIR WORKS
- SCRABBLE BACK/ HAMMER OUT CONCRETE EACH END OF EXPOSED REINFORCEMENT BAR UNTIL CLEAN STEEL IS FOUND

- WIRE BRUSH CLEAN STEEL REINFORCEMENT  
ANY BARS MISSING OVER 25% OF MASS - CONTACT ENGINEER
- INSTALL SACRIFICIAL ANODE, SIKA FERROGARD -510 PATCH, AT 600 CRS.

- PRE-DILL HOLE INTO EXG. CONCRETE AT PERIMETER OF REPAIR AREA
  - CLEAR DUST & PRE-WET HOLE FOR 15 MINS.
  - REMOVE EXCESS WATER AND APPLY SIKA FERROGARD -500 CRETE

- INSTALL FERROGARD 510 PATCH, FULLY EMBED TO 500 CRETE MORTAR
  - FIX ANODE CONDUCTING WIRE TO REPAIRED REINFORCEMENT
- REPAIR CONCRETE WITH SIKA MONOTOP -412 NFG CONCRETE REPAIR MORTAR WITHIN 2 HOURS OF INSTALLING ANODE

- PROPS SHALL REMAIN IN PLACE FOR 7 DAYS
- IF DRIP TRAY IS TO BE RE-INSTATED, CONCRETE SHALL BE TREATED WITH CROMMELIN BLACKSEAL HEAVY DUTY BITUMEN PAINT, FOR A WIDTH OF 500mm, FOR THE FULL LENGTH OF DRIP TRAY

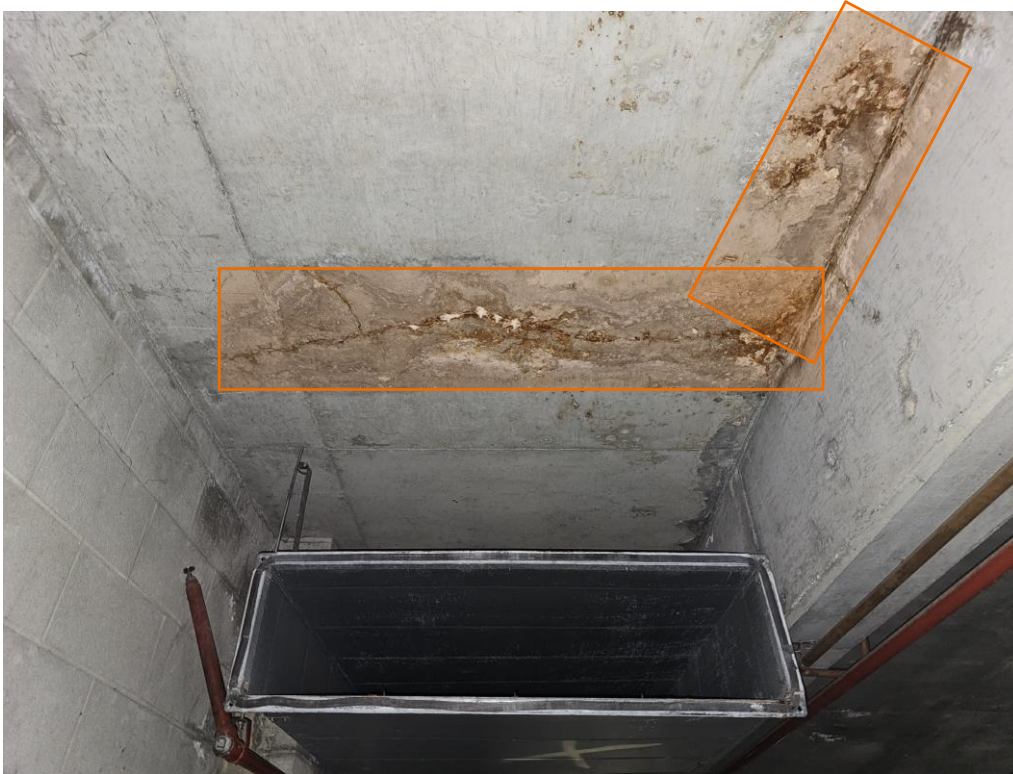
**PHOTOGRAPH 11.:** Defect Class B: Large area of straining, cracking to concrete surface

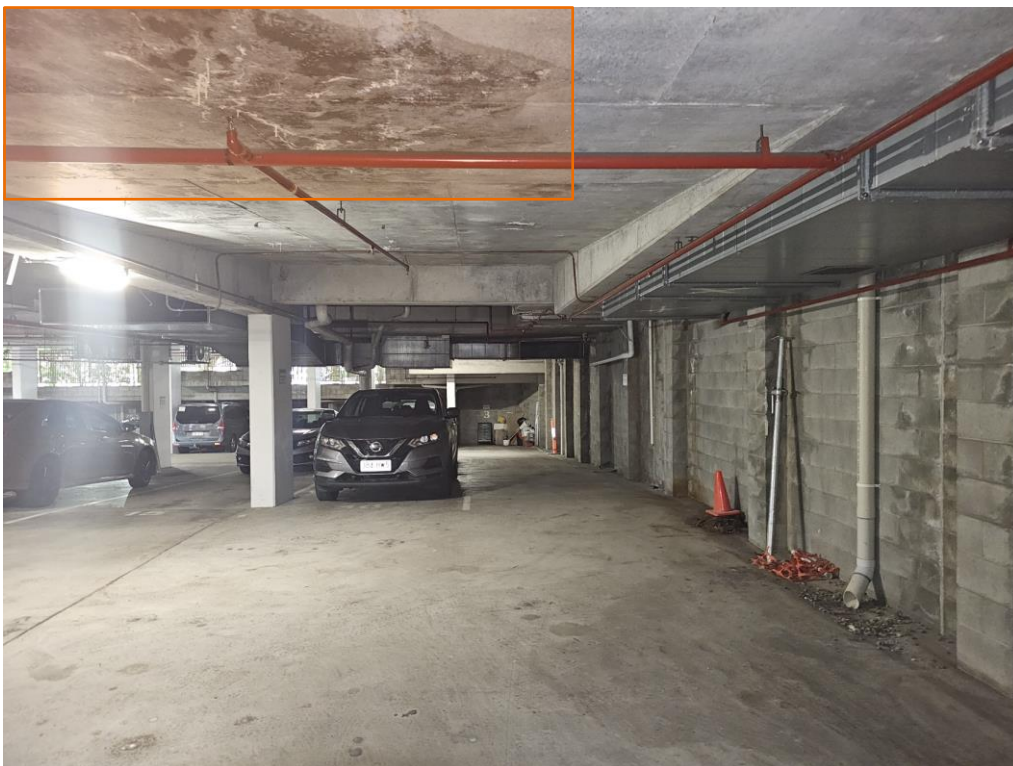
**PHOTOGRAPH 12.:** Defect Class B: Large area of straining, cracking to concrete surface

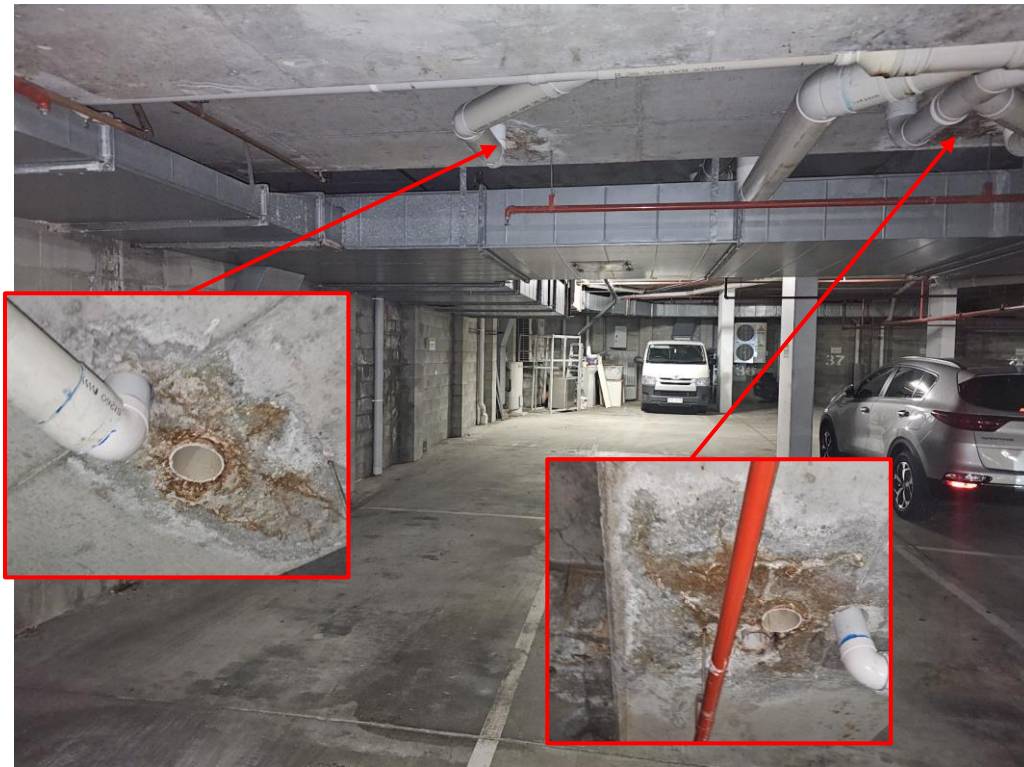
**PHOTOGRAPH 13.:** Defect Class A: Visible staining of concrete, some efflorescence visible

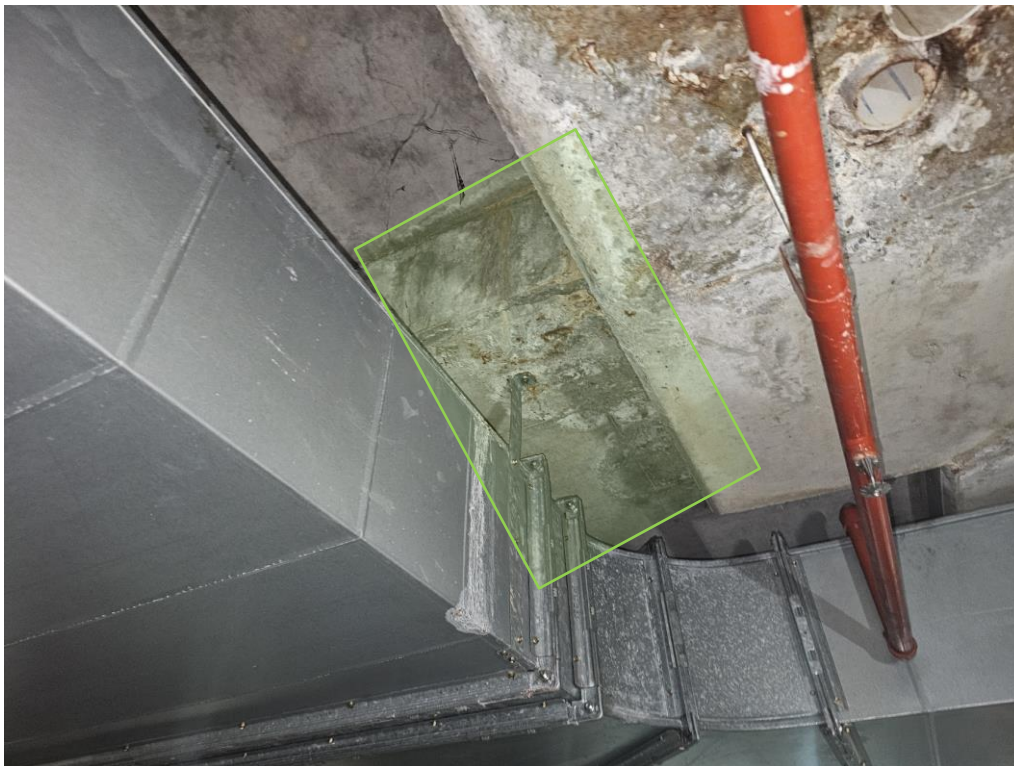
**PHOTOGRAPH 14.:** Defect Class A: Visible staining of concrete, some efflorescence visible, no visible cracking or spalling of concrete

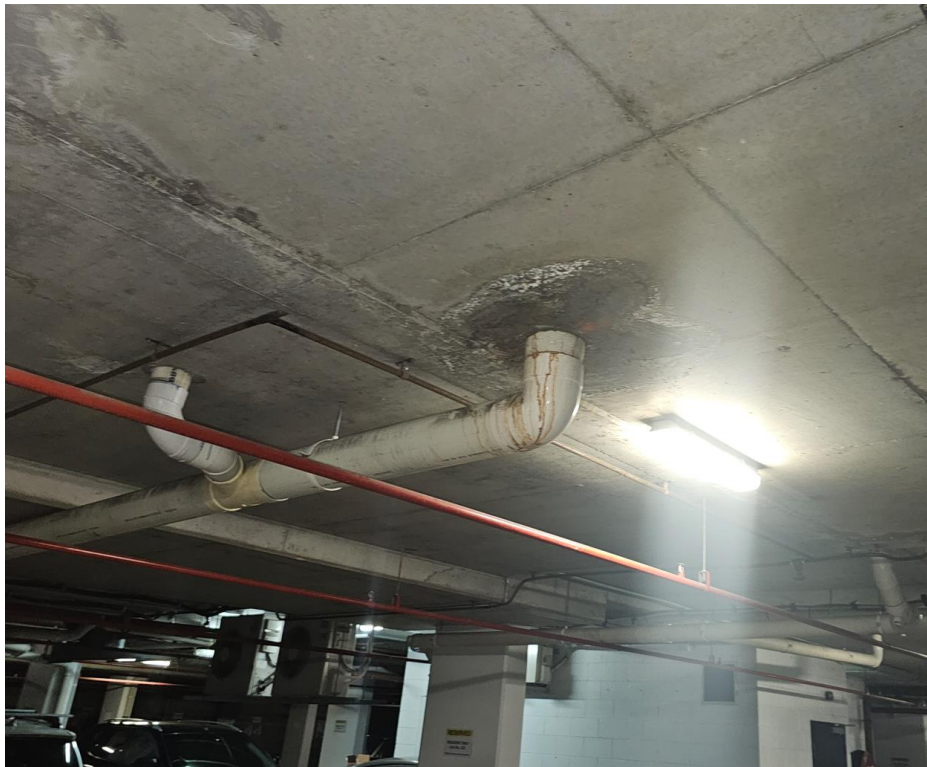
**PHOTOGRAPH 15.:** Defect Class A: Visible staining of concrete, some efflorescence visible around pipe penetration

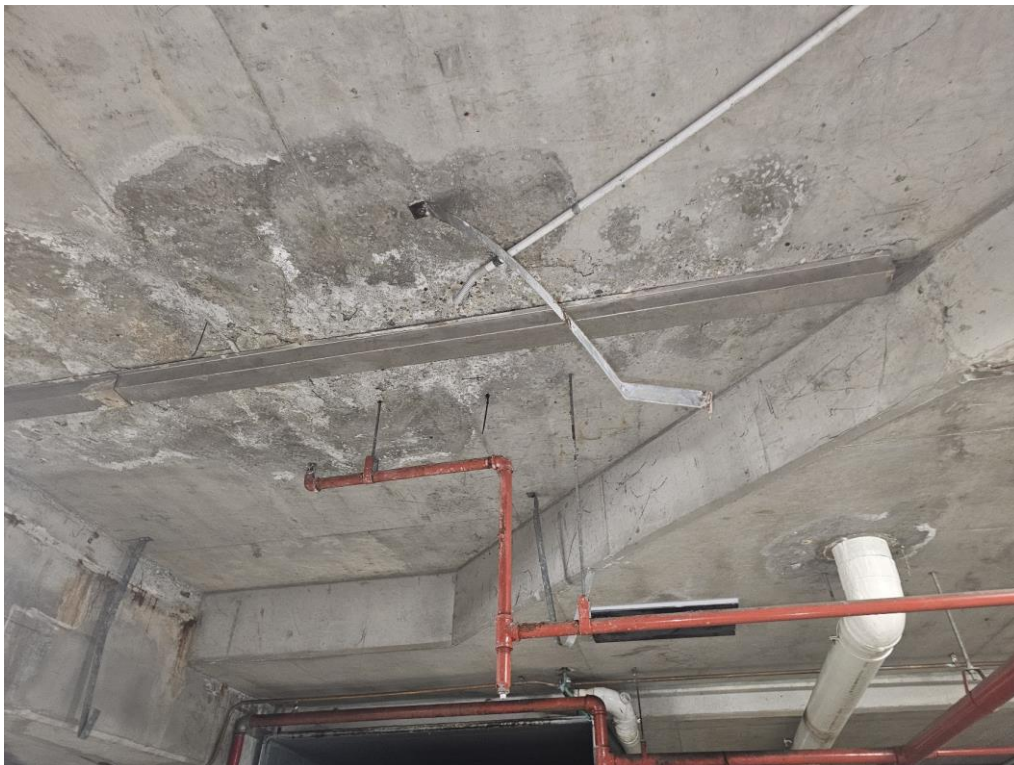
**PHOTOGRAPH 16.:** Defect Class B: Visible staining of concrete, some efflorescence visible, some spalling of concrete along drip tray

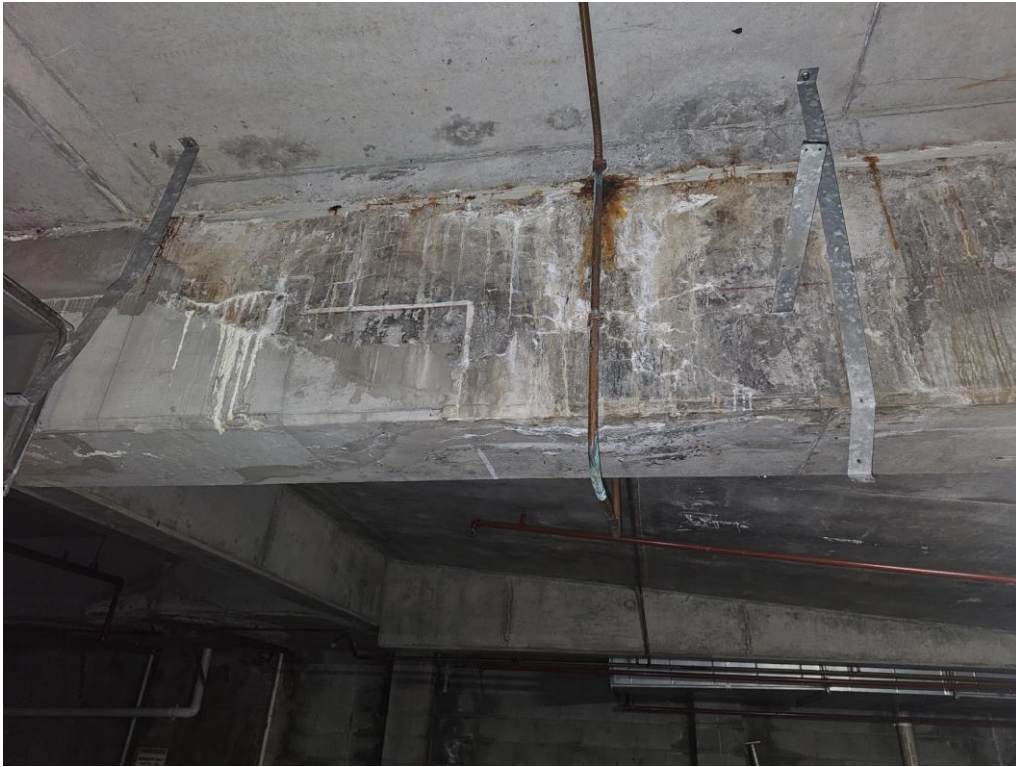
As noted in the introduction, slab pool surround had issue with water drainage, as concrete cancer/ water staining is localised to this area it is likely a result of the water drainage issues.

**PHOTOGRAPH 17.:** Defect Class C: Moderate cracking & spalling to concrete beam, beam supports pool above. Cracking depth up to 200mm into depth of beam

THIS REPAIR METHOD IS ONLY VALID IF BEAM HAS R10 TIES AT 500 CRS. MIN TO BE CONFIRMED PRIOR TO WORKS  
MAIN BEAM REINF. SHALL BE CONFIRMED PRIOR TO WORKS

- PROP SLAB EACH SIDE OF BEAM AT 1.5m CRS, PROPS SHALL BE RATED FOR 100kN EACH (10 TONNE)
- CALL ENGINEER TO SITE TO CONFIRM EXTENT OF WORKS/ SET OUT OF WORKS
- SCRABBLE BACK/ HAMMER OUT CONCRETE IN THE 2.7m AND 2.5m SECTIONS SHOWN ABOVE FOR A HEIGHT OF 200mm  
REINFORCEMENT IS TO BE FULLY EXPOSED. ALL RUSTED REINF. IS TO BE EXPOSED UNTIL CLEAN STEEL IS FOUND  
ALL CONCRETE IT TO BE LEFT AS A WELL ROUGHENED SURFACE
- WIRE BRUSH CLEAN STEEL REINFORCEMENT  
ANY BARS MISSING OVER 25% OF MASS - CONTACT ENGINEER
- PAINT ALL REINFORCEMENT WITH SIKATOP ARMATEC -110 EPOCEM
- FORM UP BOX AROUNDREPAIR CONCRETE WITH SIKA MONOTOP -412 NFG CONCRETE REPAIR MORTAR
  - RECOMMEND USING FORM BOARDS EACH SIDE OF CONC.
  - SPRAY REPAIR MORTAR UP INTO FORM BOARDS TO INSTALL TO BEAM
  - SCREED BASE OF BEAM TO FINISH
- PROPS SHALL REMAIN IN PLACE FOR 7 DAYS

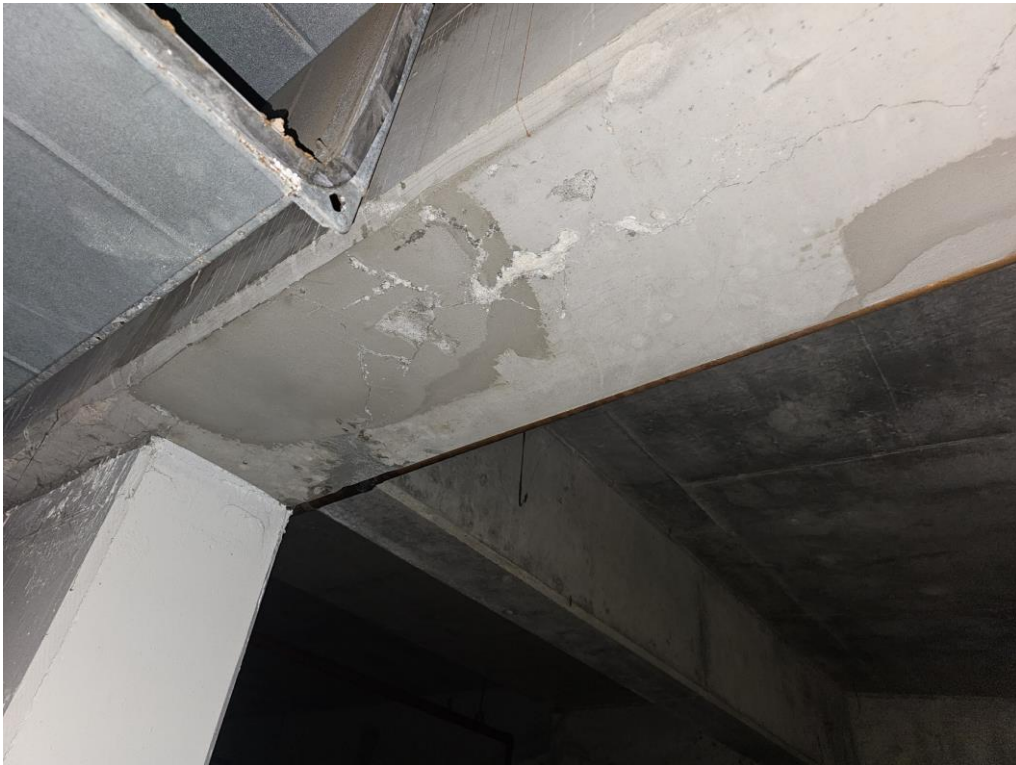
**PHOTOGRAPH 18.:** Defect Class C: Previous surface repairs evident

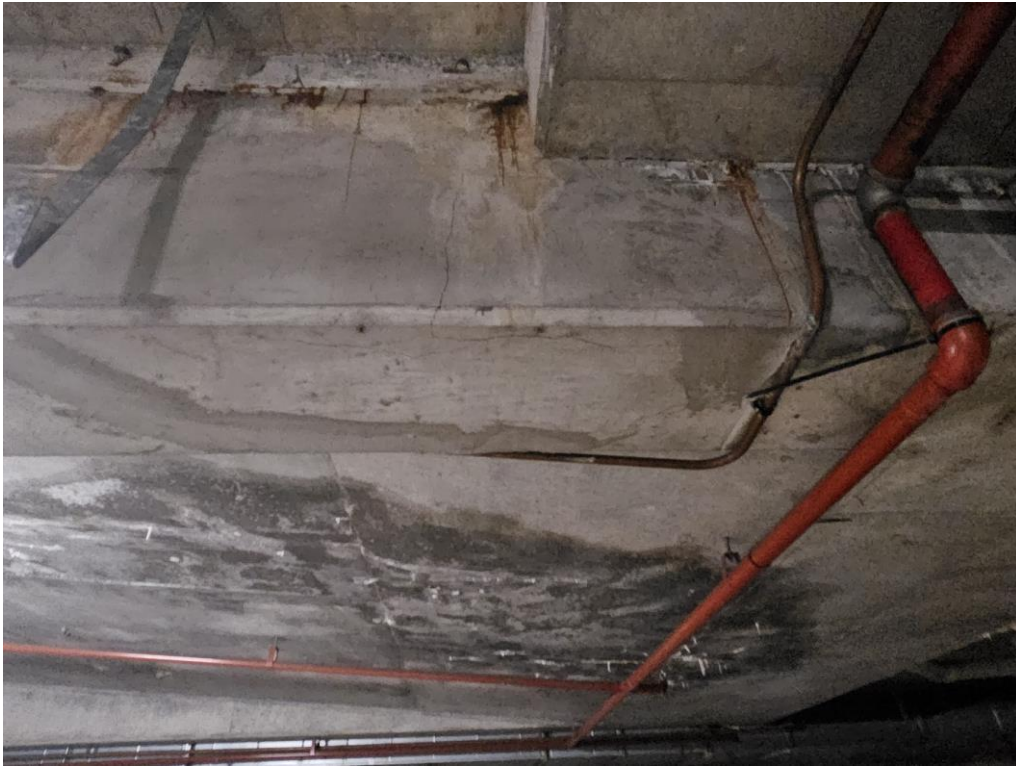
**PHOTOGRAPH 19.:** Defect Class C: Moderate cracking & spalling to concrete beam, beam supports pool above. Cracking depth up to 200mm into depth of beam

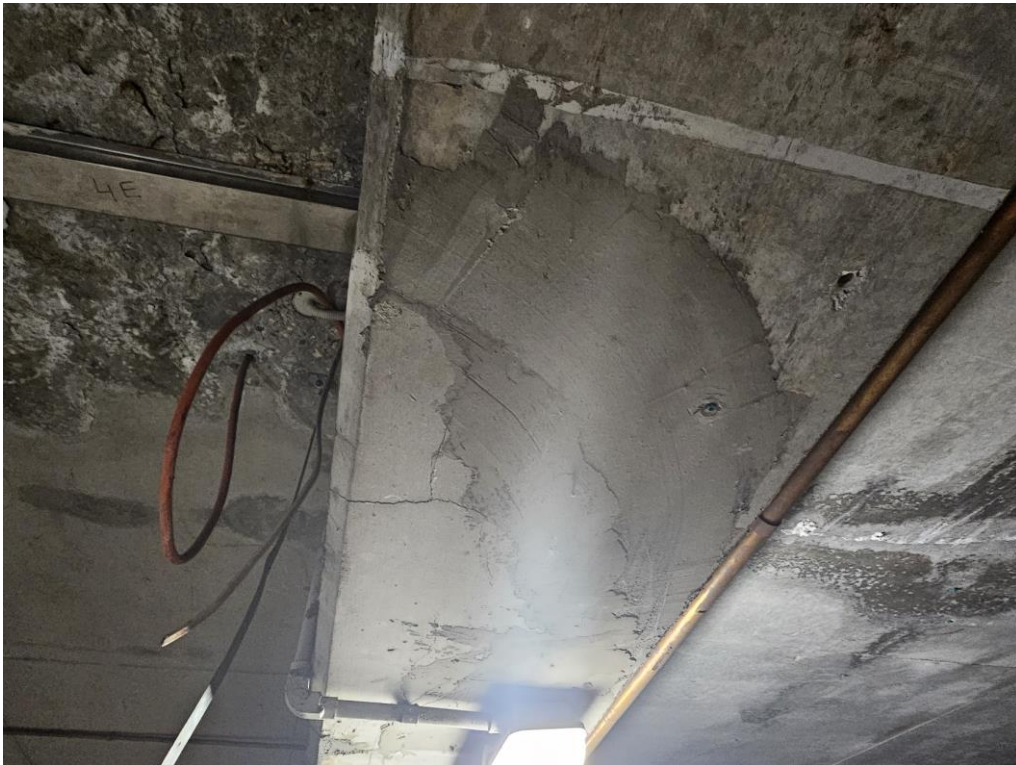
**PHOTOGRAPH 20.:** Defect Class C: Previous surface repairs evident
