**Project: C1203 Deception Bay Social Housing**  
643-651 Deception Bay Road  
Deception Bay, Queensland 4508

## Inspection: 06.89 Plant Inspection - EWP #8

| <b>Description</b> | D&S (Beel Steel) EWP Scissor lift. Sticker #23460 | | |

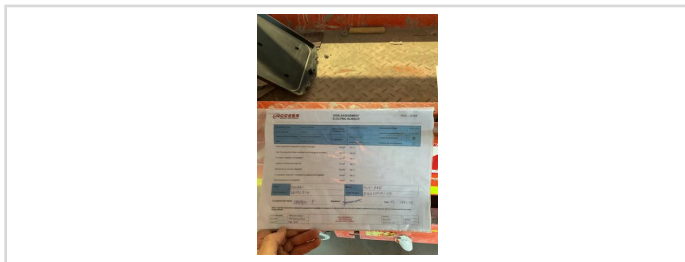
**2.6 Plant risk assessment available.**

Shane Pannell (McNab) responded with Pass on Oct 4, 2025 at 08:04 AM AEST

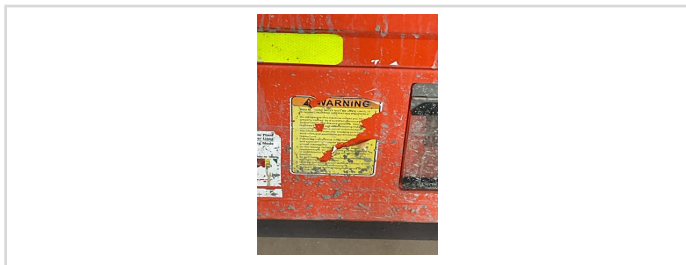
**4.3 Warning signs fitted and visible**

Warning labels on base sides need to be replaced

No obvious defects sited. Stickers at sides of base need replacing.
