## Concrete Remedial Works - 68 Latrobe Tce, Paddington

### Introduction & Background

Design Sirs has been engaged by Core4 Services to conduct a structural assessment of concrete cancer to balconies/ walkways and provide recommended repairs to same. Concerns had been raised to condition of concrete walkways and balconies when cracking, chipping, and visible areas of rusted reinforcement were observed.

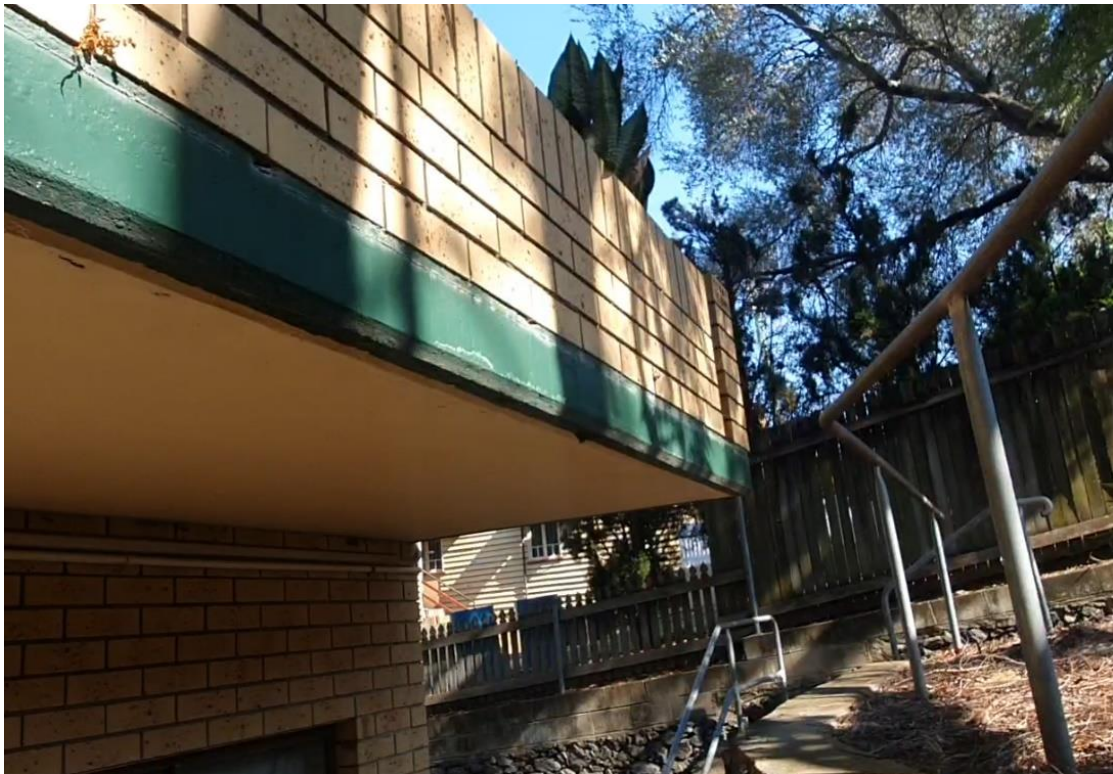
**PHOTOGRAPH 1.:** No evident concrete cancer, clean area of debris, clean surface & paint

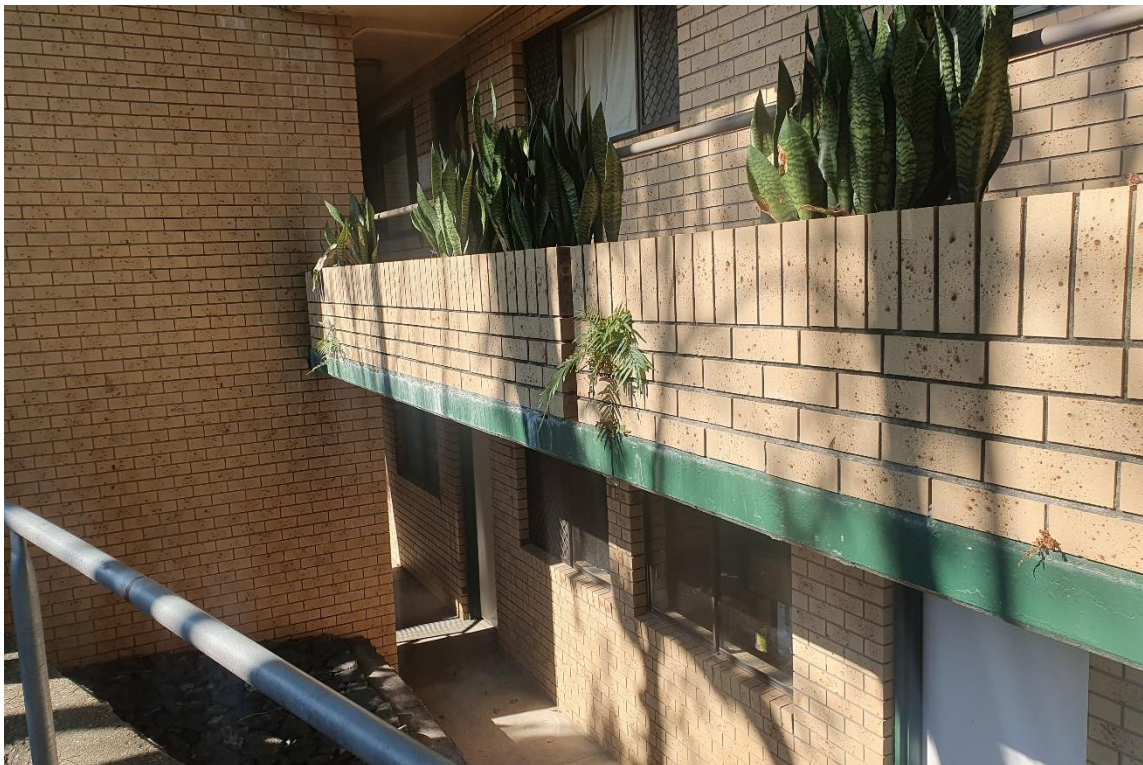
**PHOTOGRAPH 2.:** No evidence of concrete cancer. Efflorescence indicates on-going carbonation of concrete

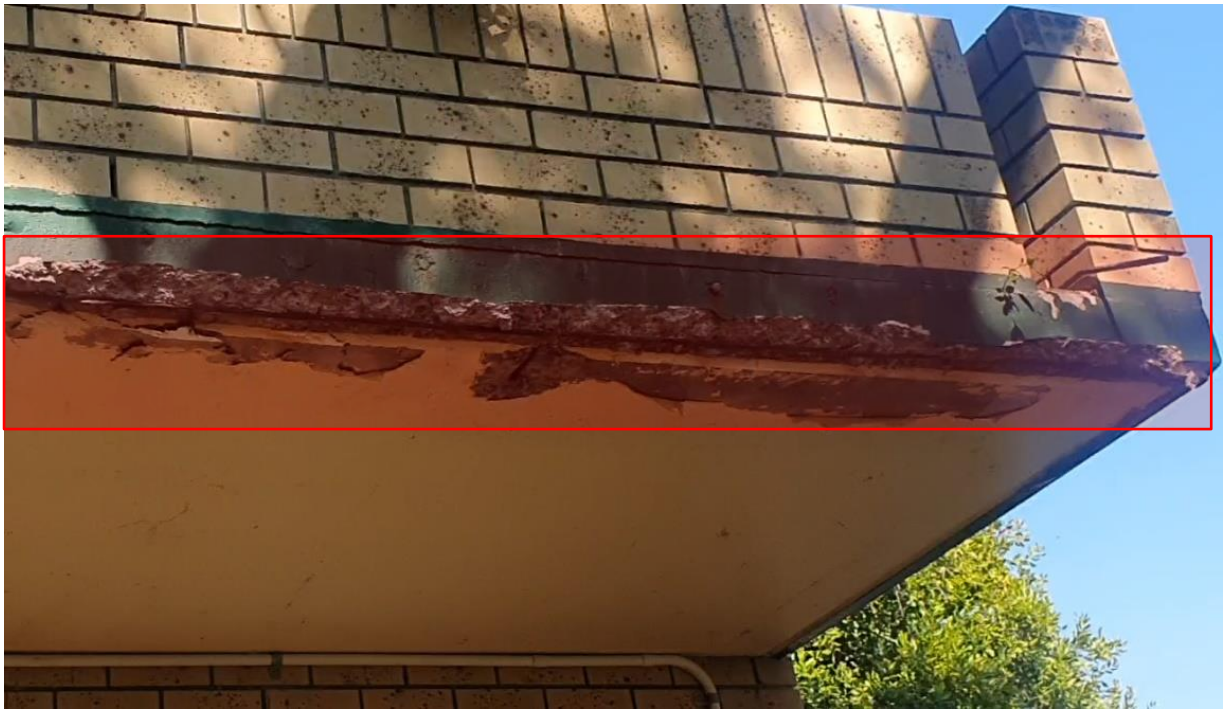
**PHOTOGRAPH 3.:** Concrete cancer to balcony slab, extends back approx.400mm. Cancer along length of balcony at various points. Garden bed slab above slab

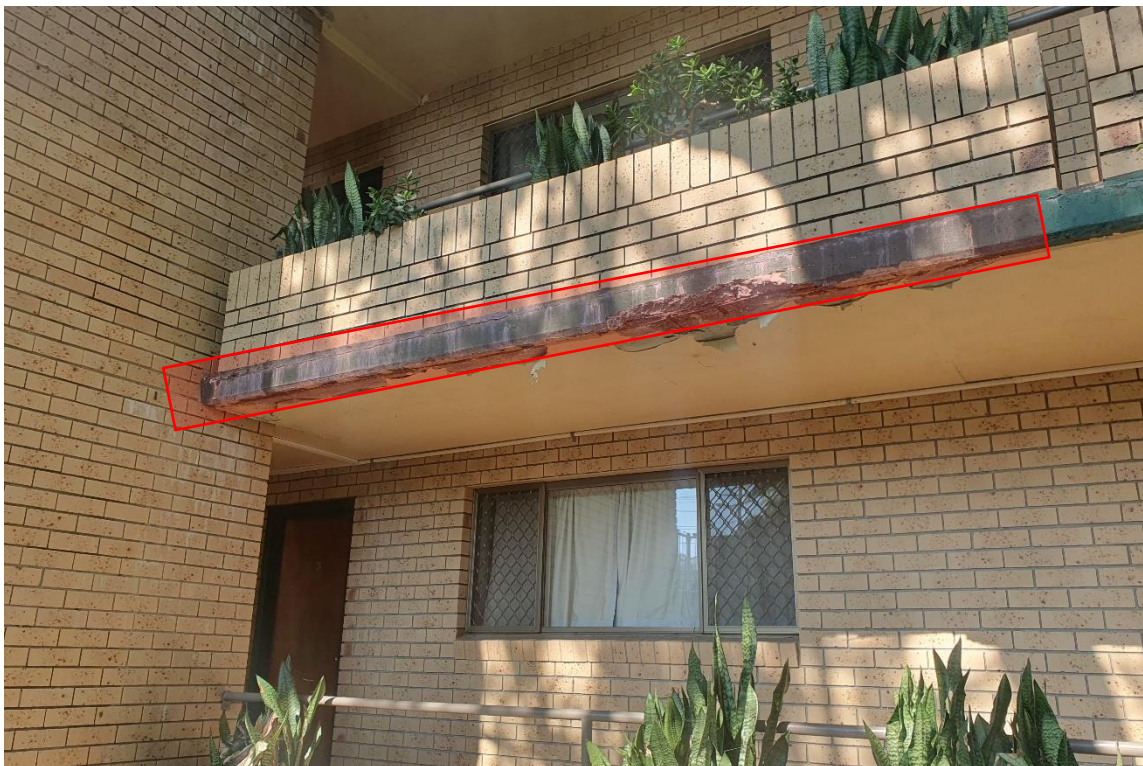
**PHOTOGRAPH 4.:** Concrete cancer to balcony slab, extends back approx.400mm

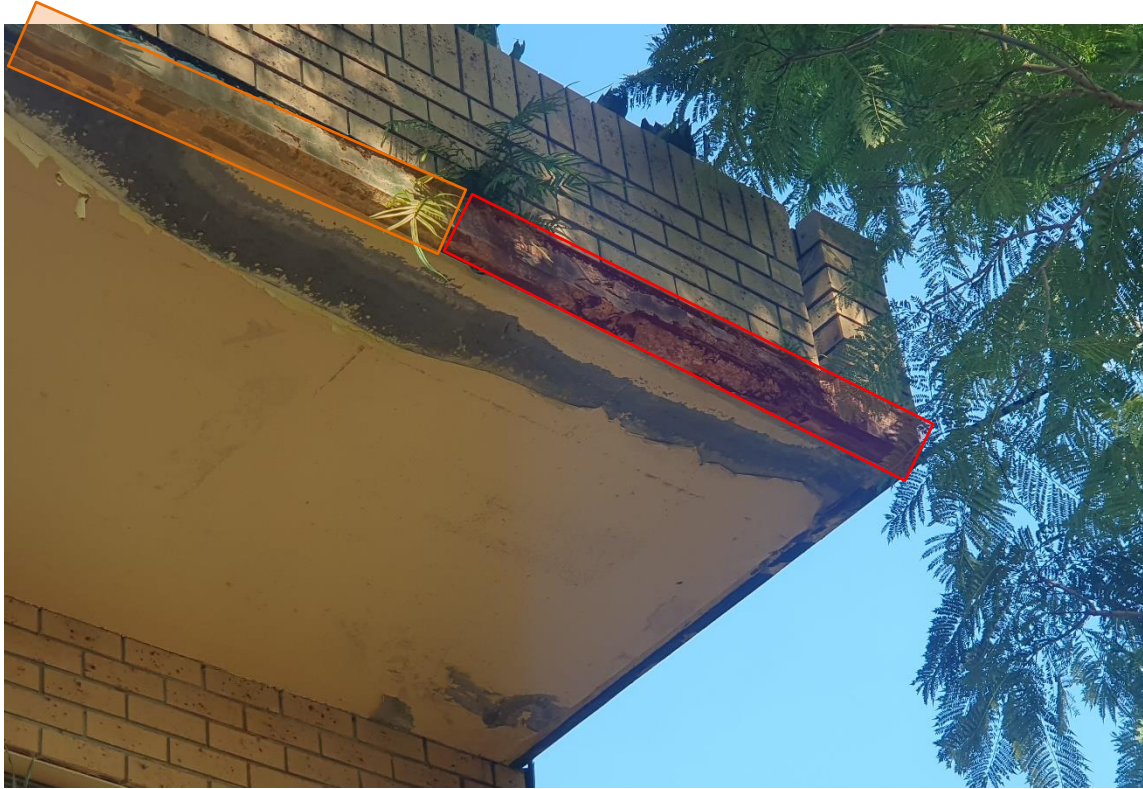
**PHOTOGRAPH 5.:** Moderate concrete cancer 2.0m from corner along balcony.

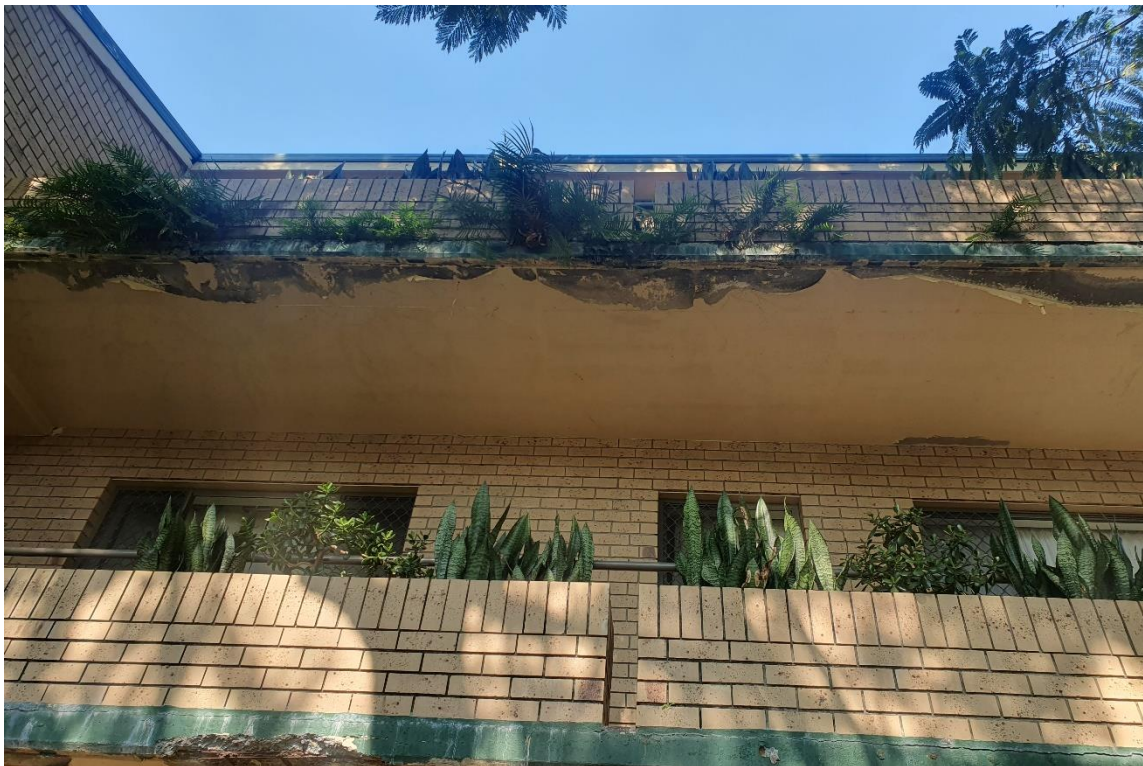
**PHOTOGRAPH 6.:** Minor areas of reinforcement exposure/ concrete cancer. Paint has significant spalling/ peeling

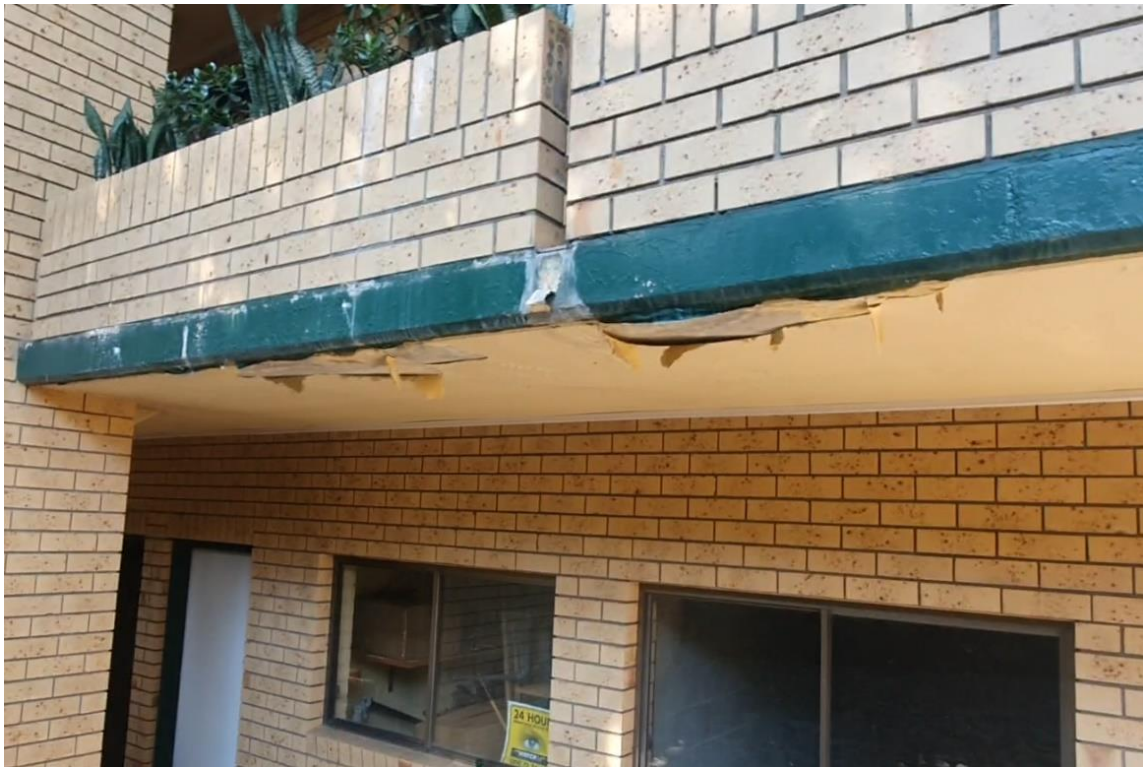
**PHOTOGRAPH 7.:** No evidence of concrete cancer, some efflorescence to concrete, paint is spalling/peeling

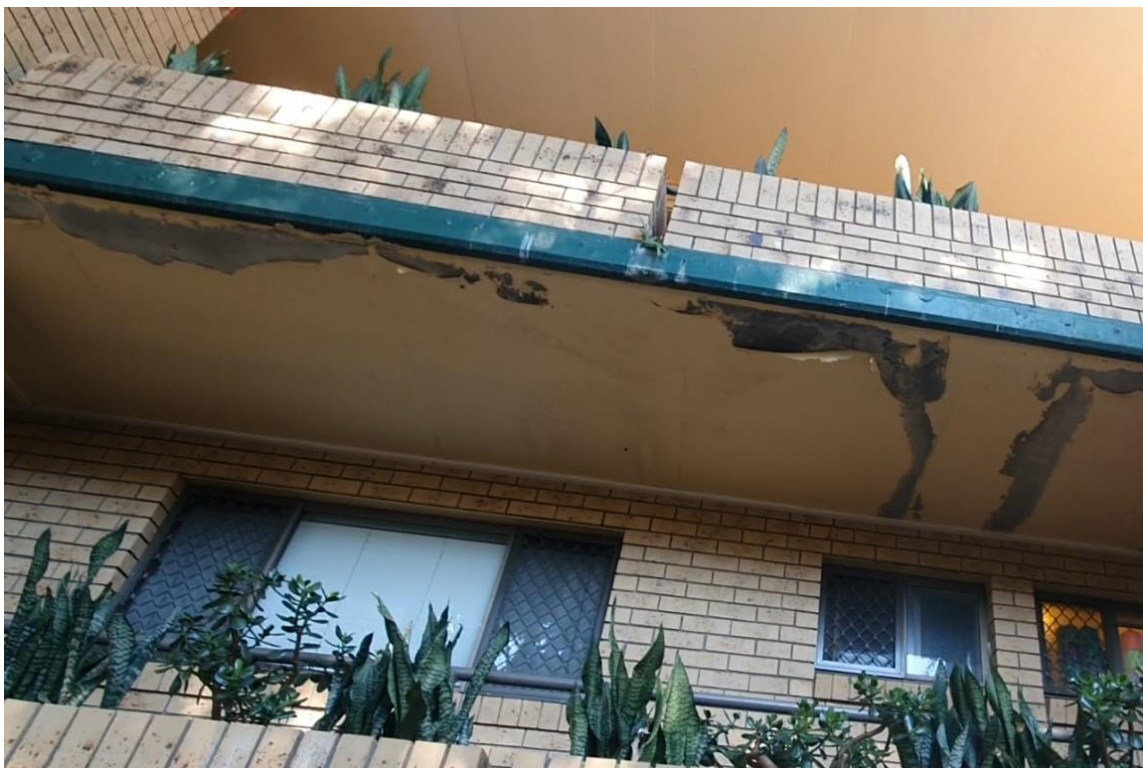
**PHOTOGRAPH 8.:** LHS – paint peeling/ spalling, concrete generally in good condition  
RHS – Concrete spalling, some voids to reinforcement

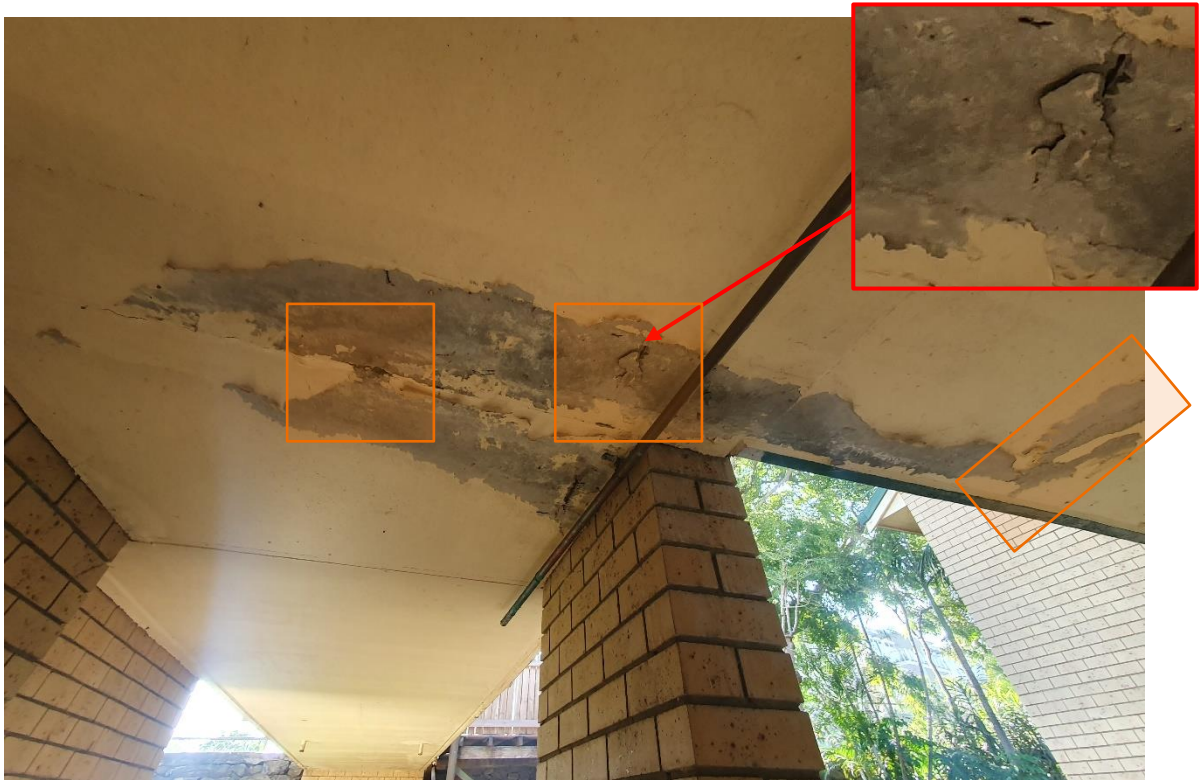
**PHOTOGRAPH 9.:** Below walkway above concrete spalling/ falling away in small sections

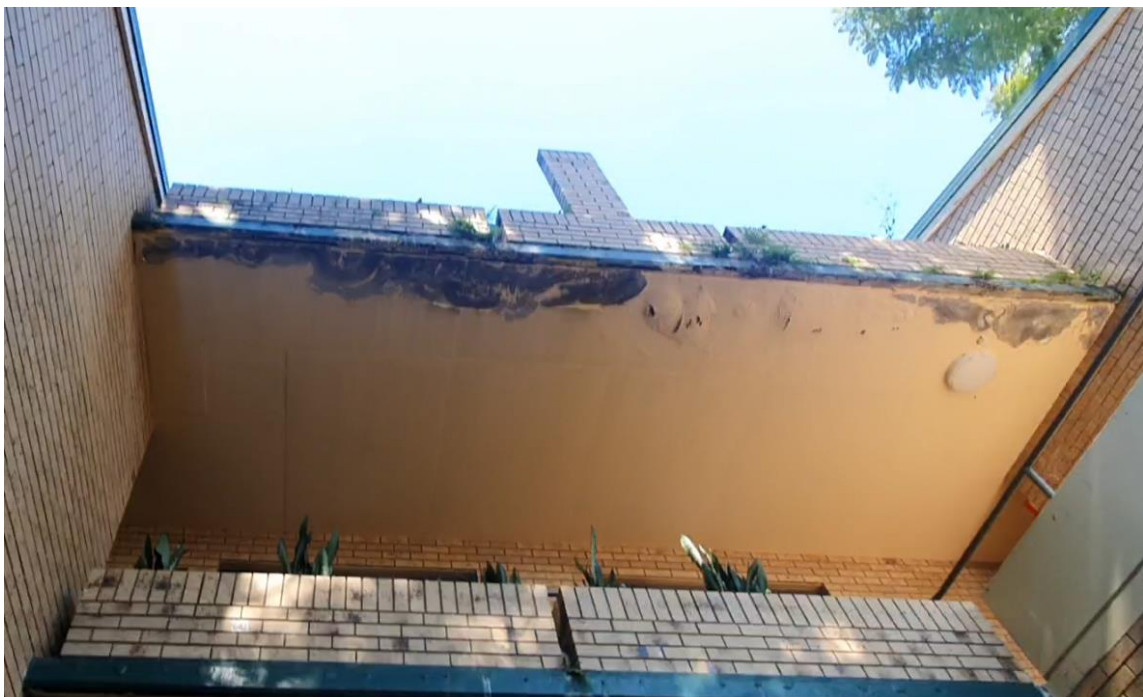
**PHOTOGRAPH 10.:** Some spalling of concrete, areas of paint fully deteriorated.

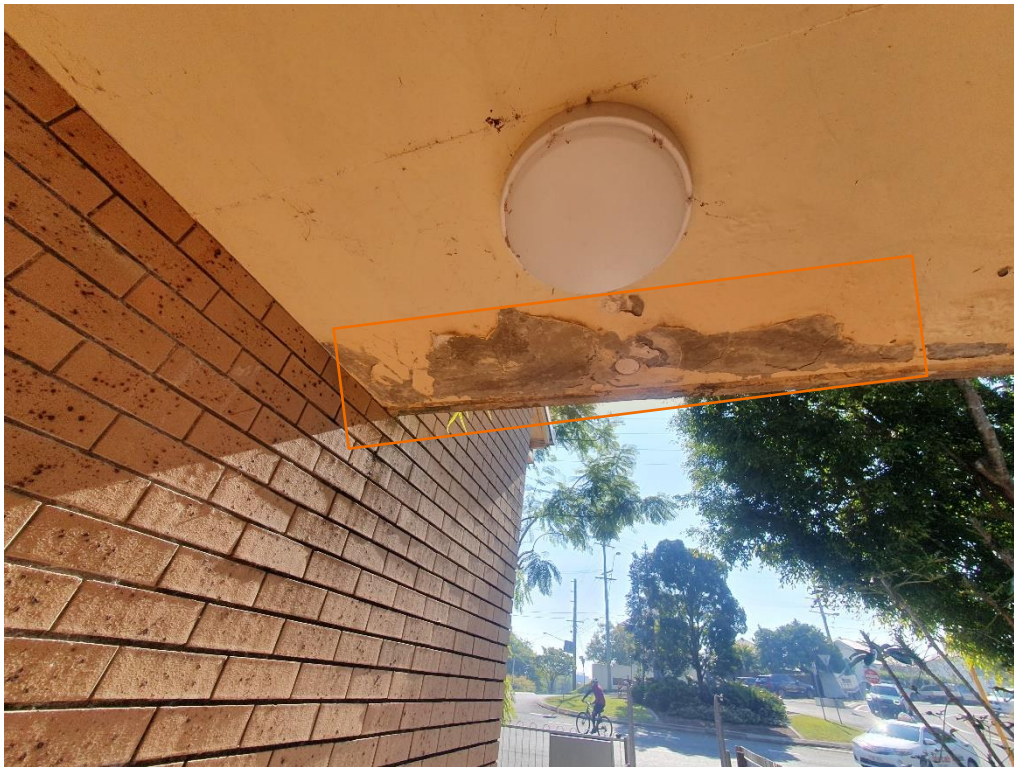
**PHOTOGRAPH 11.:** cracking to concrete slab, spalling to some areas.

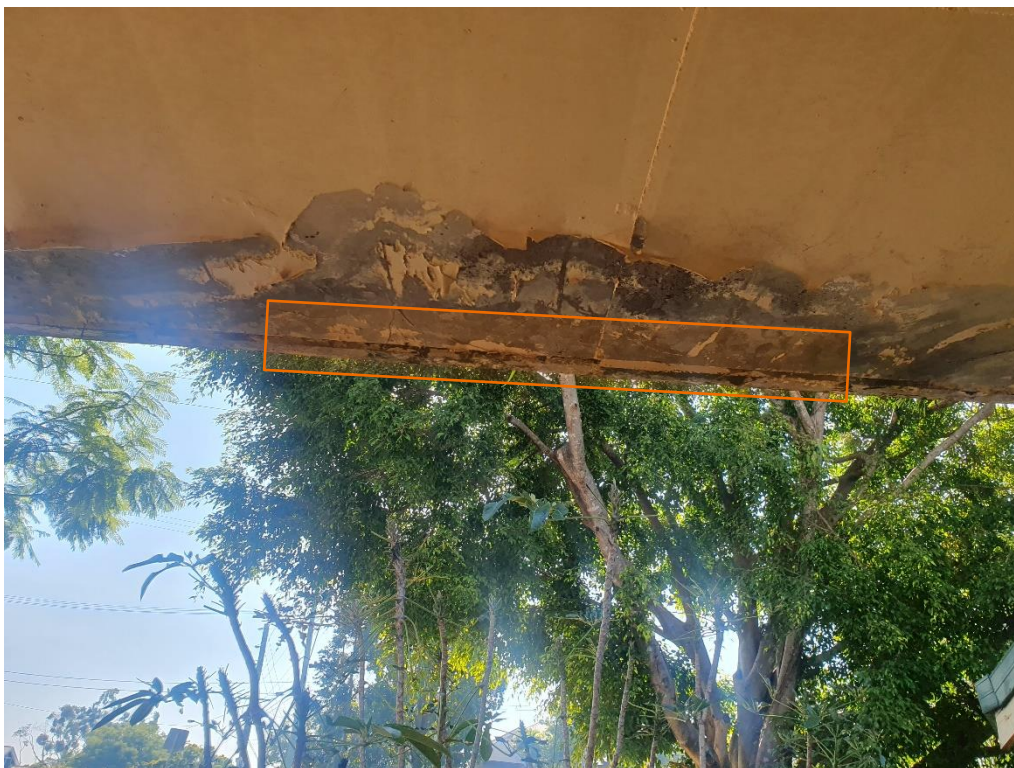
**PHOTOGRAPH 12.:** cracking to concrete slab, spalling to some areas.

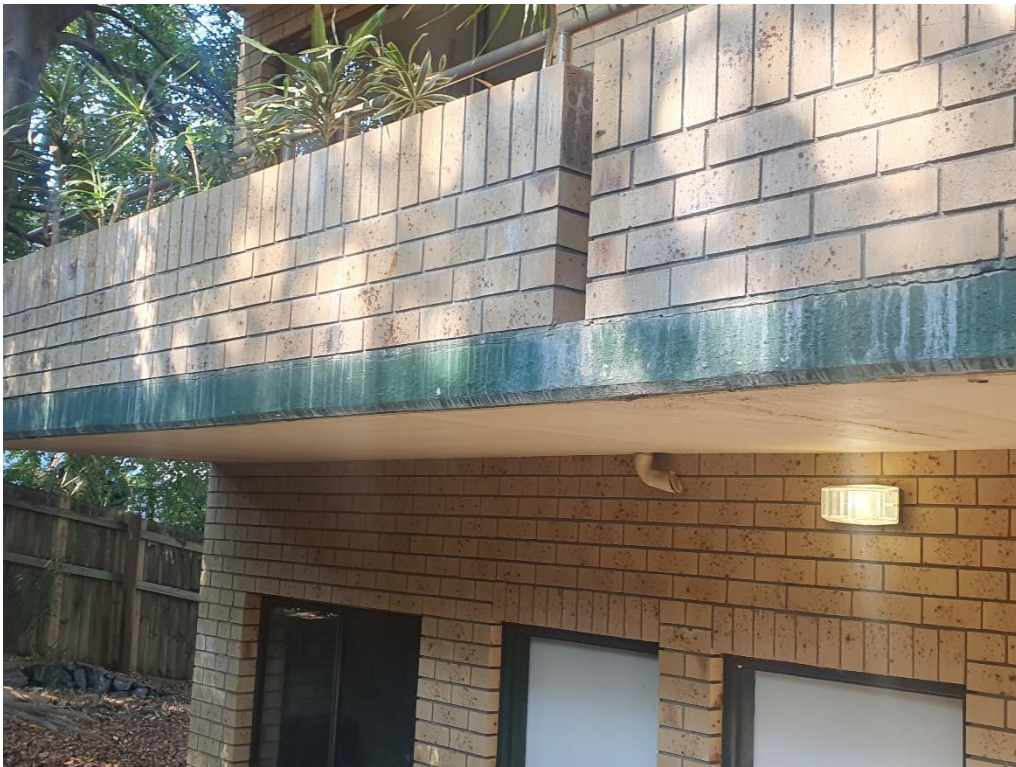
**PHOTOGRAPH 13.:** Slab in generally good condition, with some efflorescence, minor paint defects

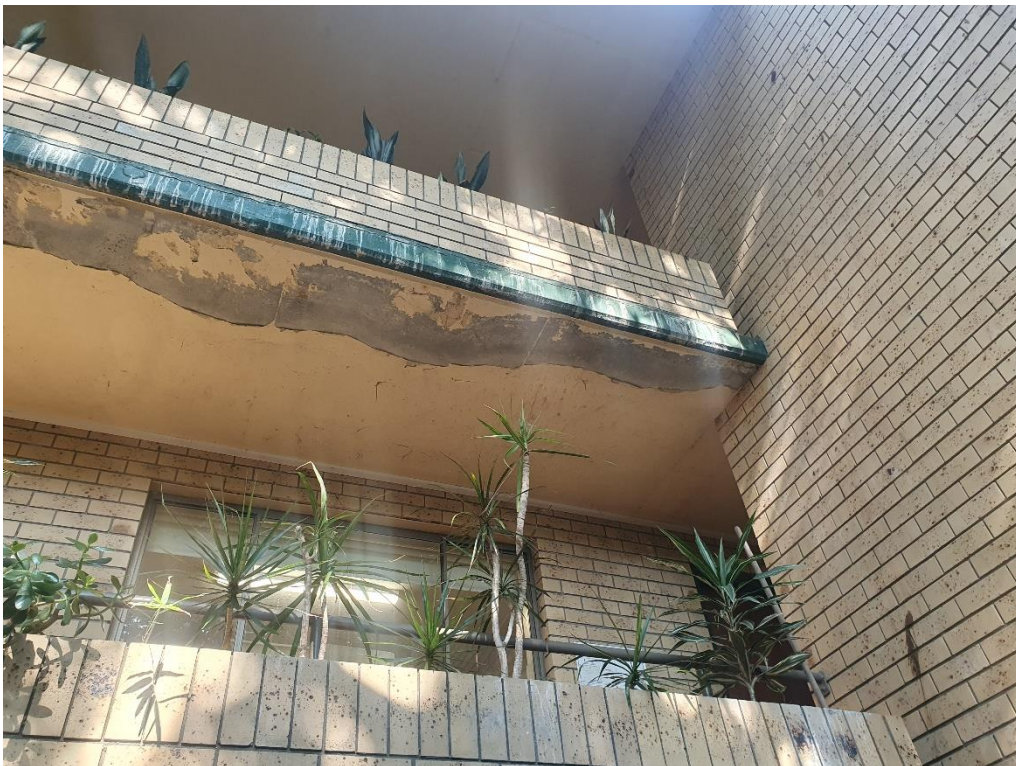
**PHOTOGRAPH 14.:** no indication of slab spalling/ cracks. Paint work has peeled away in large sections

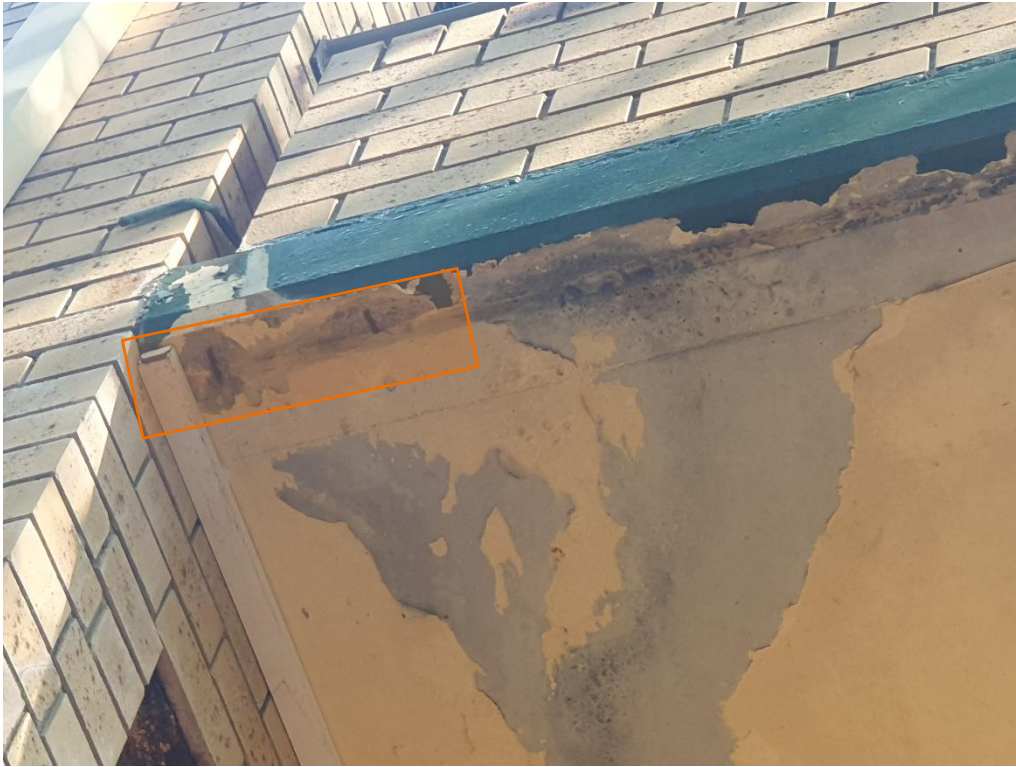
**PHOTOGRAPH 15.:** Small area of exposed reinforcement, some minor slab spalling/ deterioration

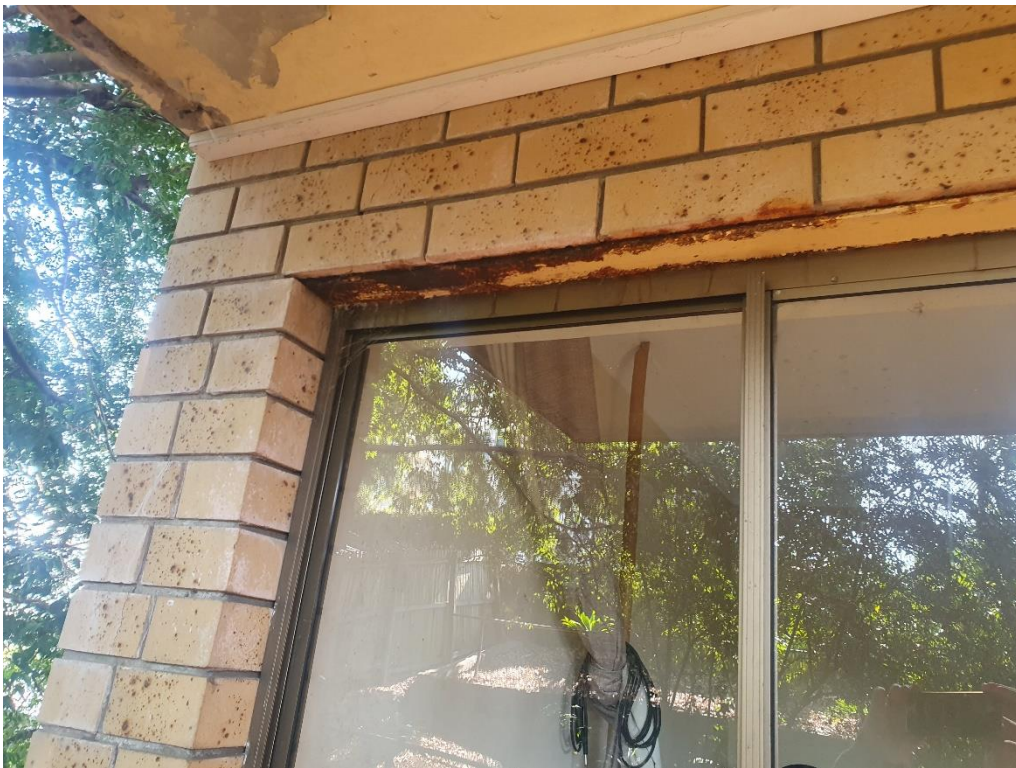
**PHOTOGRAPH 16.:** Moderate corrosion to steel window lintel

- Class D:
  - Photo 16 & 20 – Wire brush clean steel lintel, remove all corrosion and paint
  - Photo 21 – Timber rot to cladding/ fascia boards – replace with new

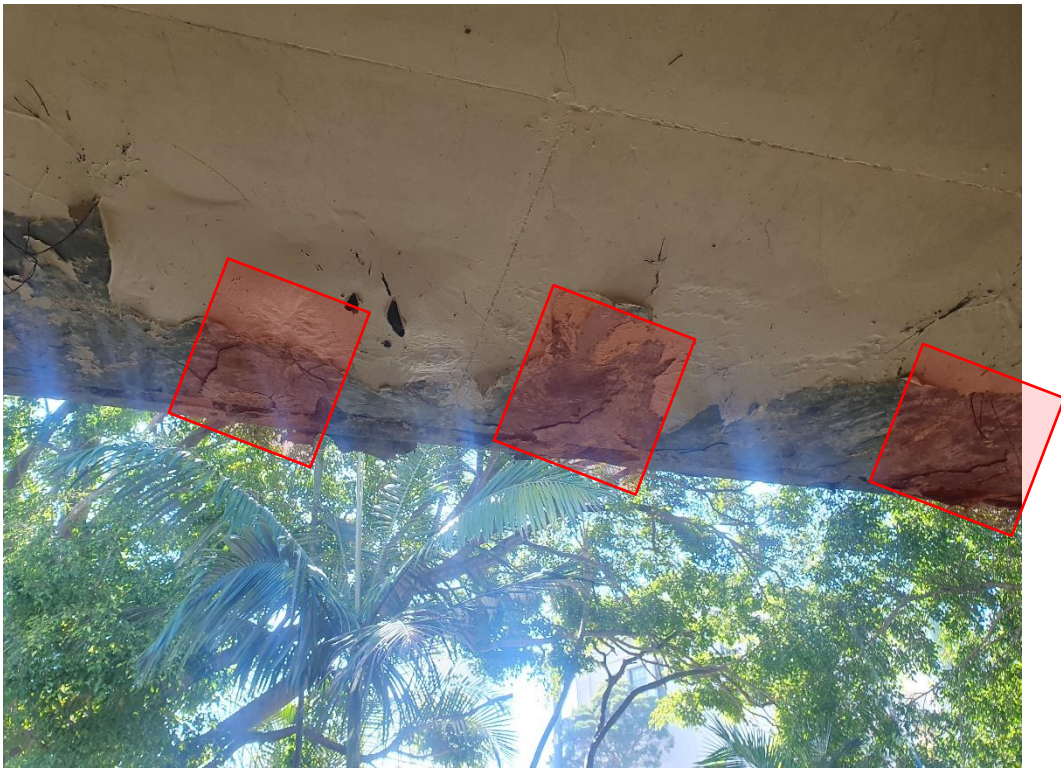
**PHOTOGRAPH 17.:** Moderate cracking to concrete slab, evidence of early spalling/ blow-out from concrete cancer

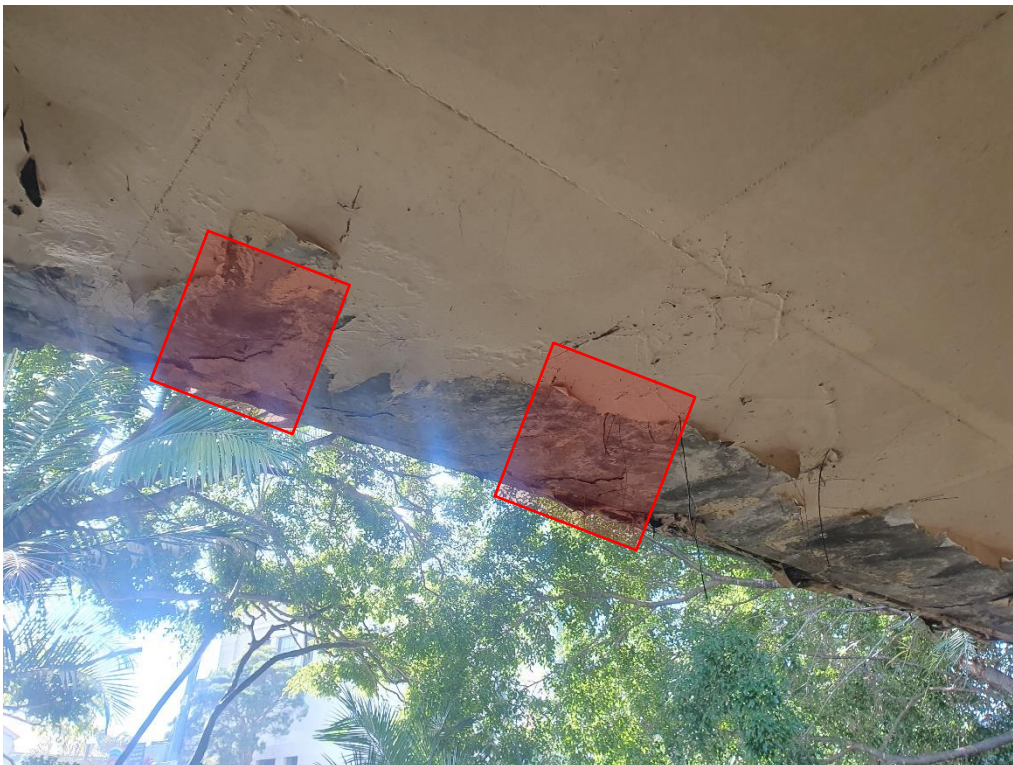
**PHOTOGRAPH 18.:** Moderate cracking to concrete slab, evidence of early spalling/ blow-out from concrete cancer

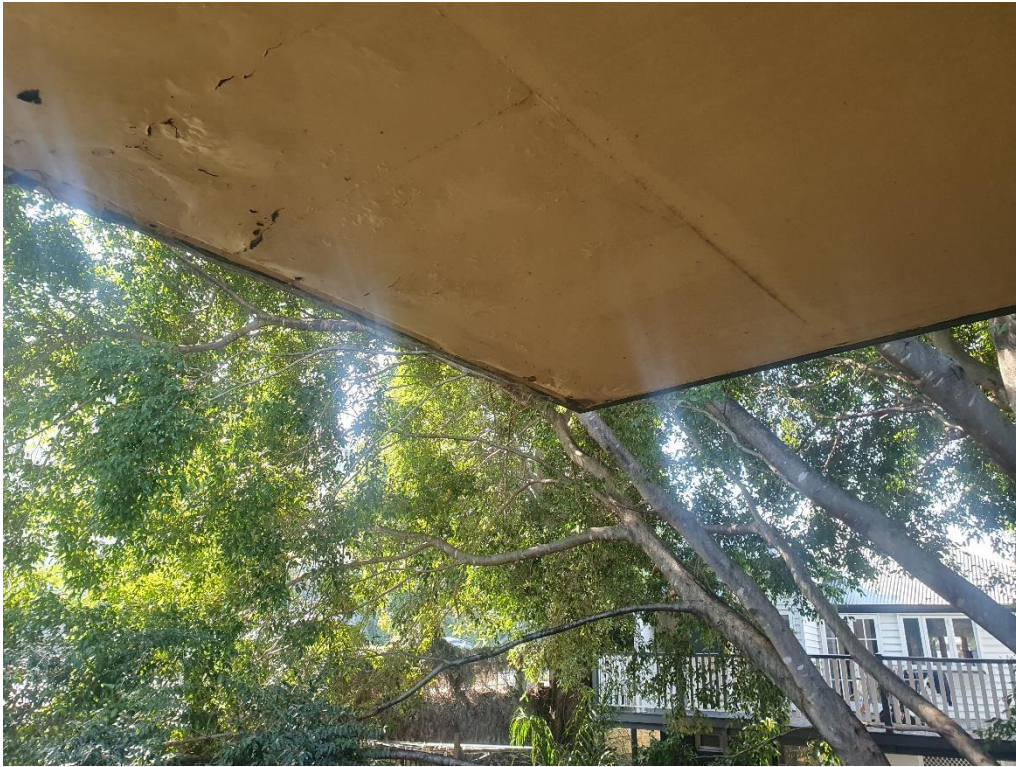
**PHOTOGRAPH 19.:** Corner of slab appears to be in generally good condition

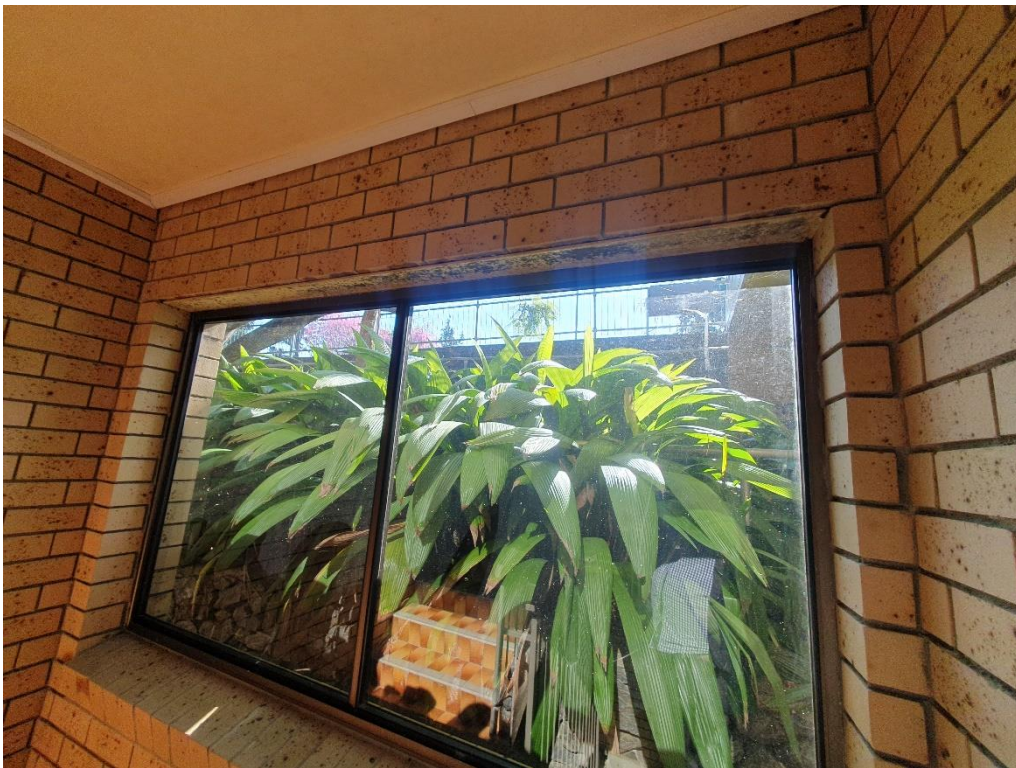
**PHOTOGRAPH 20.:** Minor corrosion to steel window lintel

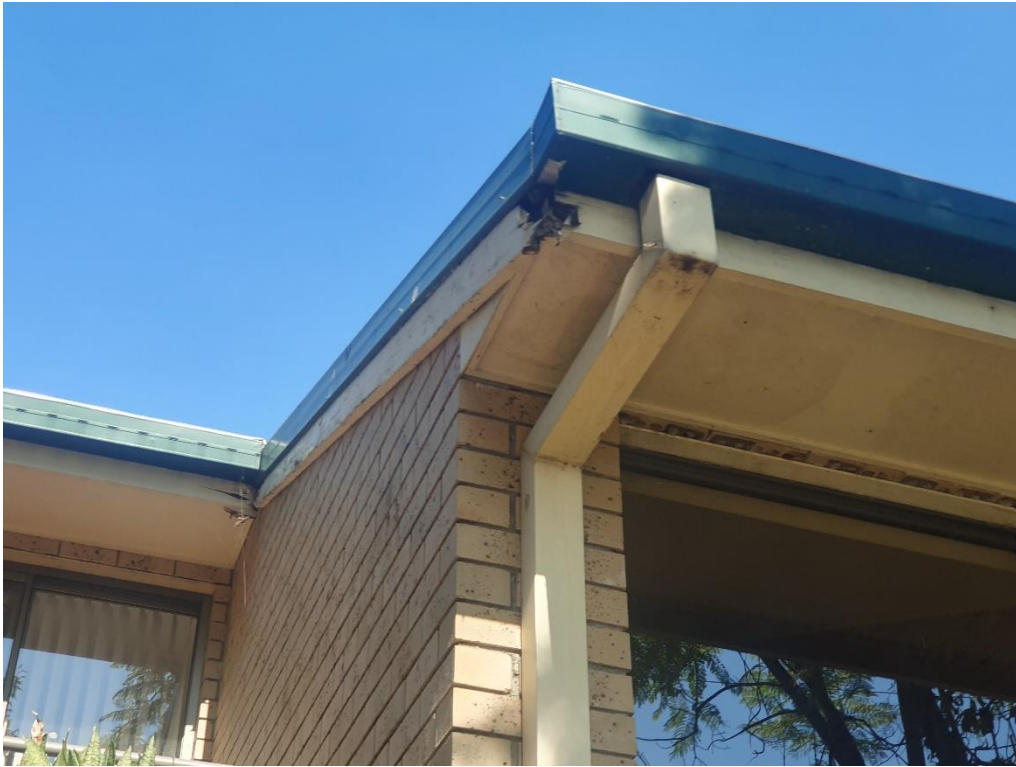
**PHOTOGRAPH 21.:** Severe timber rot to timber skirting along roof eave

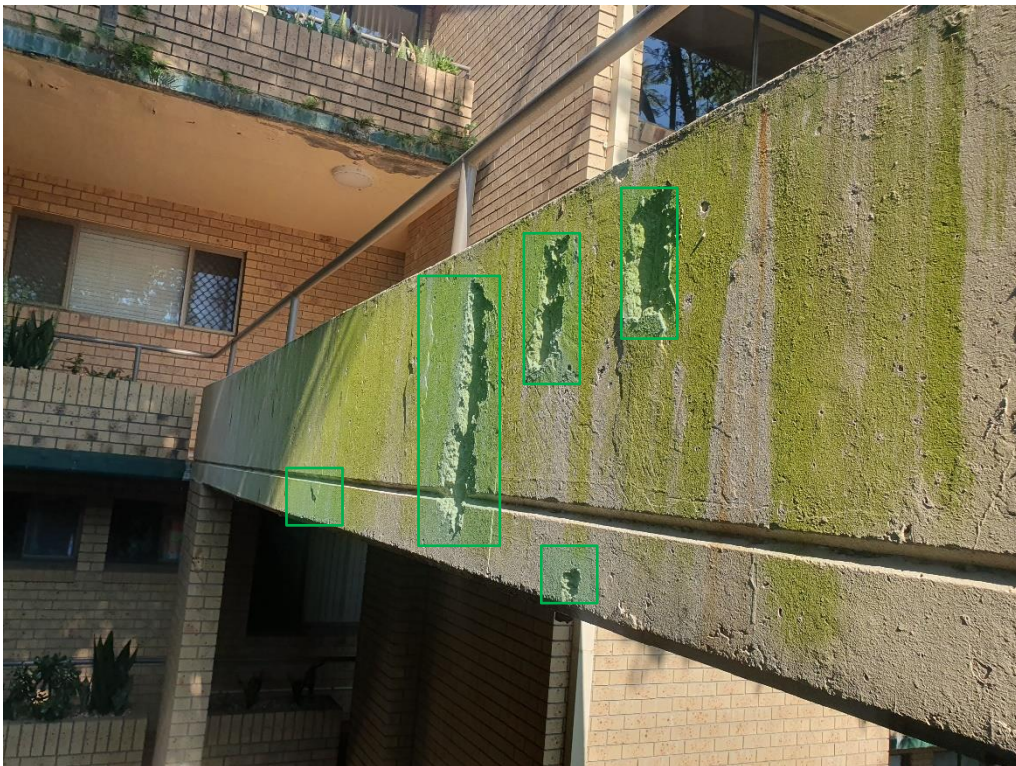
**PHOTOGRAPH 22.:** Spalling of concrete wall over bridge, evident of concrete blow out due to concrete cancer

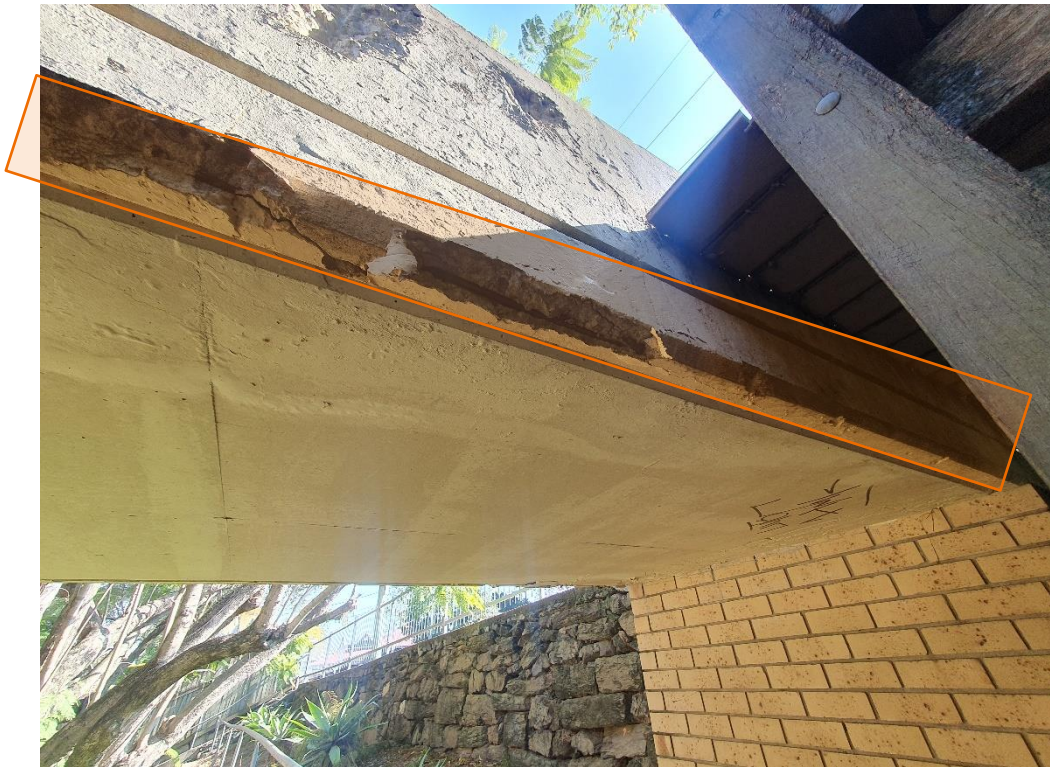
**PHOTOGRAPH 23.:** Underside bridge, moderate concrete cancer. Concrete spalling/ deterioration along underside edge

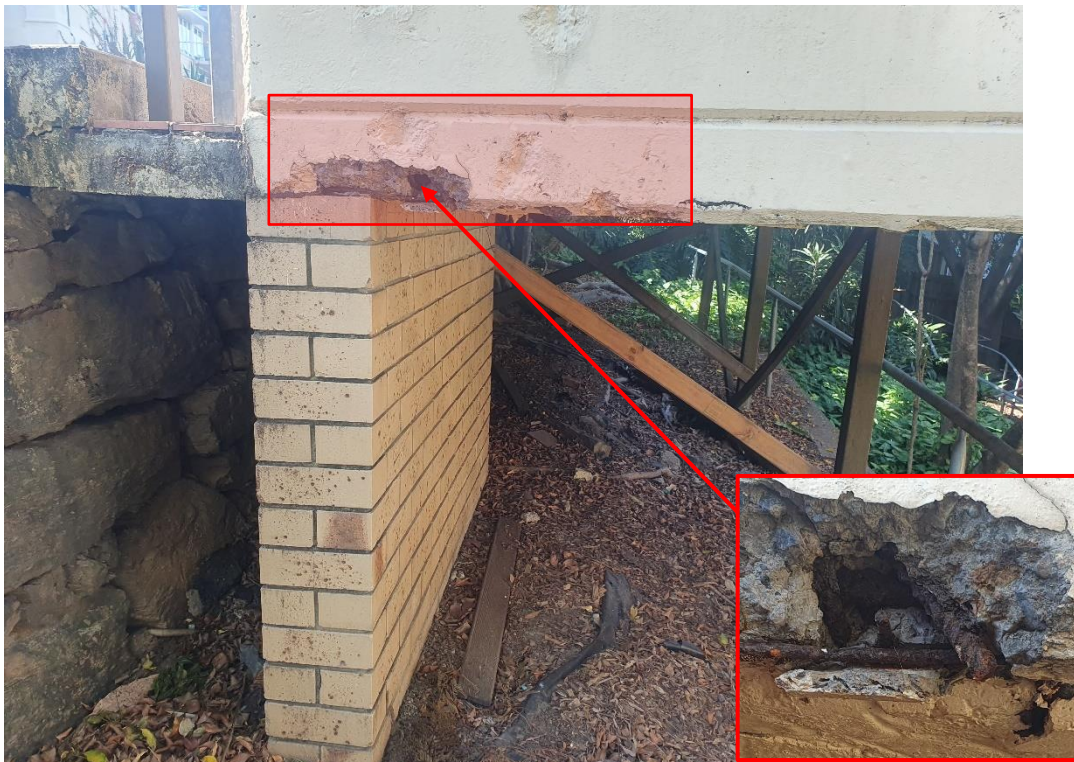
**PHOTOGRAPH 24.:** Large void near bridge support wall, severe corrosion to reinforcement. Large chunks of slab are missing/ have fallen away

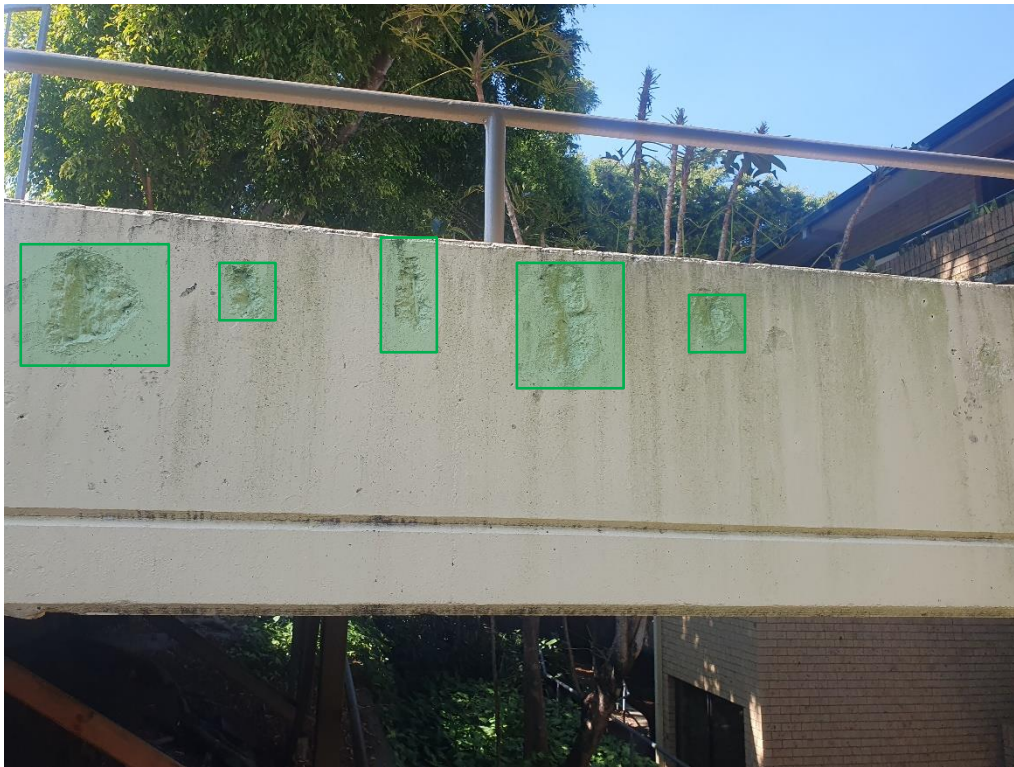
**PHOTOGRAPH 25.:** Spalling of concrete wall over bridge, evident of concrete blow out due to concrete cancer

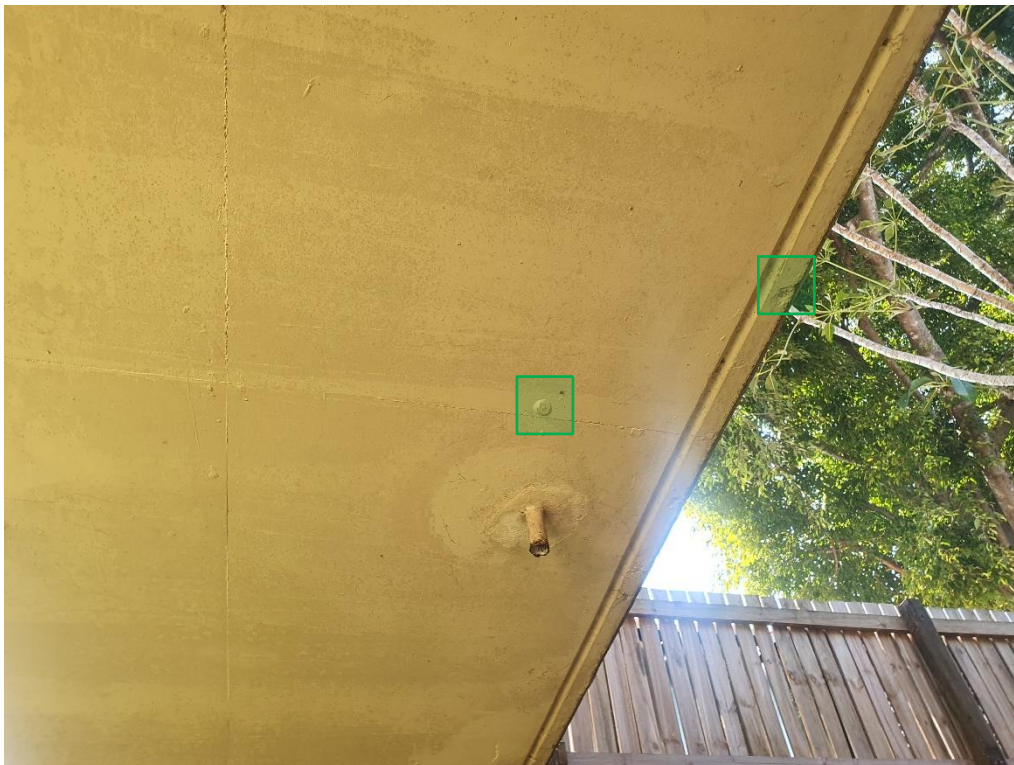
**PHOTOGRAPH 26.:** Minor defects to underside bridge, minor areas of spalling/ paint deterioration

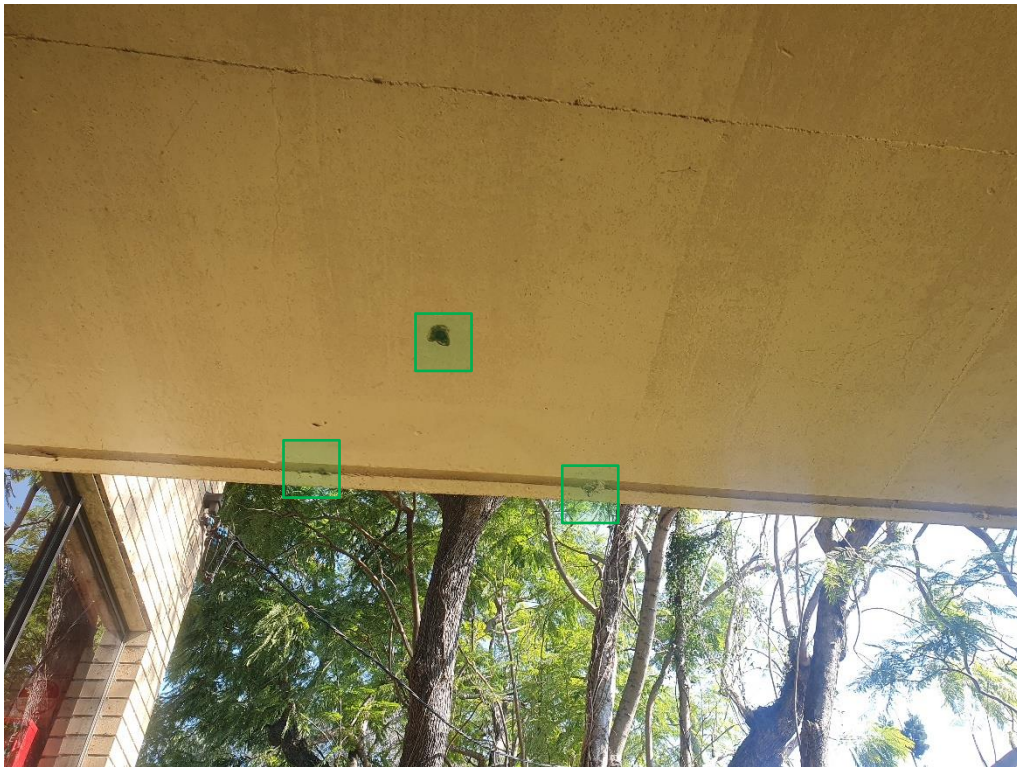
**PHOTOGRAPH 27.:** Minor defects to underside bridge, minor areas of spalling/ paint deterioration
