## Concrete Remedial Works - 68 Latrobe Tce, Paddington

### Introduction & Background

Design Sirs has been engaged by Core4 Services to conduct a structural assessment of concrete cancer to balconies/ walkways and provide recommended repairs to same. Concerns had been raised to condition of concrete walkways and balconies when cracking, chipping, and visible areas of rusted reinforcement were observed.

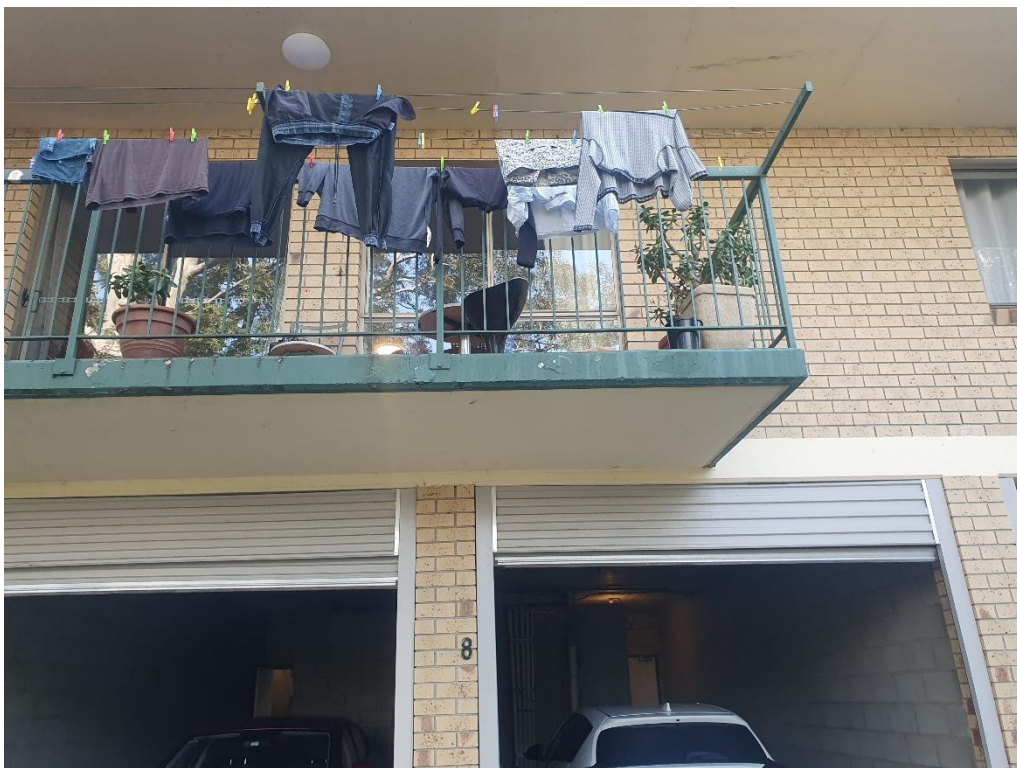
**PHOTOGRAPH 28.:** No evidence of concrete cancer, minor indications of deterioration. Minor defects to paint coating

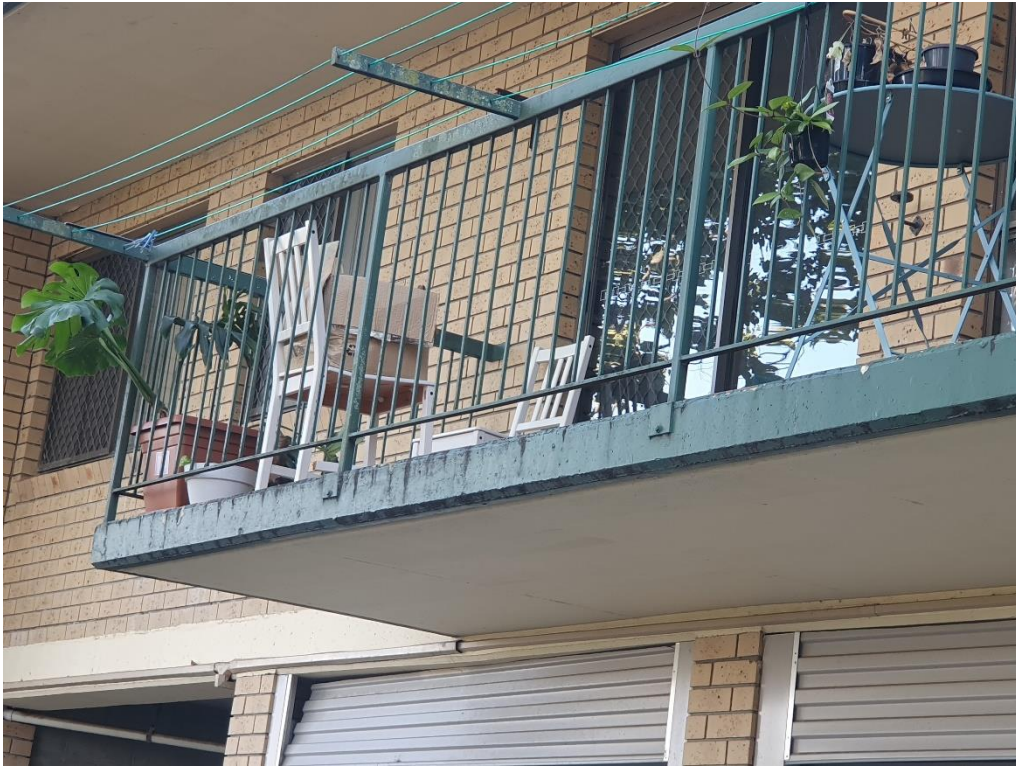
**PHOTOGRAPH 29.:** No evidence of concrete cancer, minor indications of deterioration. Minor defects to paint coating

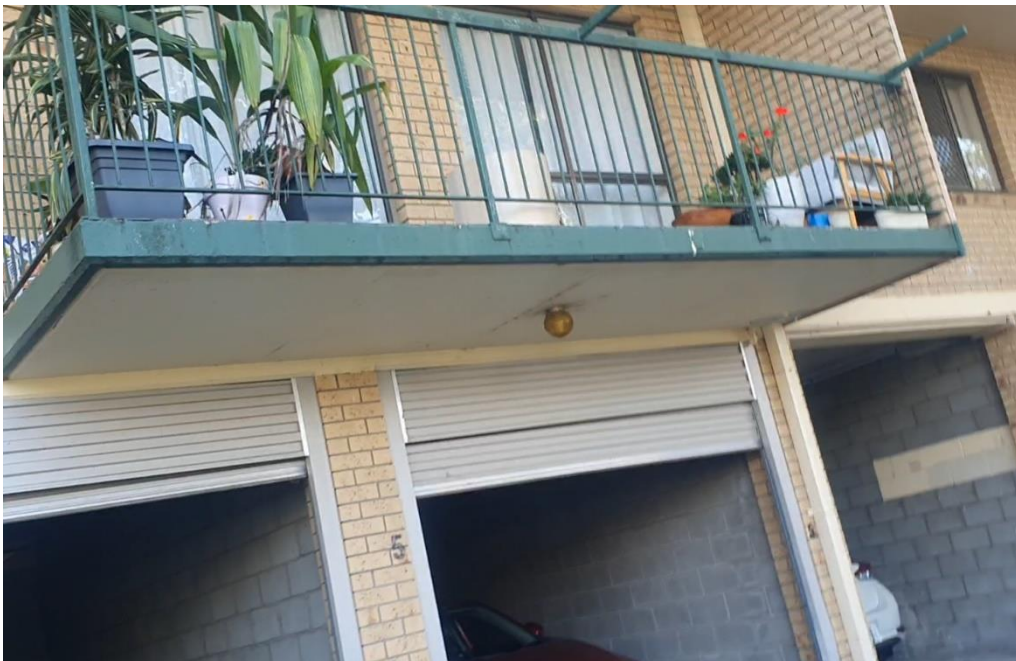
**PHOTOGRAPH 30.:** No evidence of concrete cancer, minor indications of deterioration. Minor defects to paint coating

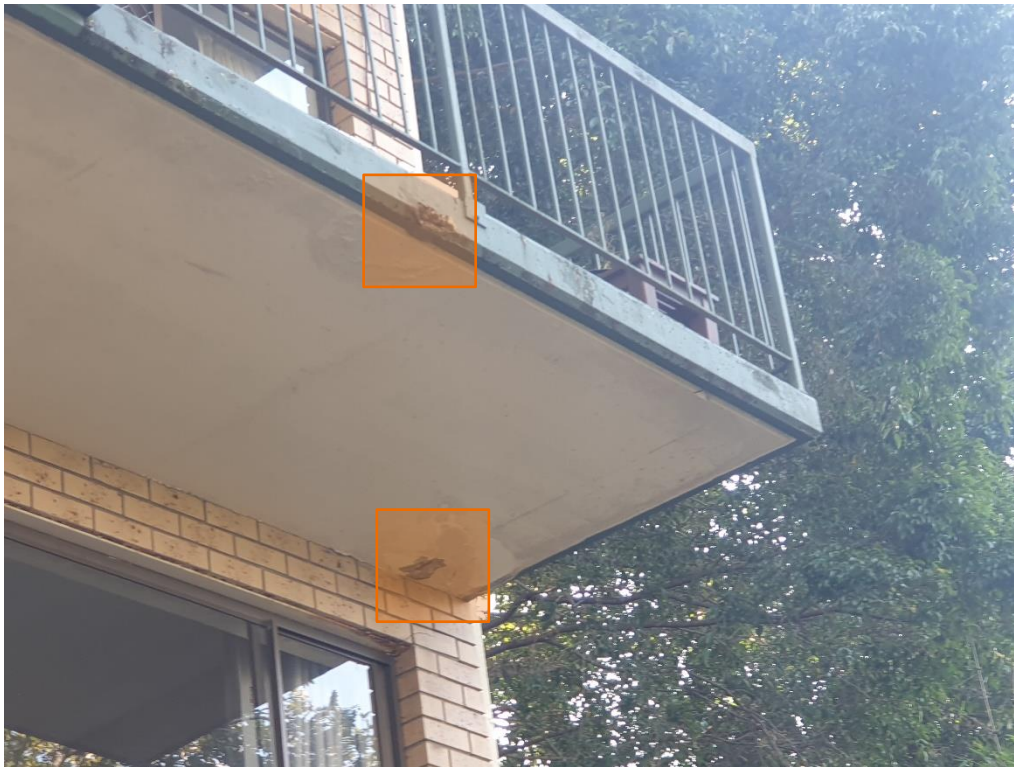
**PHOTOGRAPH 31.:** Minor spalling/ blow out of concrete slab. Small area of reinforcement visible

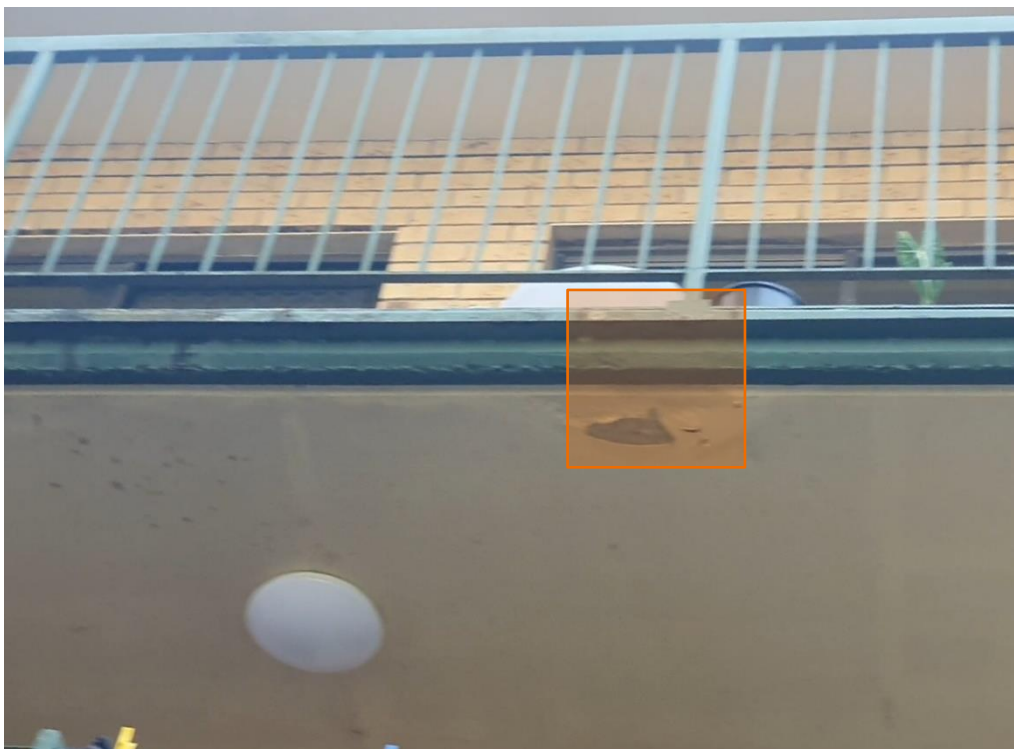
**PHOTOGRAPH 32.:** Minor spalling/ blow out of concrete slab

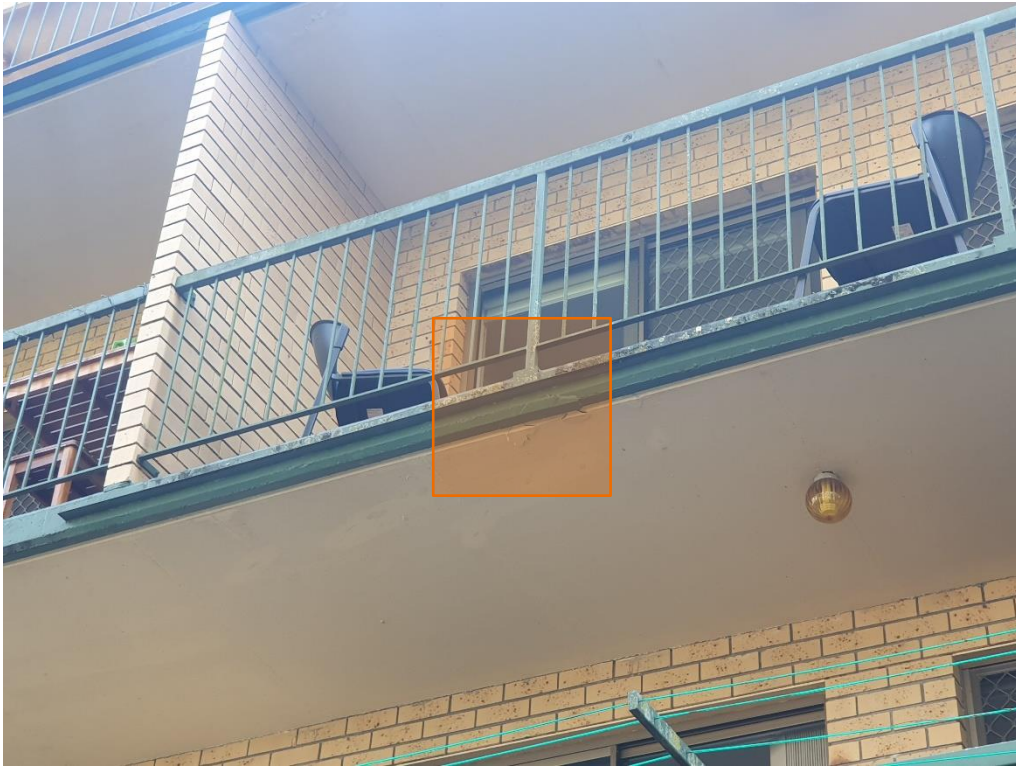
**PHOTOGRAPH 33.:** Minor spalling/ blow out of concrete slab

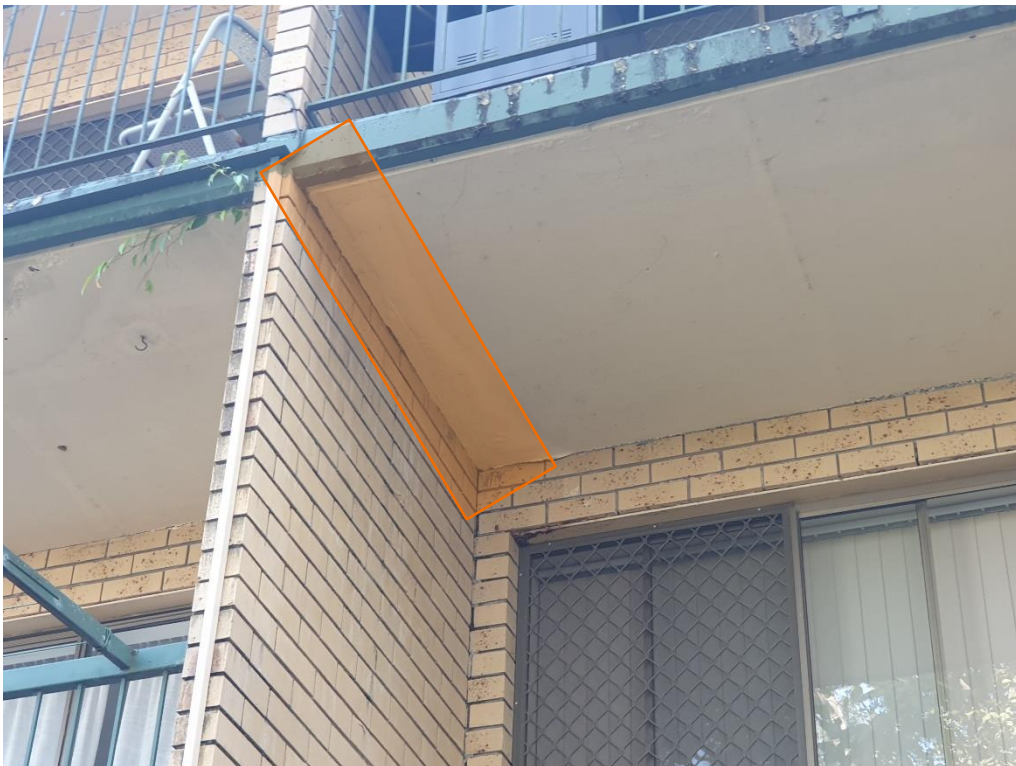
**PHOTOGRAPH 34.:** Concrete slab expansion alongside brick support

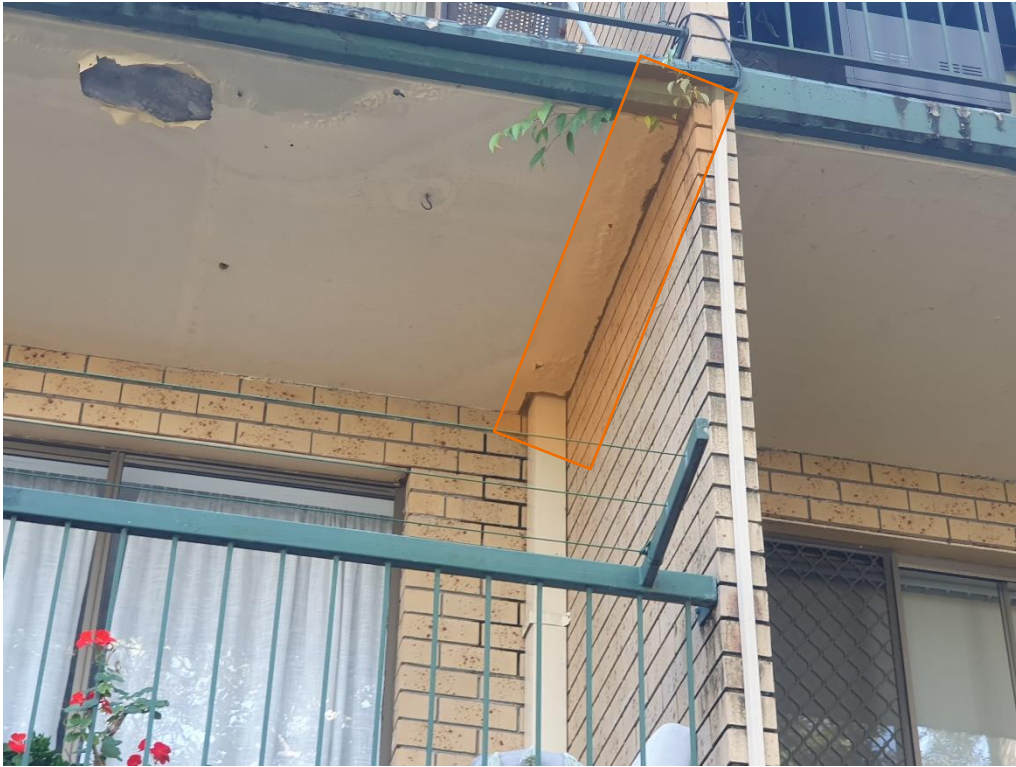
**PHOTOGRAPH 35.:** Concrete slab expansion alongside brick support

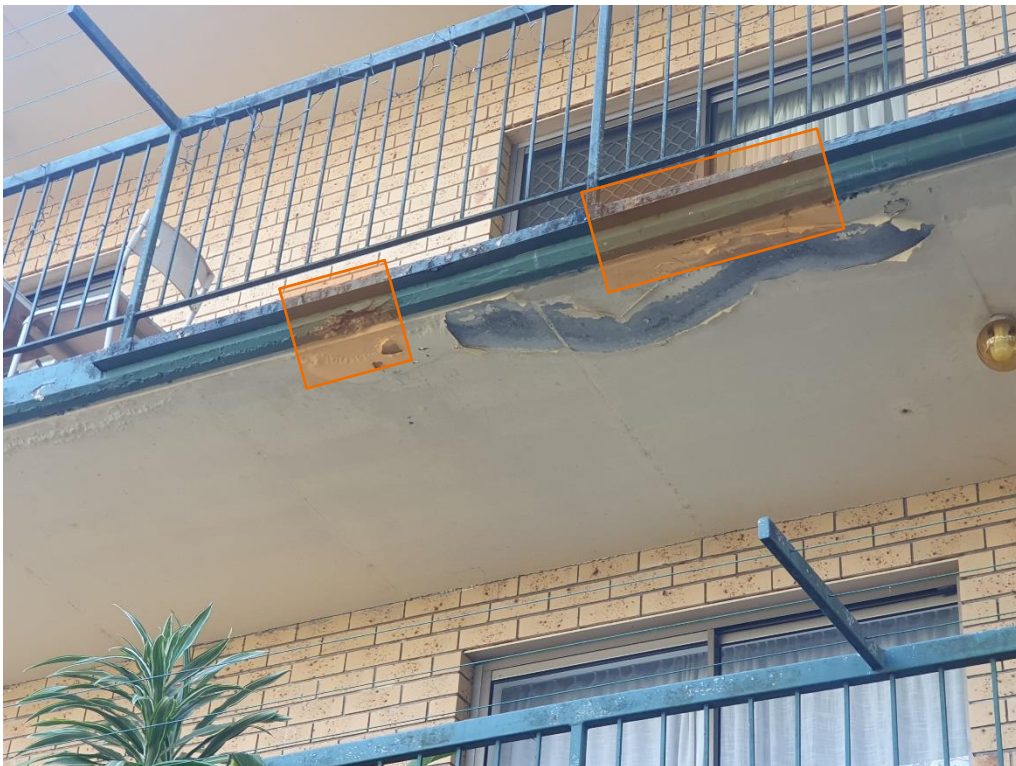
**PHOTOGRAPH 36.:** Sections/ chunks of concrete slab have fallen away, sections of reinforcement corroded/ exposed

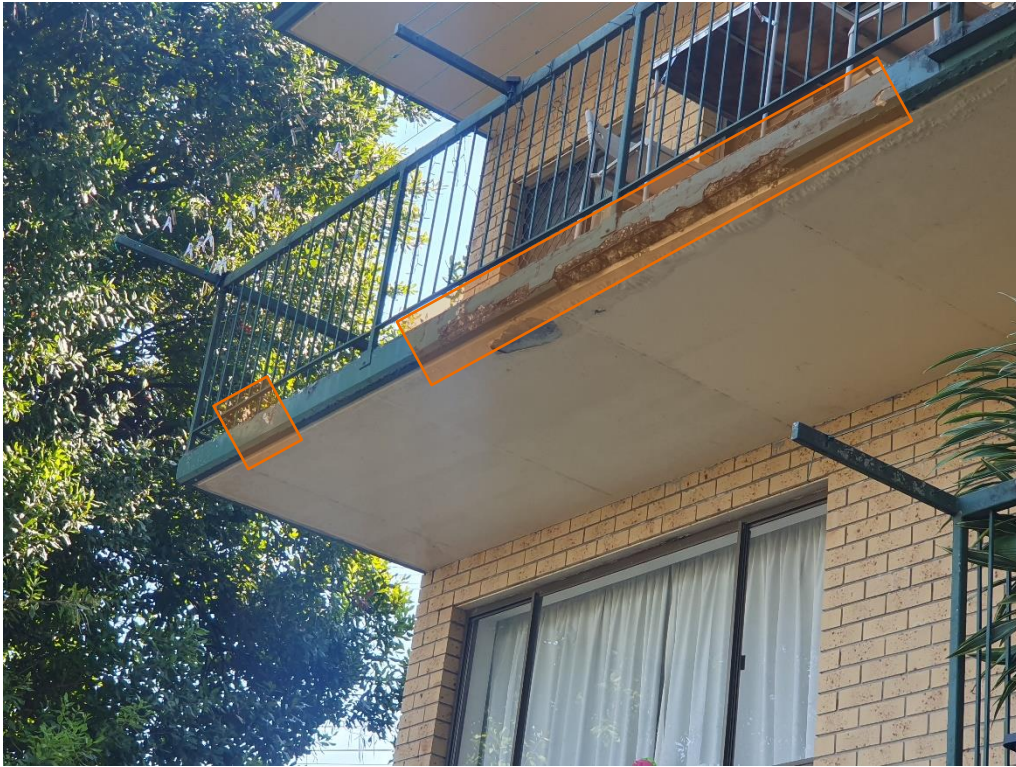
**PHOTOGRAPH 37.:** Sections/ chunks of concrete slab have fallen away, sections of reinforcement corroded/ exposed

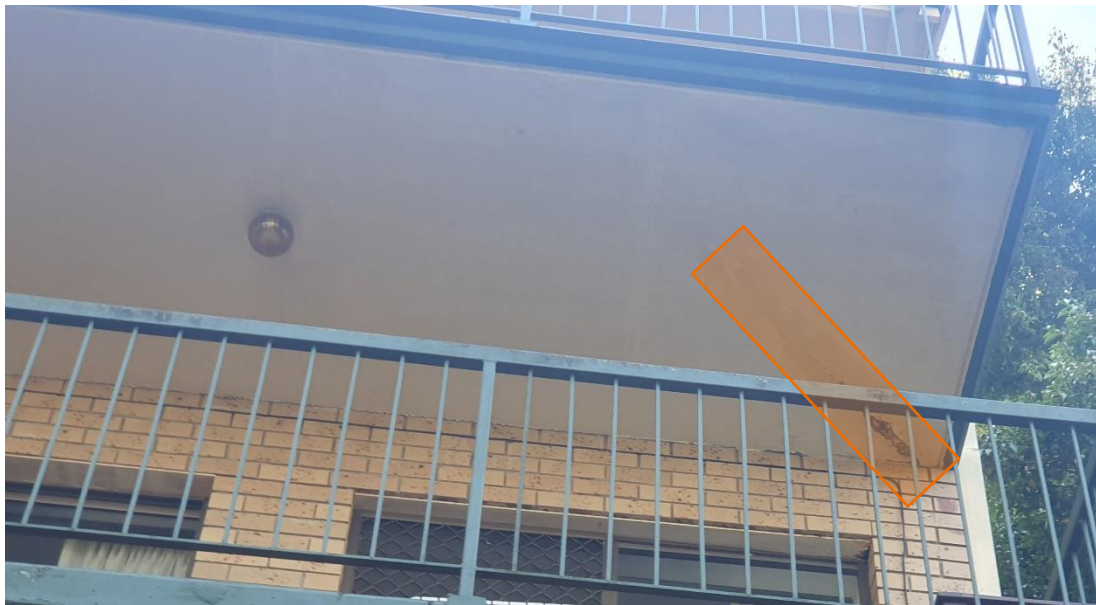
**PHOTOGRAPH 38.:** Long dark stain/ crack indicates early reinforcement corrosion

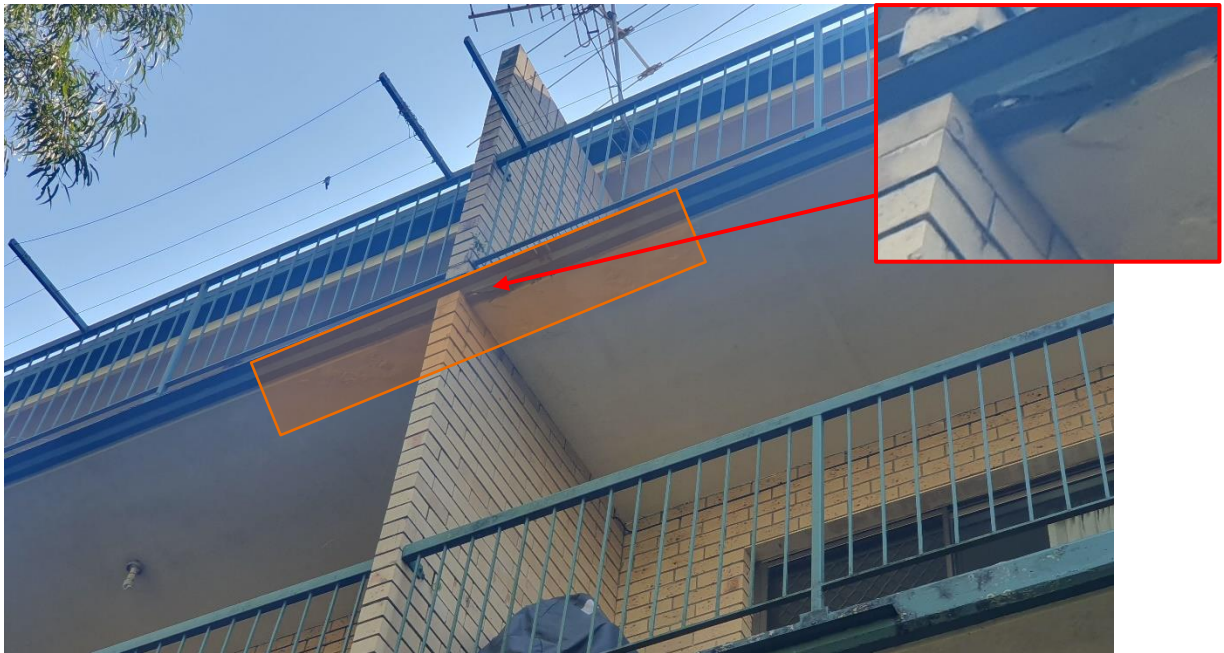
**PHOTOGRAPH 39.:** Sections/ chunks of concrete slab have fallen away, sections of reinforcement corroded/ exposed

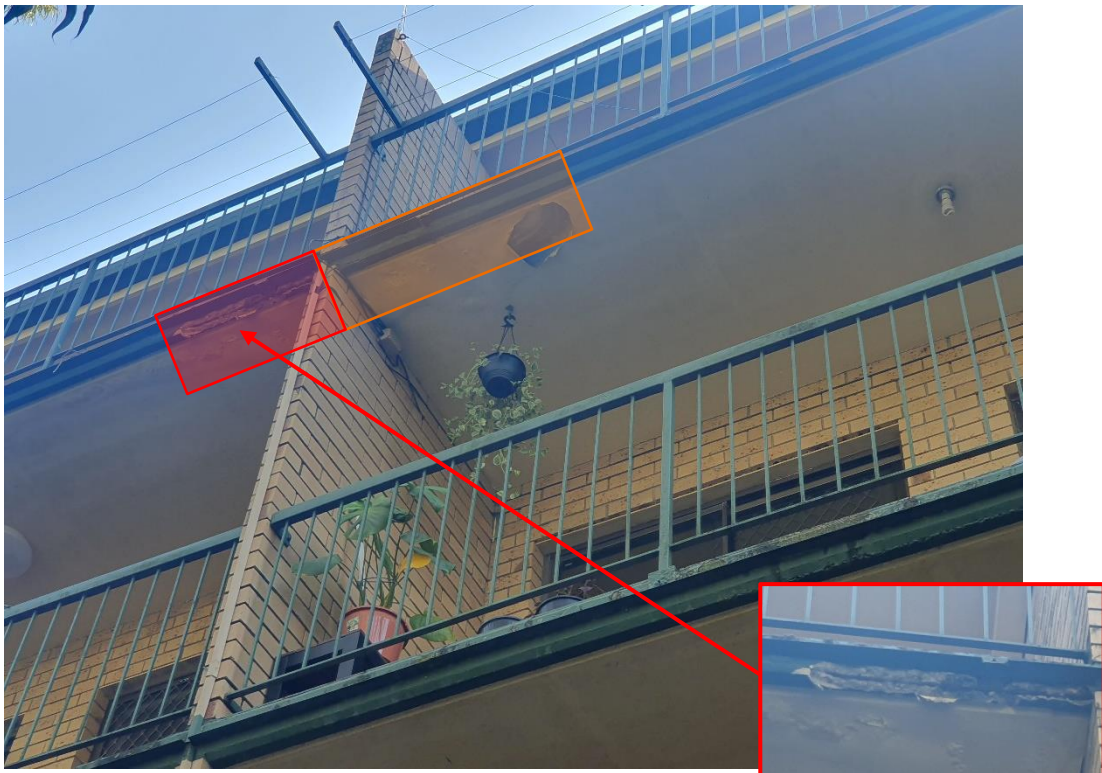
**PHOTOGRAPH 40.:** Sections/ chunks of concrete slab have fallen away. Large areas of reinforcement reinforcement corroded/ exposed

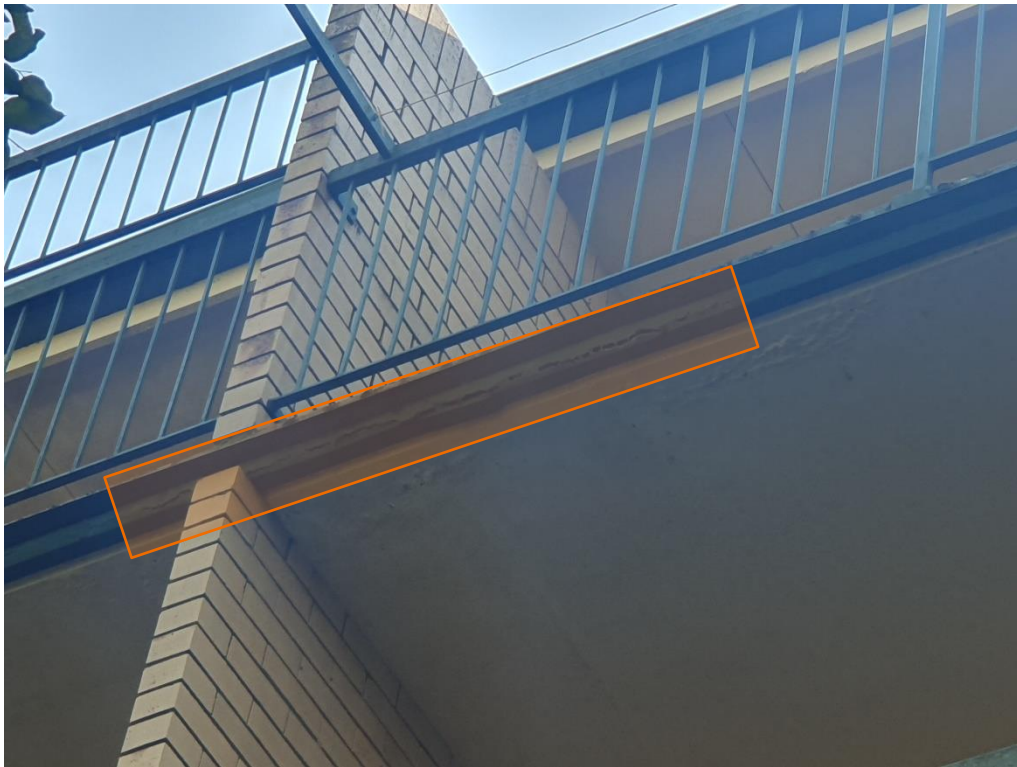
**PHOTOGRAPH 41.:** No evidence of concrete cancer. Efflorescence indicates on-going carbonation of concrete

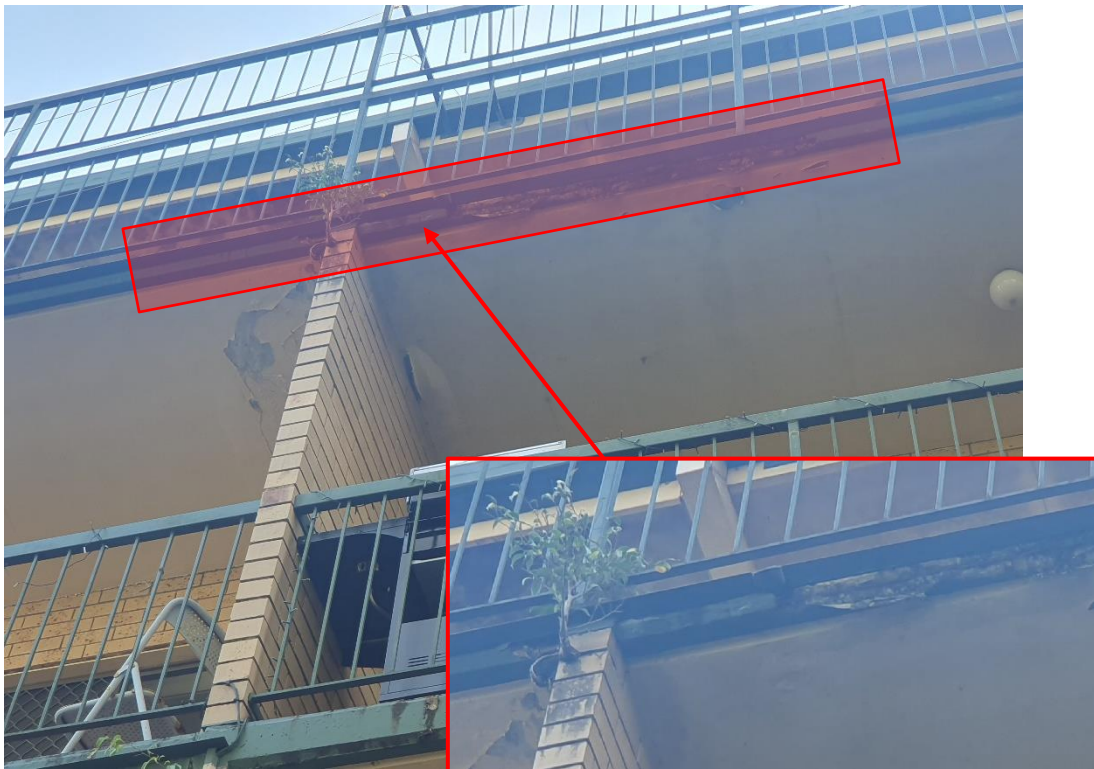
**PHOTOGRAPH 42.:** No evidence of concrete cancer. Efflorescence indicates on-going carbonation of concrete

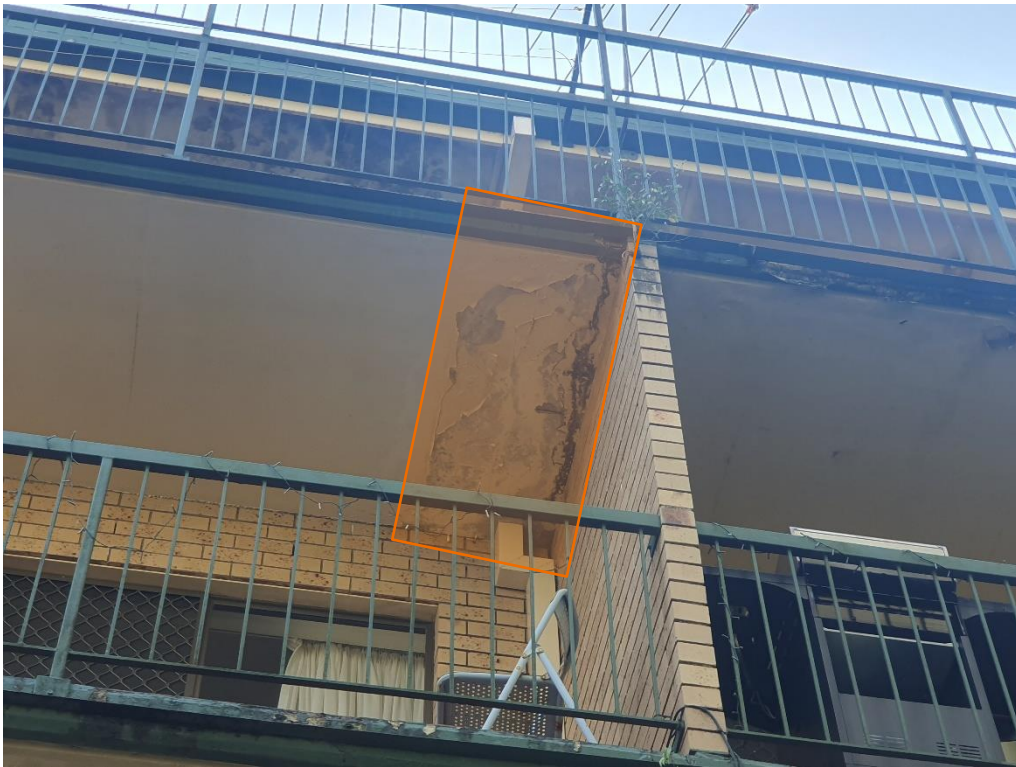
**PHOTOGRAPH 43.:** No evidence of concrete cancer. Efflorescence indicates on-going carbonation of concrete

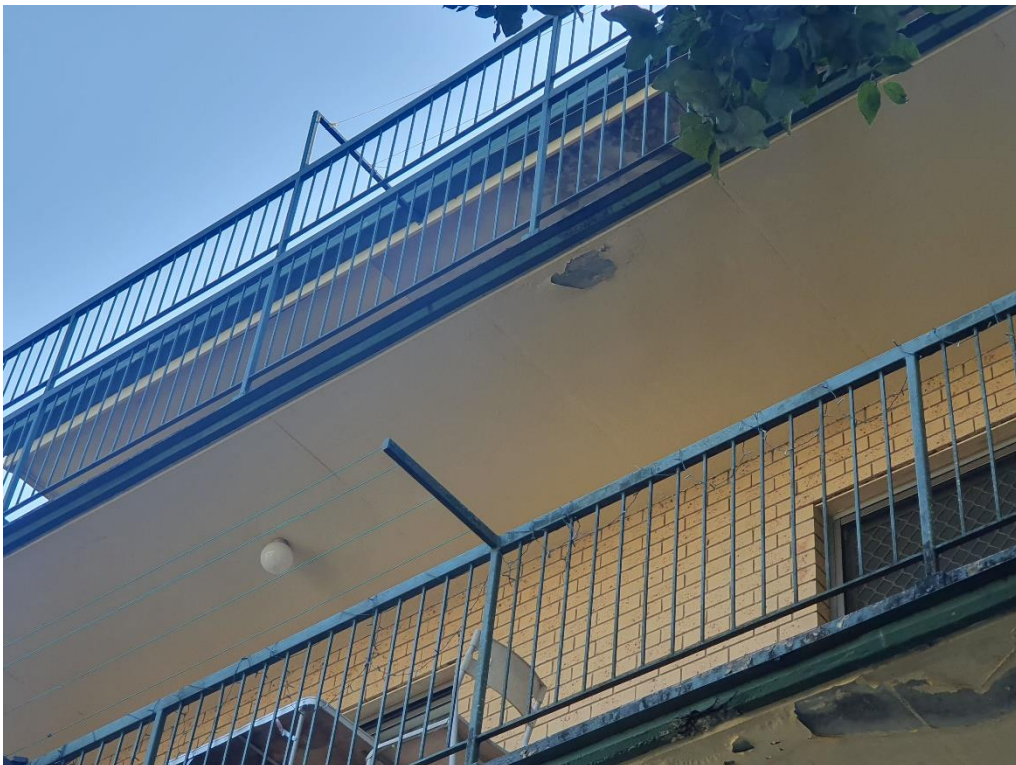
**PHOTOGRAPH 44.:** No evidence of concrete cancer. Efflorescence indicates on-going carbonation of concrete
