# K73 - E-T-8-0905 Management Site Safety & Environment Inspection

| Date | 06/12/2022 10:59:54 |
| Project Name | K73 - ASMTI |

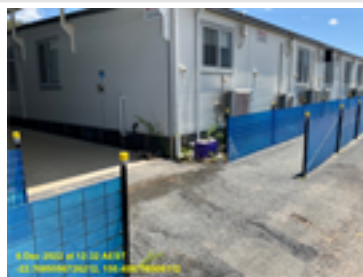
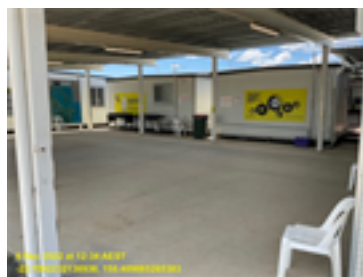
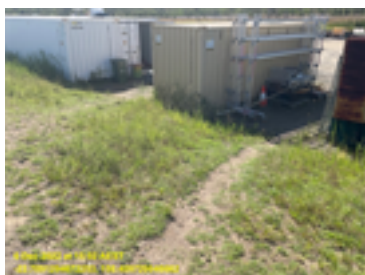
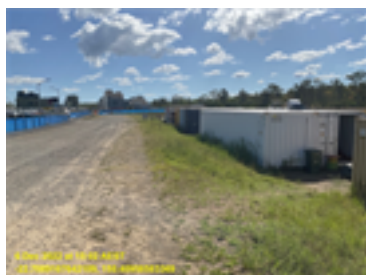
#1

| # | Comments | Created By | Date |
|---|---|---|---|
| 1 | <p>Site Offices:- As attached show's multiple entrances for our site offices/office breezeway. these ramps, entrances and access towards the offices are consistently kept to a high standard and maintain cleanliness, thanks to our Peggy (Cleaner - Jennifer Rybarczyk). Our main access breezeway get's high pressure washed of a minimum of once a month. I've also captured our main point of entry which tags on to our well delineated Peccaform walkway which we utilise all through the UOLF site, This will be elaborated more within public protection (fencing). Another used entrance is through our Pre-start area, which also get's pressure washed and is kept to a high professional and safe standard.</p> <p>Laydown Area:- General access/Egress is attached, and show's pathways leading from our office down through near our containers. As elaborated within 'Edge protection/Fall prevention' the access grass batter is maintained throughout the project by our On-Country Workforce. As described below, Site office and Laydown area for access to site have implemented blue Peccaform walkway's for a designated work area access walkway. There are multiple area's to exit these walkways to access the laydown area. The current material within the laydown consist of hard and flat material which aids any plant/personnel movement and interaction within the pad.</p> | Rhys Yasso (LORA Construction Victoria/SA Region/Queensland) | 06/12/2022 13:36:04 |

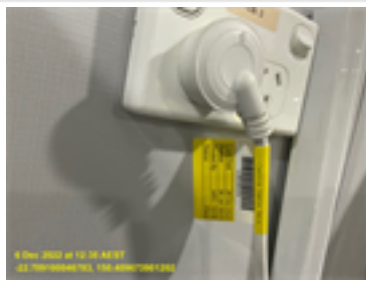
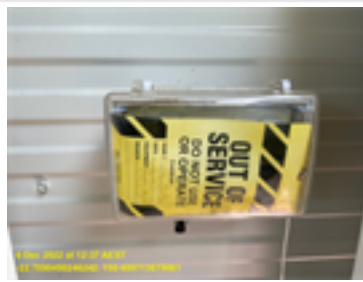
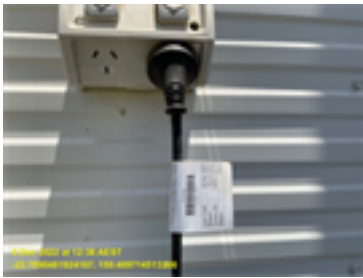
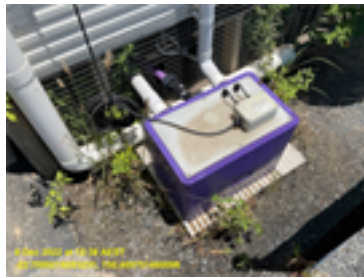
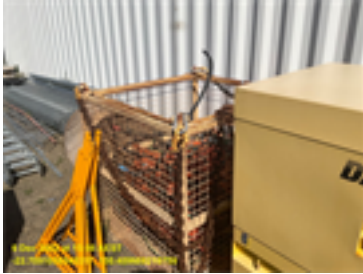
#6

| 6 | <p>Site Offices:- A general walkaround was conducted around all the site offices for an inspection for any electrical equipment that may be damaged, untested, or untagged. Generally all offices including crib rooms were currently valid with electrical tested equipment, however there was a finding that one of the water pump/filters system that plumbs to our main office kitchen, was not valid in tested and tagged. Please see attached for examples of valid tested and tagged electrical leads/equipment around the site offices, and the evidence showing one of our water pump systems being untested. This pump has most likely been missed whilst Sub-Contractor NRG has conducted there quarterly site tests.</p> <p>Laydown Area:- No electrical area had been found on the laydown area pad itself, however multiple sub-contractor storage containers are locked that would potentially have electrical equipment inside. However, any equipment that is used on site are consistently inspected by LO'R Supervision on a regular basis to ensure all testing and tagging is up to date.</p> | Rhys Yasso (LORA Construction Victoria/SA Region/Queensland) | 06/12/2022<br>12:43:45 |

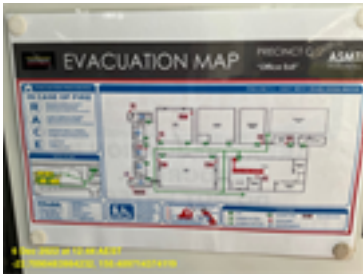
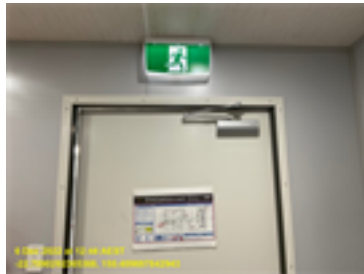
#8

| 8 | <p>Site Offices:- Within all office and crib rooms are an evacuation procedure/diagram/map attached within the inside of the door entrances. These are specific to what room the evacuation plan is currently in - this will include the procedure, any relevant information regarding the evacuation procedure, and map diagram of where to evacuate. Each room is fitted with an emergency light above the main entrance inside, this is well lit and well noticeable in case of this situation. During a Short Term Workers Induction each personnel are inducted on where the evacuation point is and where to group.</p> <p>Laydown Area:- As elaborated above, all Short Term workers are inducted on where the emergency evacuation location is (Site Office Carpark)</p> | Rhys Yasso (LORA Construction Victoria/SA Region/Queensland) | 06/12/2022<br>14:06:48 |

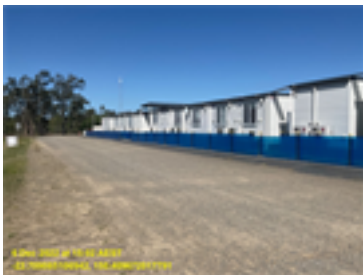
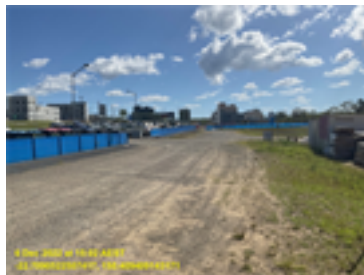
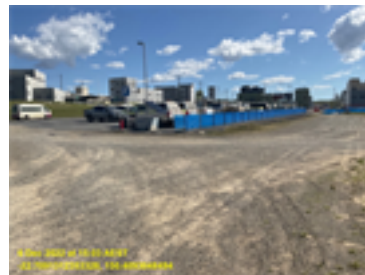
#9

| 9 | Site Offices & Laydown Area:- As attached show's our site utilising blue Peccaform walkways, to delineated a work area access walkway to ensure there is safe and professional standard of separation between plant, equipment and worksite interaction. These walkways are implemented around the site office entrances and connect to the walkways to access site. Due the high traffic of our Laydown area with skidsteers, truck deliveries and telehandler operations we have not utilised fencing, as these would become more of an obstruction. The laydown area is constantly gaining and removing materials to and from - Utilising a fenced boundary would only potentially be in the proximity of material relocation. | Rhys Yasso (LORA Construction Victoria/SA Region/Queensland) | 08/12/2022<br>13:14:30 |

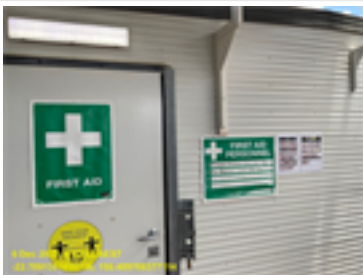
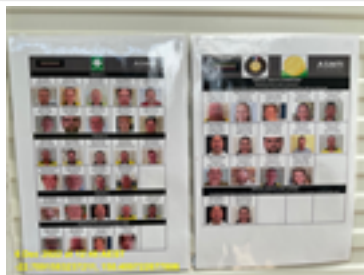
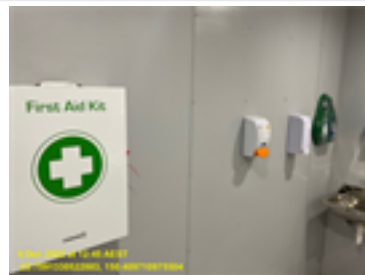
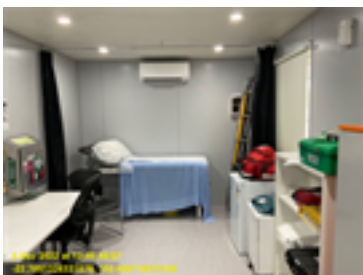
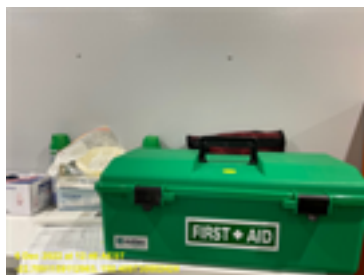
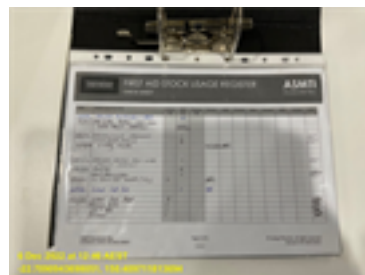
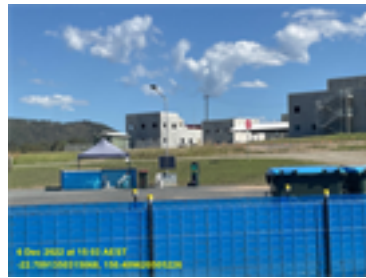
#11

| 11 | <p>Site Offices:- Within our main site offices we have a designated First Aid Room. This room displays clear signage on the door representing first aid, and a list of first aid personnel. These lists of personnel include All Precinct's First Aid Person(s), Mental Health Champions, Mental Health First Aiders, Rockhampton Office &amp; Project Wide. Within this room contains various first aid kits, first aid materials, equipment and substances, SDS's for all office hazardous substances. For additional materials and equipment within the room, please see attached. This first aid room contains a stock usage register which keeps track of any materials used for a re-stock, and there is a 6monthly check for all stocks (First Aid Room Check Sheet) - This has been inspected is currently in date.</p> <p>Laydown Area:- There are currently no first aid facilities in the proximity of the laydown area, however as elaborated before during a STW induction, first aid facilities are familiarised. We also have implemented Nurse Call Stations on site which contain first aid materials and substances - One is located beside our smokers hut, which is only approximately 20m from the laydown area.</p> | Rhys Yasso (LORA Construction Victoria/SA Region/Queensland) | 06/12/2022<br>12:47:40 |

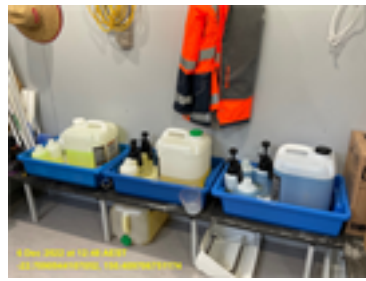
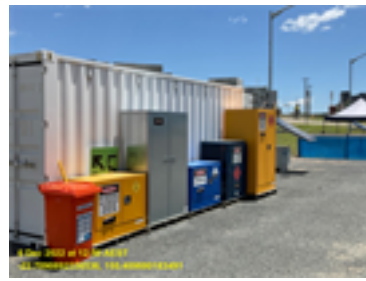
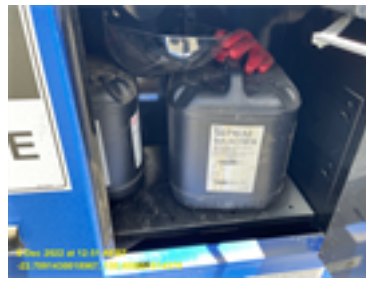
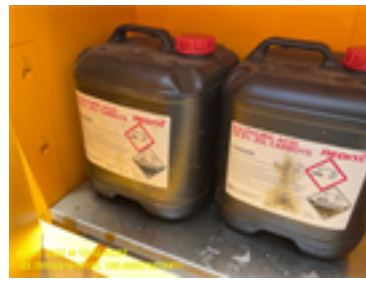
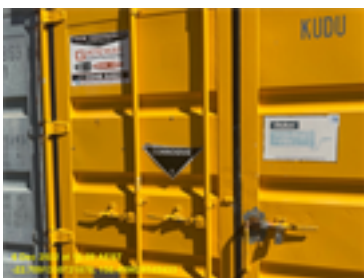
#14

| 14 | <p>Site Offices:- All hazardous substances used on these Amenities are currently stored away in a safe and correct manner in the designated cleaning storage room. Please see attached for some of the main hazardous substances used. Within the female change room (Cleaning storage) the substances located inside are used in the cleaning process (Toilet Bowl Cleaner, Lemon Grass Disinfectant, Active Rip Off) When distributing these chemicals into a spray bottle or the mop bucket, she's compliant with using the correct and safe procedures and using the correct PPE. All relevant SDS's for these used chemicals are accounted for and stored in the Safety Data Sheet Register located within our first aid facility room as per attached. Only a few spray bottles of these substances are stored within the Site Amenities, and when in need of refilling Jennifer brings them back to storage room to undertake correct procedure. Each substance is positioned within a tub for excess/spillage, and uses of an individual flask/measuring jug for each product to maintain correct ratio mixture and prevention of cross contamination between chemicals. Our other hazardous substances are for our water pump system, these include Sulphuric Acid (pH) and Sodium Hypo (mV). These are stored correctly within the designated storage area's and the correct procedures are used while changing these chemicals connected to our water pump system.</p> <p>Laydown Area:- No hazardous substances were found within the laydown area, however one container had signage of corrosive attached. This container belongs to McAlister and Bradford (Waterproofers) - There substances are considered hazardous and are required to have the SDS' on hand inside, However this container is locked, once they return myself or Chris McErlean will conduct an inspection to see if they are being complacent with this procedure.</p> | Rhys Yasso (LORA Construction Victoria/SA Region/Queensland) | 08/12/2022<br>14:02:50 |

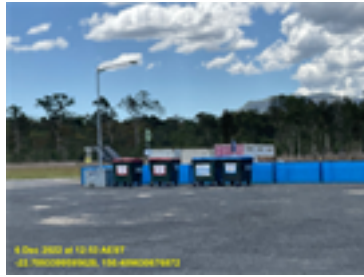
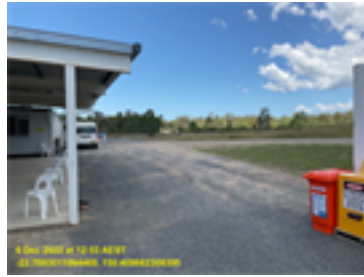
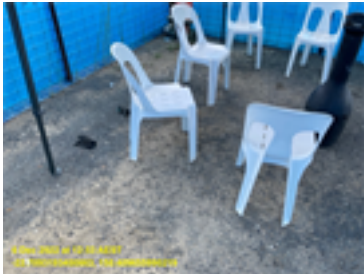
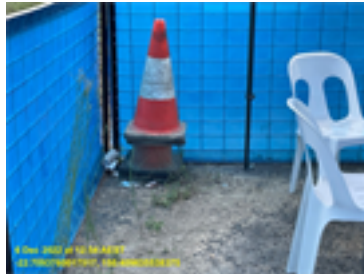
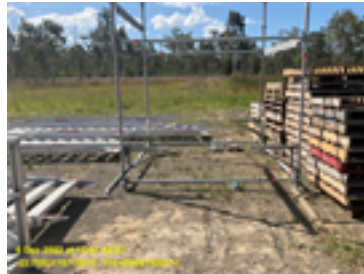
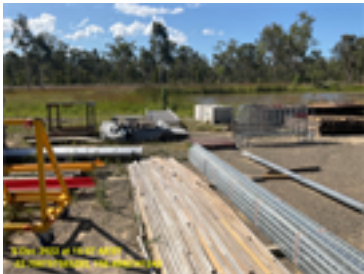
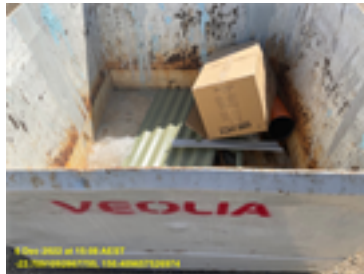
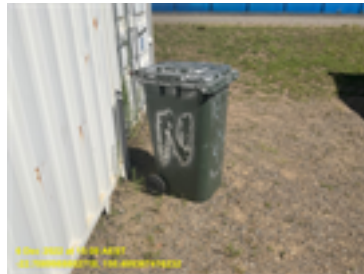
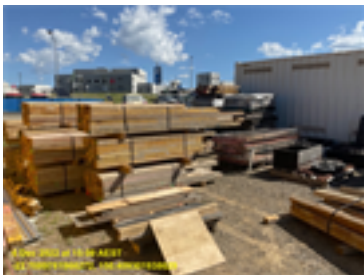
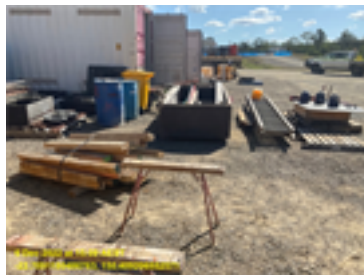
#16

| 16 | <p>Various VEOLIA skip and wheelie bins have been ordered to be utilised on site to assist our waste and housekeeping management. There is currently 1 skip bin located within our Laydown area that evidently show's its utilised constantly. All skip bins on site are regularly emptied by our Telehandler operator (Peter Walker). For our main site office rubbish removal we currently have 2 General waste bins, 2 Cardboard Waste bins, and 2 wheelie bins within the office area for convenient use.</p> <p>Site Offices:- As mentioned within access &amp; egress our main office area internally and externally are kept to a clean and professional standard thanks to our cleaner Jenny. However during inspection around external office grounds within the smoker's area, there seem to be various amount of rubbish, scrap and cigarette butts. A wheelie bin is located within the smokers hut so this finding will be brought to the workforce's attention during a pre-start or a subcontractor co-ordination meeting to distribute the information that this can be improved.</p> <p>Laydown Area:- It was found during the inspection of the laydown area that the housekeeping standard is okay, but can be approved. Multiple miscellaneous items were found scattered around the laydown area serving no current purpose, this potentially warrants the delegation of our labour force to give a hit sweep of an Emu-Parade as well as a reminder to the sub-contractors using the laydown for housekeeping. It was found that Mitcon's laydown section could definitely need a tidy up due to various materials not being utilised and do not have continuous use planned. Brendan Butler (Site Manager) has spoken to the relevant personnel through Mitcon for this to be rectified immediately.</p> | Rhys Yasso (LORA Construction Victoria/SA Region/Queensland) | 06/12/2022<br>15:51:02 |

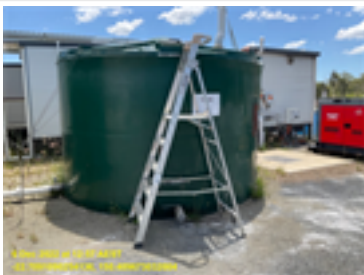
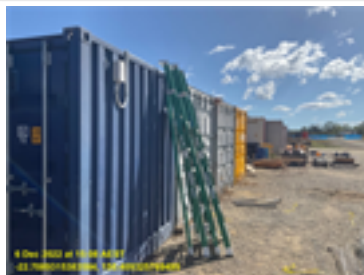
#17

| 17 | <p>Site Offices:- Only one ladder is utilised with our Site Offices which is located beside our septic tanks. This ladder is used to record daily readings of sewage tank levels, and conduct Monday morning checks of all Fuel, Sewage, and water recorded by our On-Country Workforce.</p> <p>Laydown Area:- there was no sighted ladder located within the laydown area.</p> | Rhys Yasso (LORA Construction Victoria/SA Region/Queensland) | 08/12/2022<br>14:31:42 |

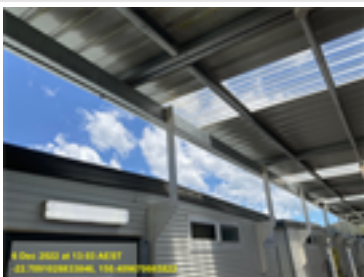
#18

| 18 | <p>Site Offices:- As attached show's sufficient light down our breezeways, office amenities, and within rooms. All internal lights are sensors which are always on.</p> <p>Laydown Area:- Not applicable as no lighting needed, and no nightshift works are ever conducted.</p> | Rhys Yasso (LORA Construction Victoria/SA Region/Queensland) | 08/12/2022<br>14:33:13 |

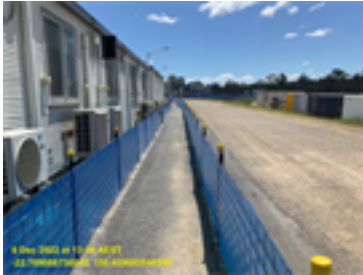
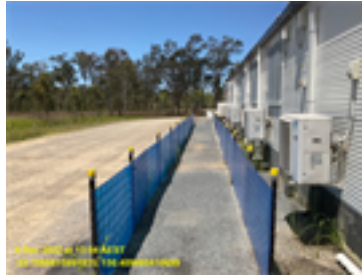
#27

| 27 | Refer to Fencing and Access/Egress for information for public protection standards being maintained and implemented. | Rhys Yasso (LORA Construction Victoria/SA Region/Queensland) | 08/12/2022 14:41:22 |

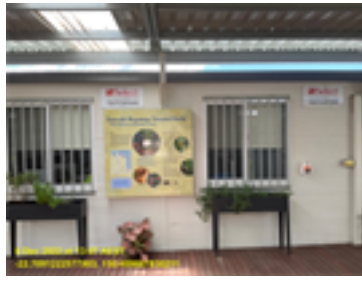
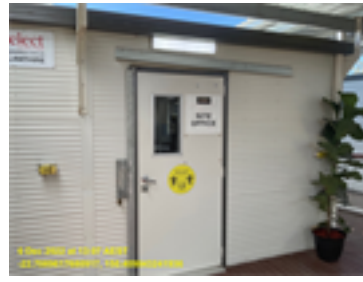
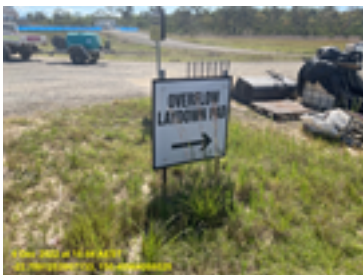
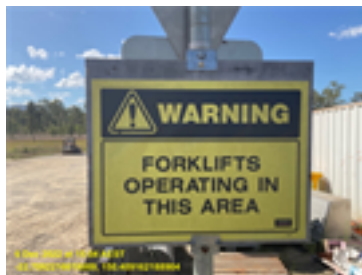
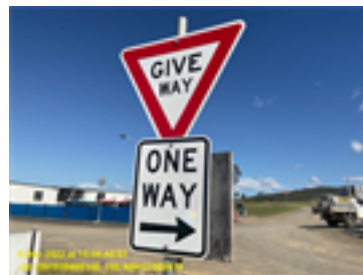
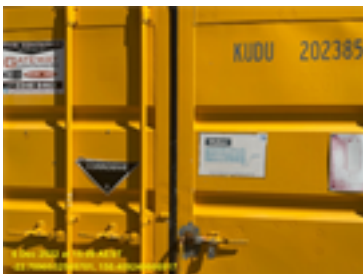
#32

| 32 | Site Offices:- Attached show's clear signage erected at the entrance of the site offices, displaying access route and office information. Within our site offices display a high standard of signage, displaying all designated rooms, Covid-19 Requirements signage, Informational boards on 'Shoalwater Bay' and other relative indigenous definitions.<br><br>Laydown Area:- Attached show's signage erected at the entrance of the laydown area displaying road and warnings signs of (Warning forklifts operating in this area, Give way & One Way). Due to being at peak on our site, and the large increase of plant and personnel interaction these signs serve a high and safe purpose. | Rhys Yasso (LORA Construction Victoria/SA Region/Queensland) | 08/12/2022 14:48:44 |

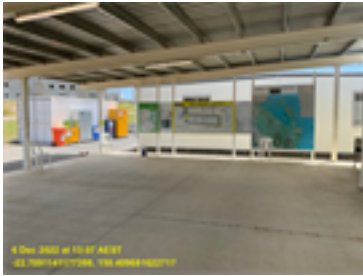
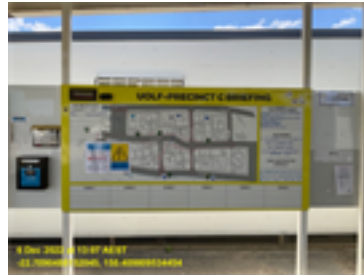
#35

| 35 | Site Offices:- Attached show's our pre-start area, which is located between our site offices. Toolbox talks and pre-starts are held here each morning at approximately 6am. Having this talks gives subcontractors a great sense of co-ordination and what works to expect prior to commencing works. This pre-start area is always maintain and cleaned by our Peggy(Jenny).<br><br>Laydown Area:- Not applicable as a laydown area. | Rhys Yasso (LORA Construction Victoria/SA Region/Queensland) | 08/12/2022 14:50:23 |

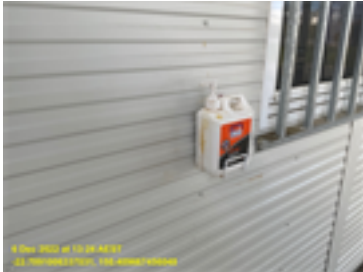
#36

| 36 | Site Offices:- UV Protection is supplied throughout our offices, as per attached show's mounted sunscreen which are located outside the crib rooms and within the pre-start area. Due to the rise in heat climate, these are getting utilised more commonly, but a great observation to see that are being used to help our subcontractor personnel be UV Protected. The smokers area also is covered by a Gazebo that was erected months ago for shade.<br><br>Laydown Area:- No UV Protection is supplied within the laydown area, however ad described above they are located within the offices and also out on side within our Hydration Stations. | Rhys Yasso (LORA Construction Victoria/SA Region/Queensland) | 08/12/2022 14:53:00 |

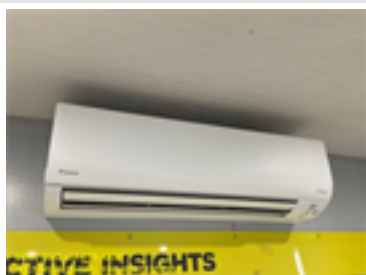
#5

| # | Comments | Created By | Date |
|---|---|---|---|
| 5 | Aircon's within the site offices have recently been cleaned by our On-Country Labourforce, approximately 3 weeks ago. This task is under their monthly tasks to do. | Rhys Yasso (LORA Construction Victoria/SA Region/Queensland) | 06/12/2022 15:18:29 |
