## TEMPORARY WORKS RISK ASSESSMENT

Project Name: Palm Beach to Tugun (PB2T)Project No: 022005Temporary Works Reference No: 5

## SITE INSPECTION REPORT

| Proof roll test inspection of the temporary working platform condition at BR07 Abut B (RL6.3). | | | |

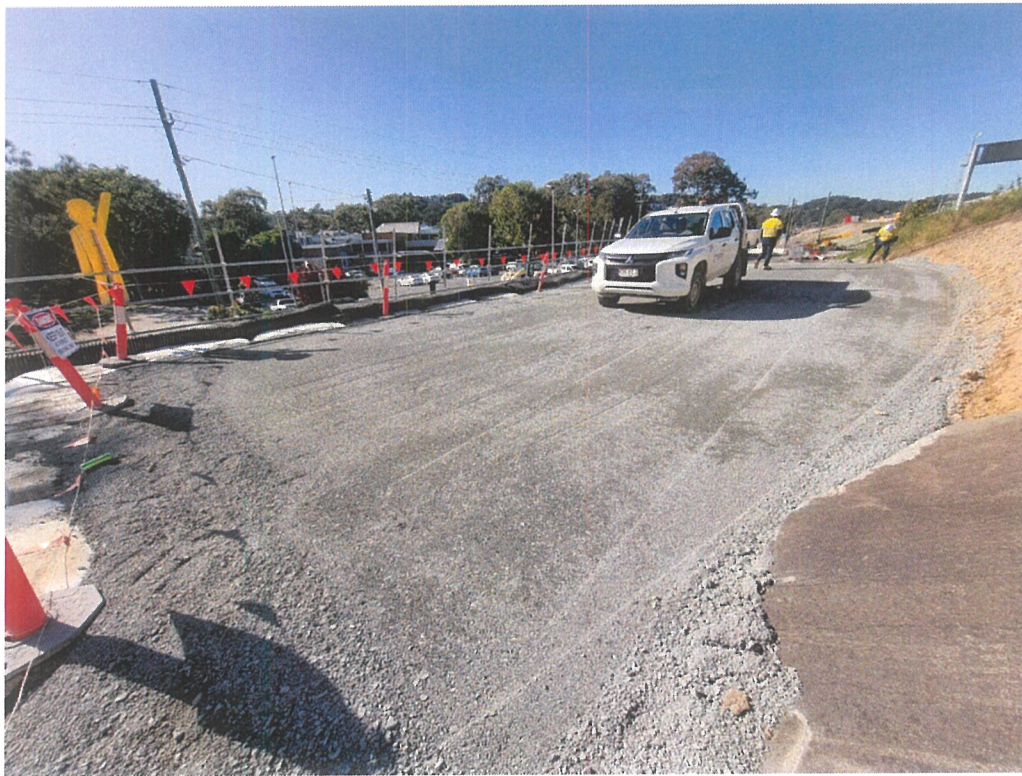
Photo 1. View of the CFA piling platform at BR07 Abut B.

- The proposed location platform material is observed to be a well-compacted RSS material.
- A proof roll assessment was undertaken using a fully loaded 14 T single axle water cart.
- Some minor deformation was observed on one area of the platform.
- SWC has also requested GCS to inspect the ramp. It is understood that the general fill material on the ramp has been capped with a layer of granular material.
- Materials on the ramp were observed not to be well compacted.
- A proof roll test on the ramp showed a lot of deflection was observed along the ramp.

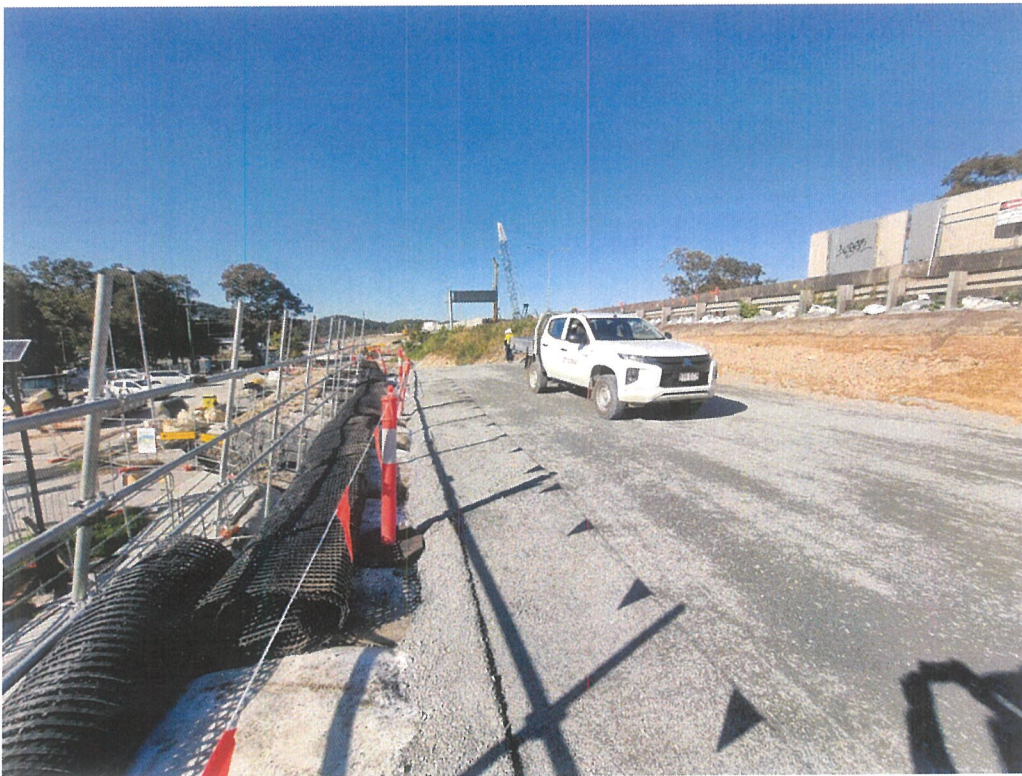
Photo 2. Some minor deformation was observed on one area of the platform.

- As there was some minimal deflection on the platform area, GCS require Min. 6.0m (L) x 2.4m (W) x 20mm (T) steel plate to be placed under the tracks and extraction foot of the piling rig during piling operation.
- A min. 1.5m edge distance from the edge of the outrigger pad to the protection wall shall be kept during the operation.
- SWC shall ensure the surface below the steel plates are well compacted and flat so the plates are in full contact with the surface.
- GCS recommend that the soft spots observed on the ramp be compacted and maintained prior to themobilisation.

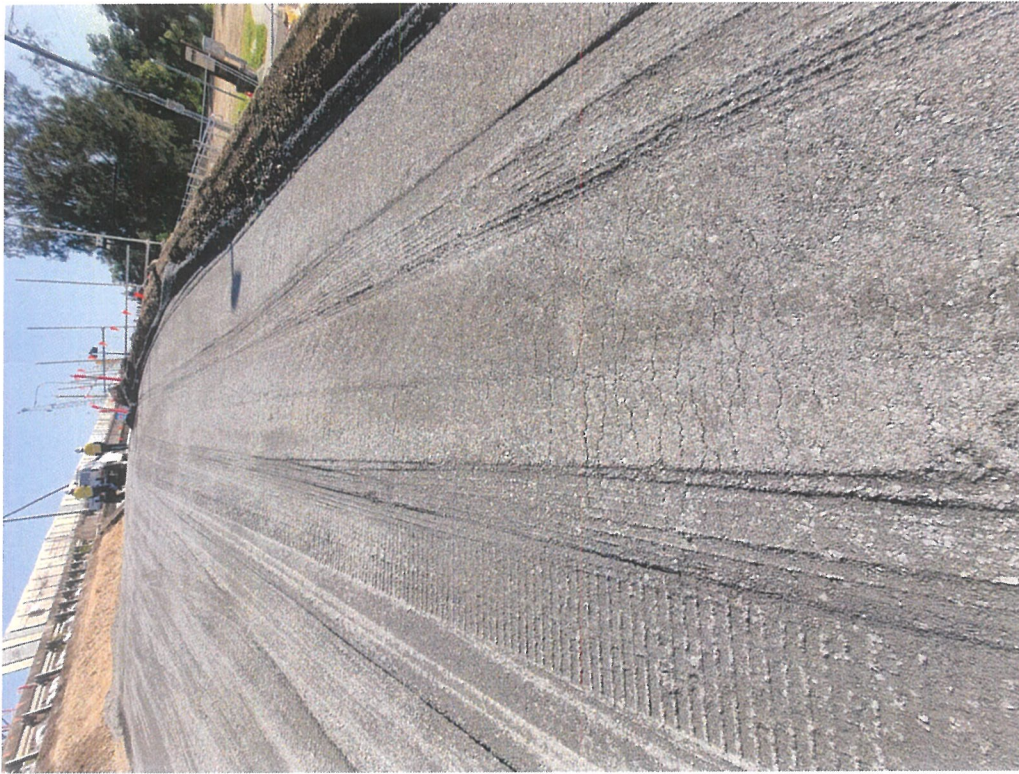
Photo 3. Material on the ramp was observed not to be well compacted. During the proof roll test heaving and deflection was observed along the ramp.
