| Client | Gabrielli Constructions Pty Ltd | | <h2 style="margin: 0;">INSPECTION AND TEST PLAN</h2> |
| Project Name: | Wellington Street Depot | | |
| Task: | Inground Stormwater – Stage 1 Carpark | ITP: In Ground Stormwater | |

| Client | | Gabrielli Constructions Pty Ltd | | <h1 style="text-align: center;">INSPECTION AND TEST PLAN</h1> | | | |
|---|---|---|---|---|---|---|--|
| Task: | | Inground Stormwater Pits – Stage 1 Carpark | | ITP: In Ground Stormwater Pit | | ITP No. 015 | |

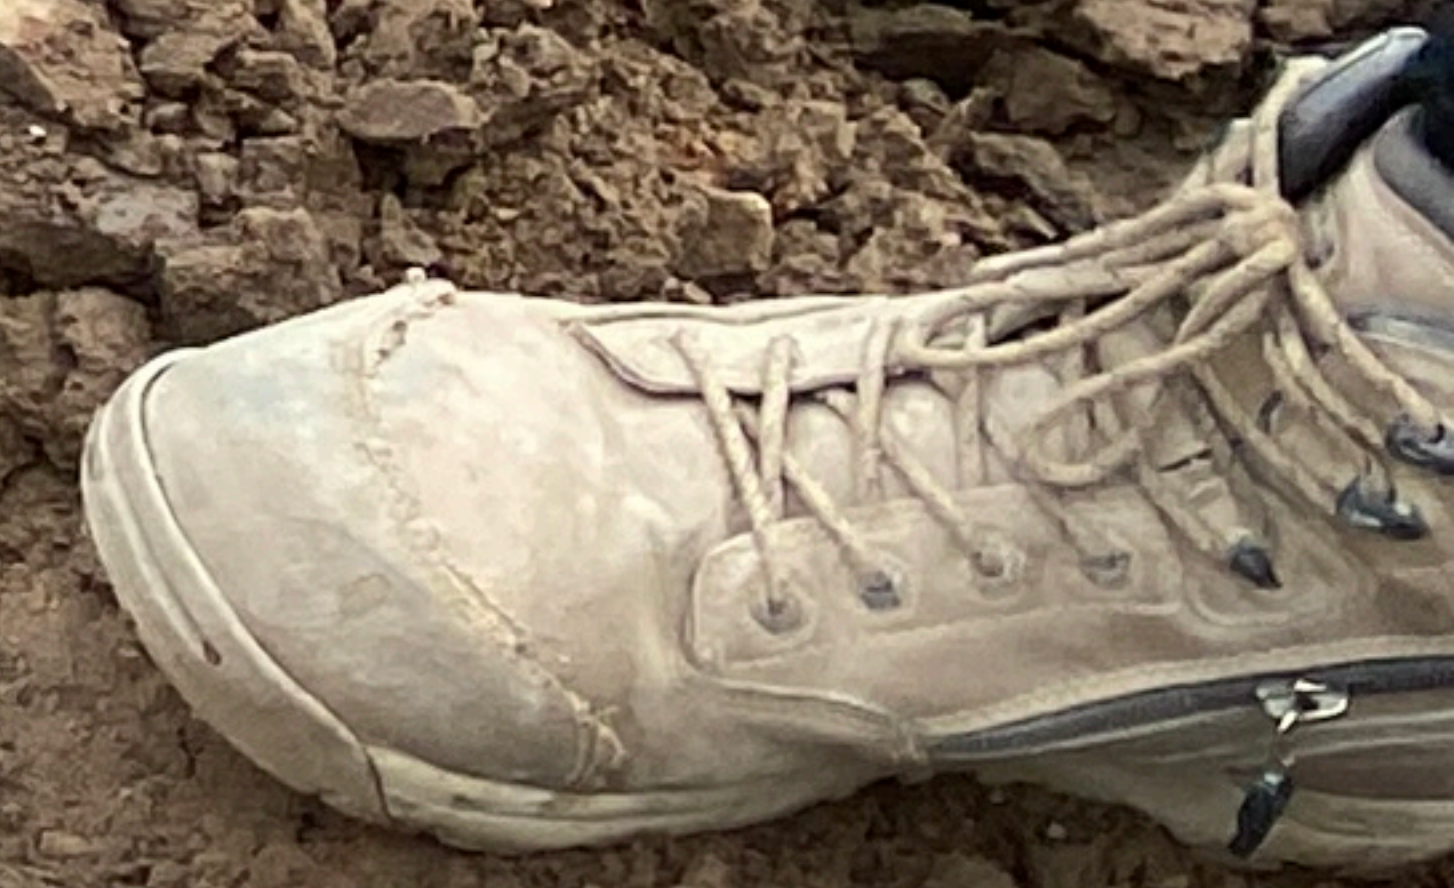
Proof roll subgrade inspection 10/06/23 2:00pm

Practically the entire pavement area showed excessive movement and sponginess, especially the darker coloured areas.

It is recommended that the subgrade be removed to a depth of 200mm below the design subgrade level and replaced with a 200mm layer of Type 2.5 material.

If there is movement detected then it is recommended that a layer of TX160 or equivalent be installed at subgrade level.

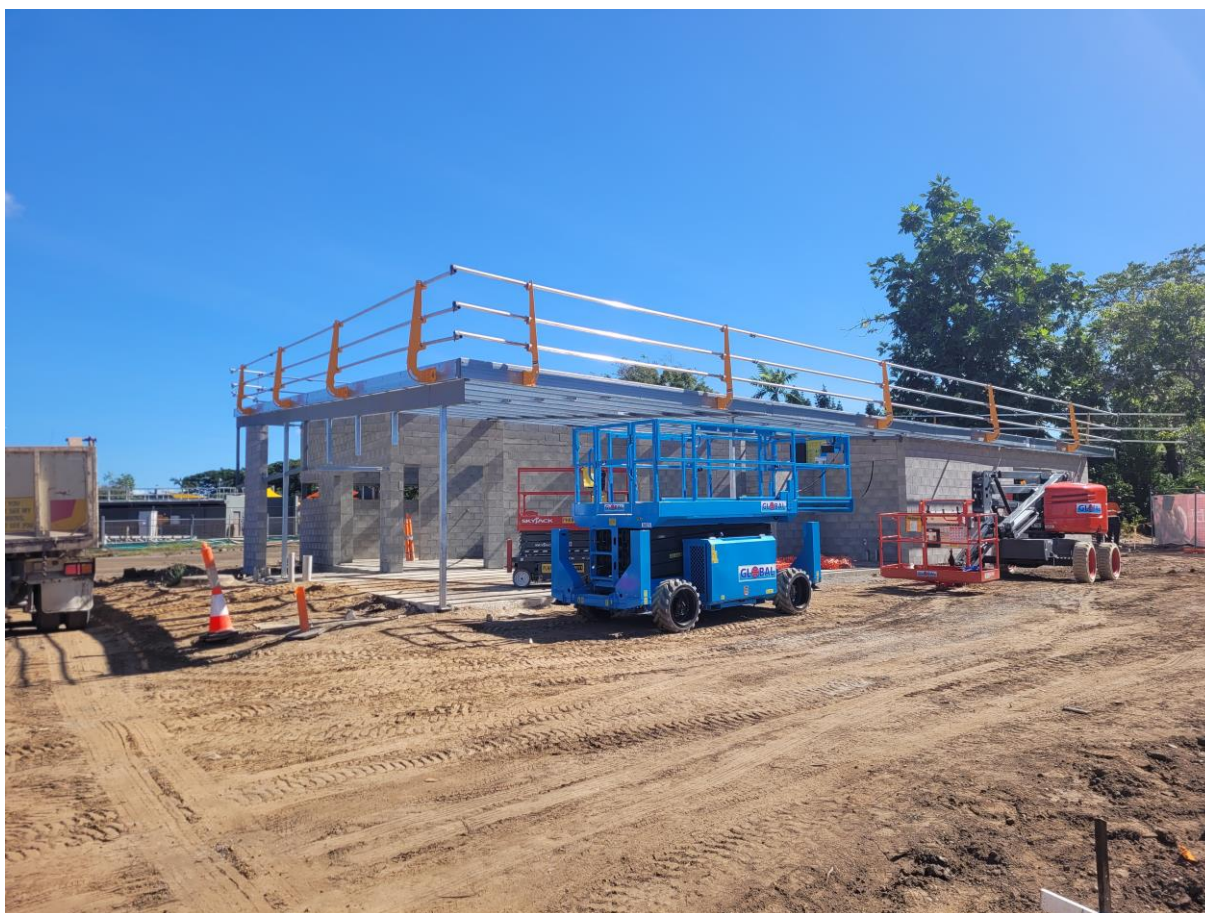
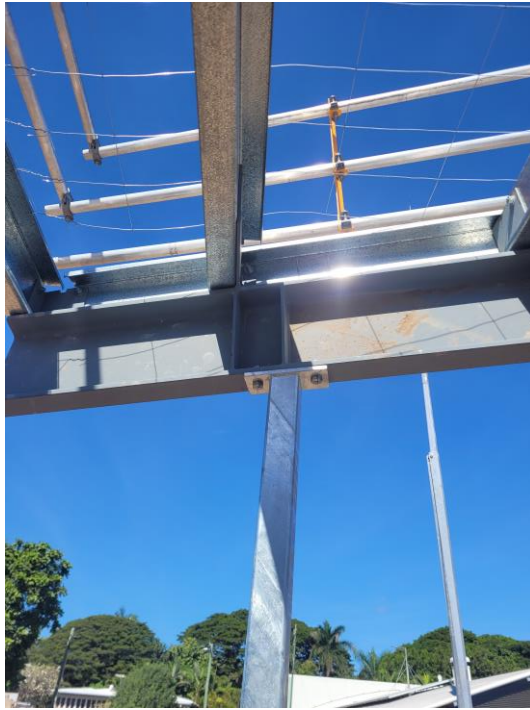
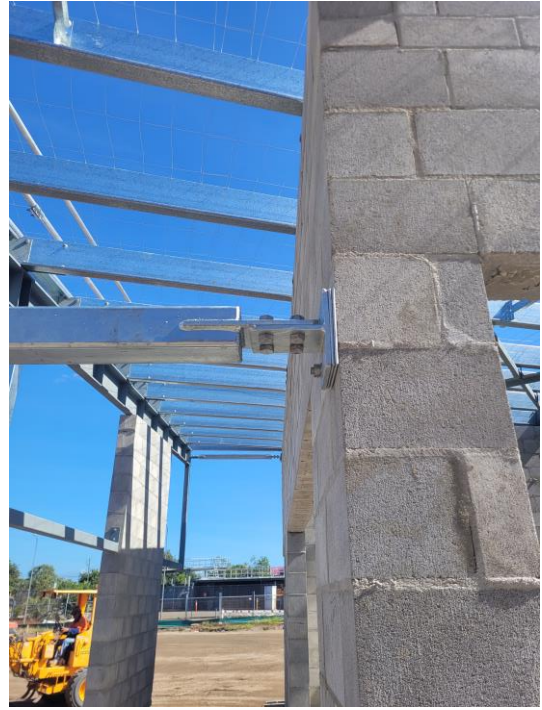
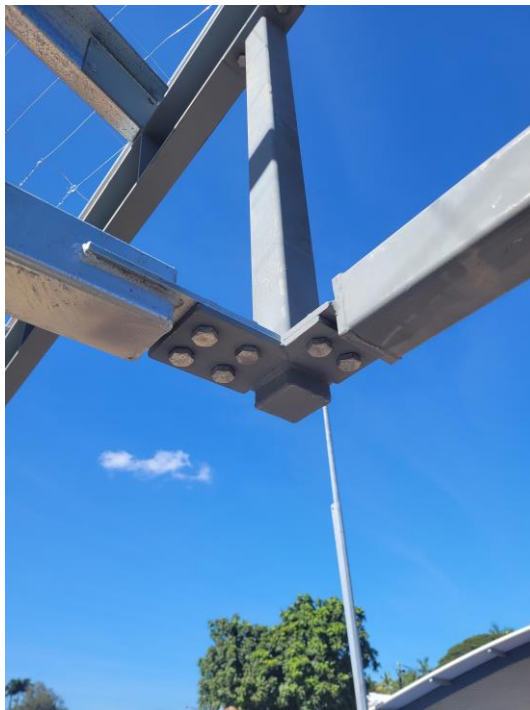
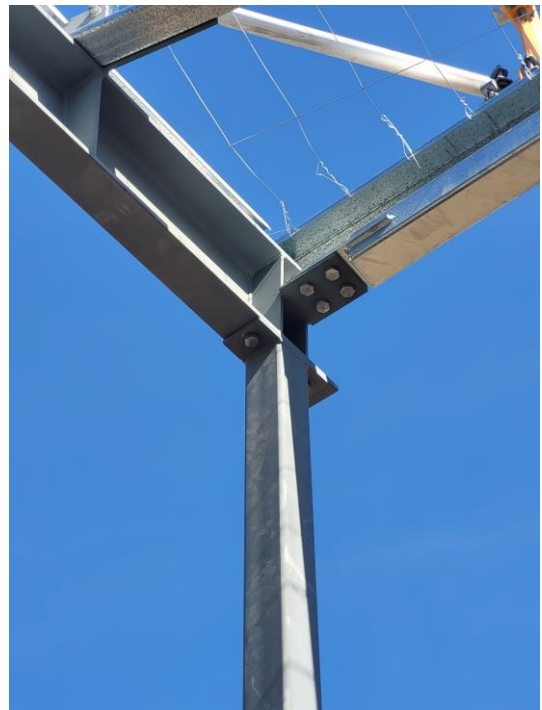
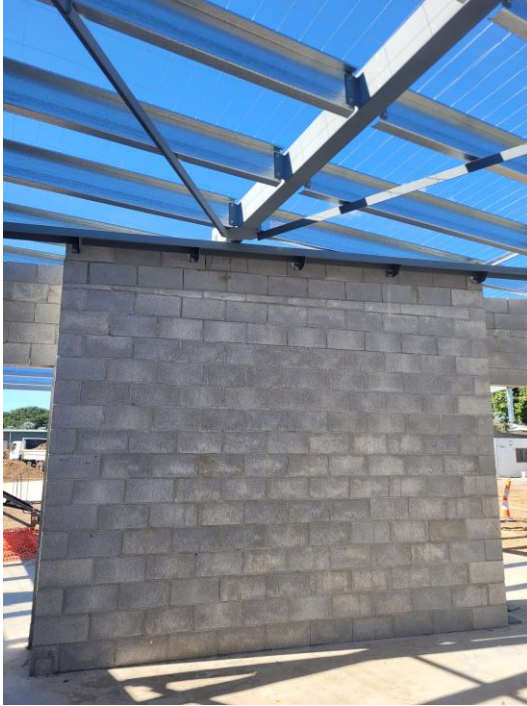
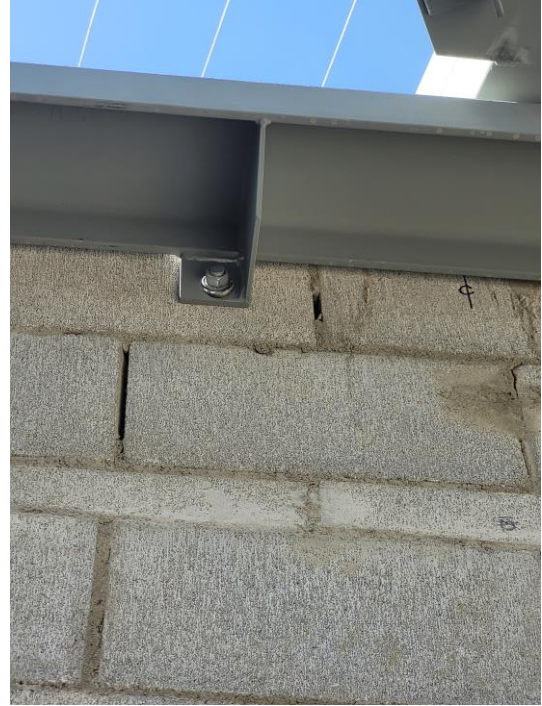
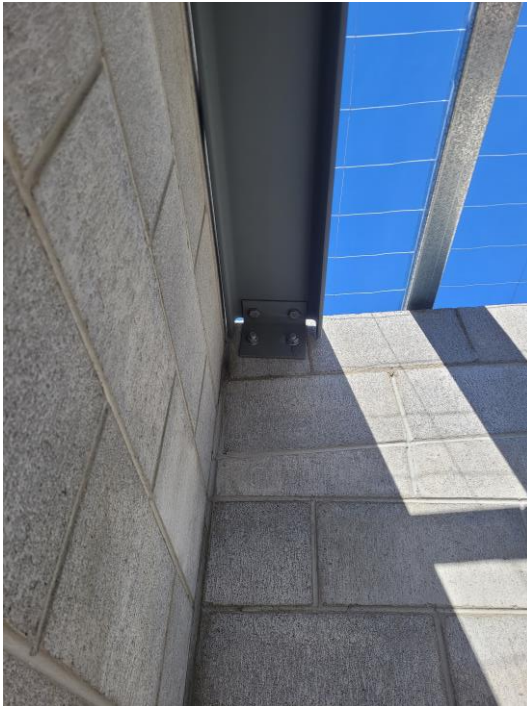
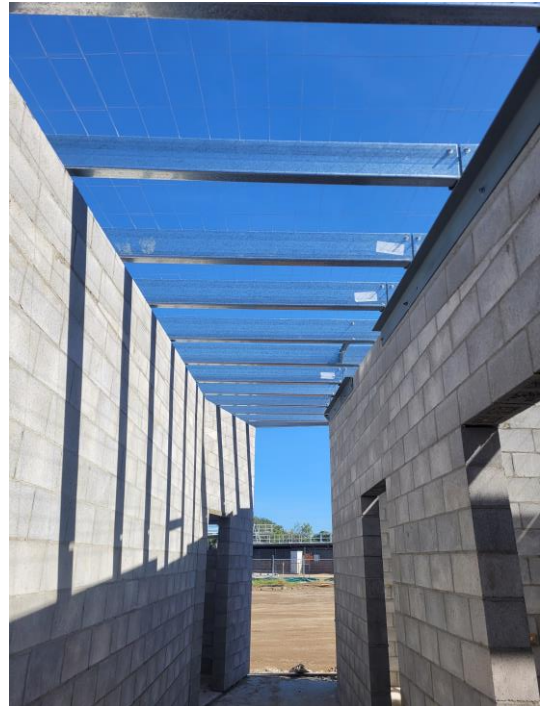
Inspected Amenities frame.

Structural framing complete.

Member sizes and connections are consistent with construction issue drawings.

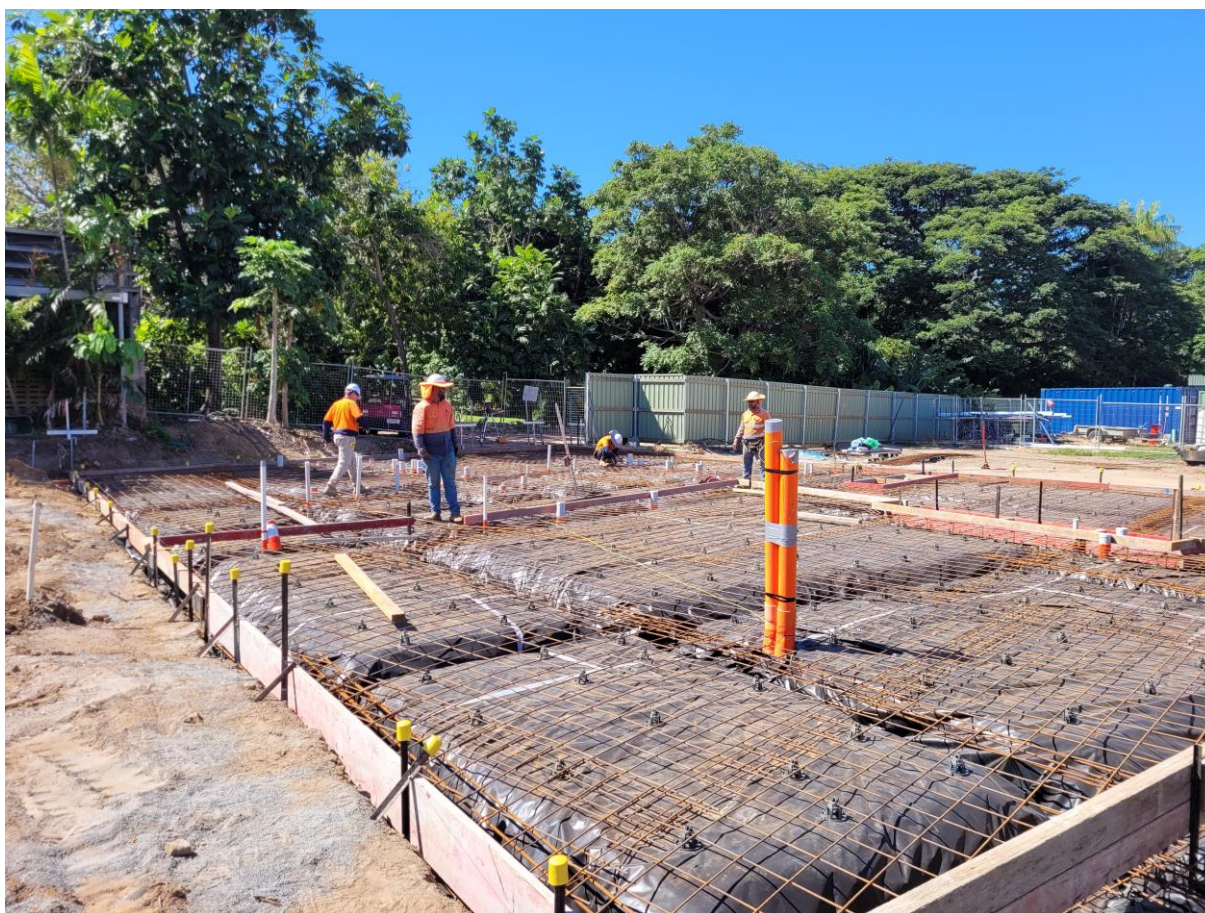
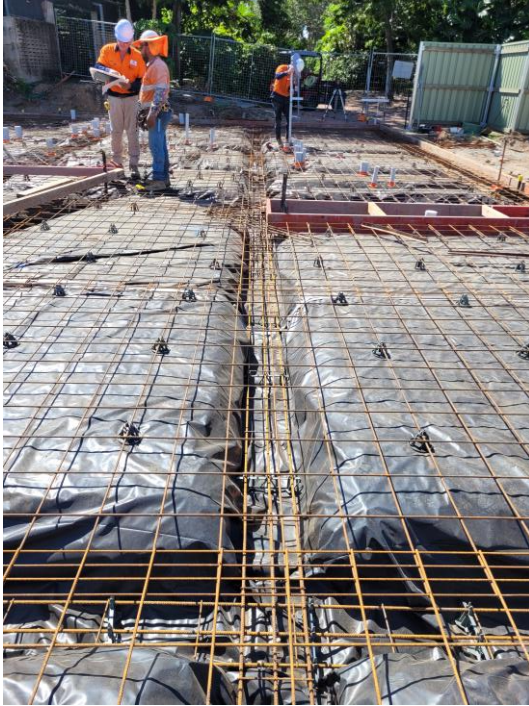
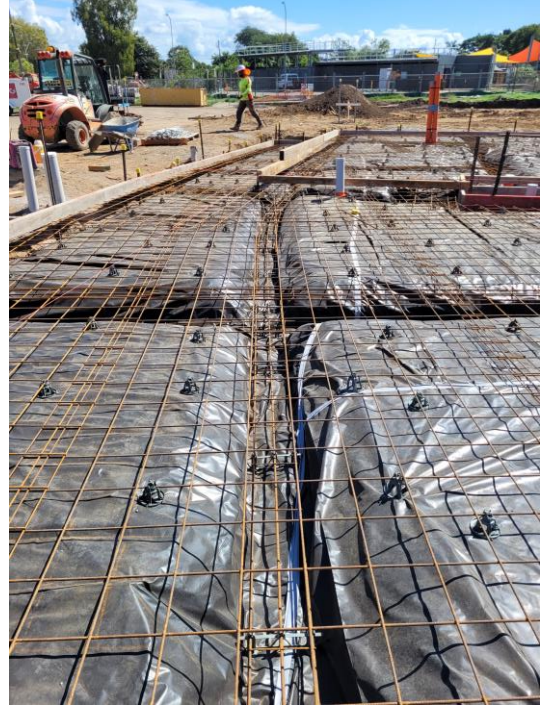
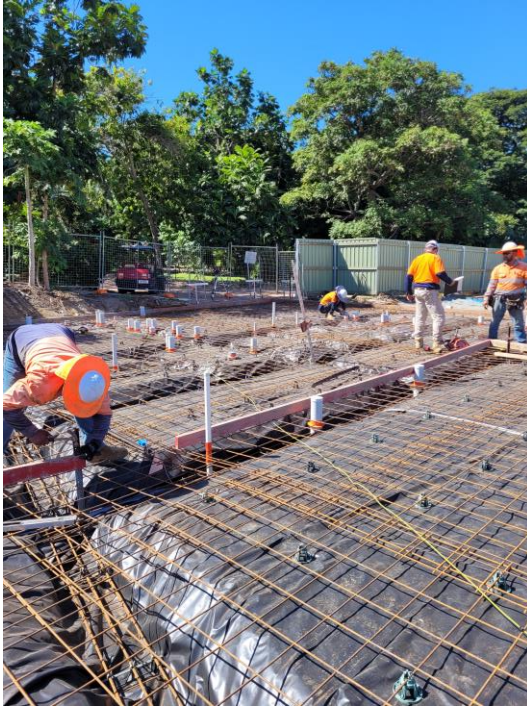
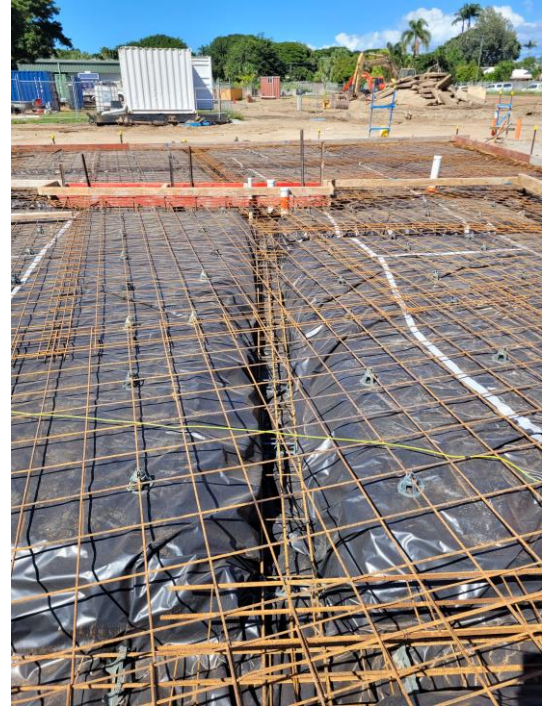
Inspected Amenities slab.

Ground floor slab reinforcing complete.

Reinforcing correct. Cover adequate.

- Ensure N16 starter bars are placed at all corners, intersections and at 800 crs max.
- Vibrate concrete.
- Maintain minimum cover.

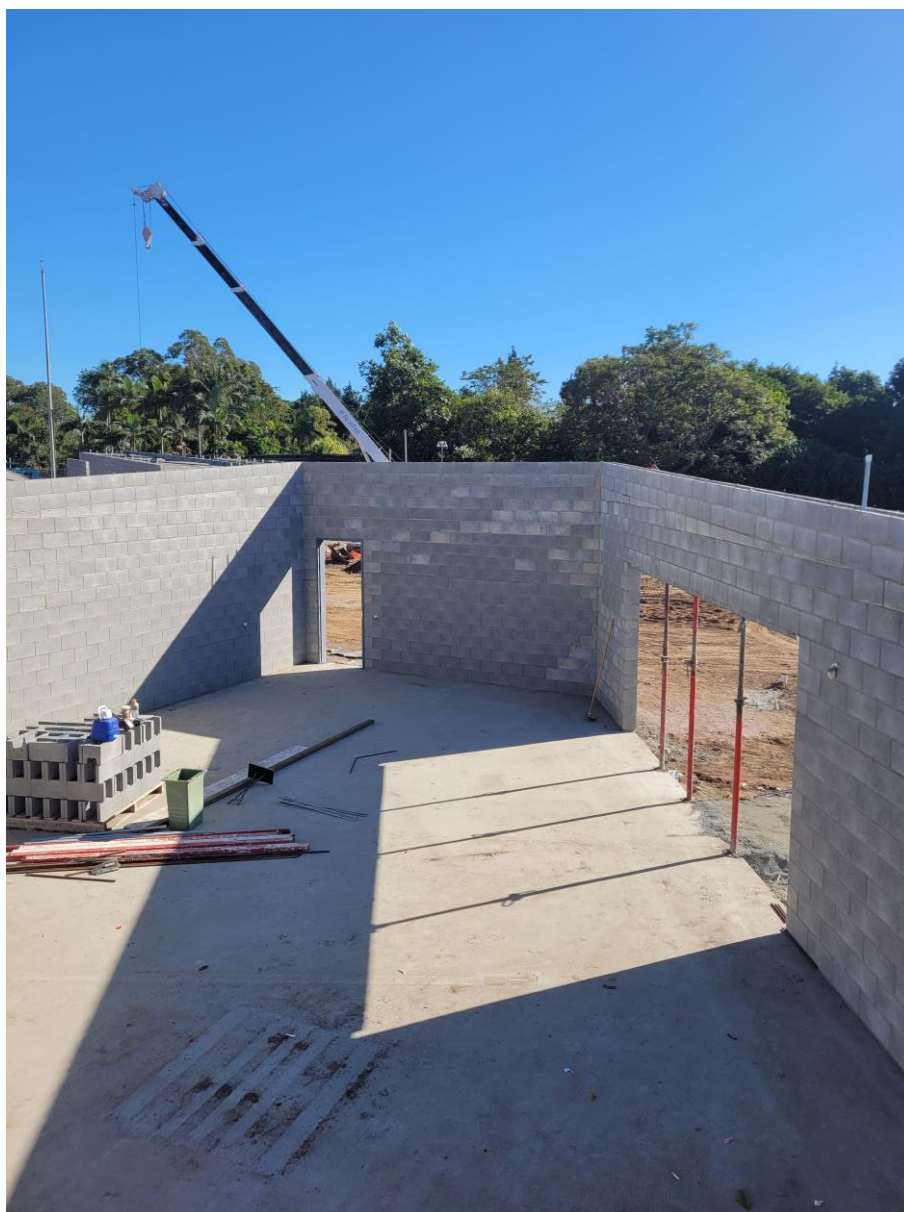
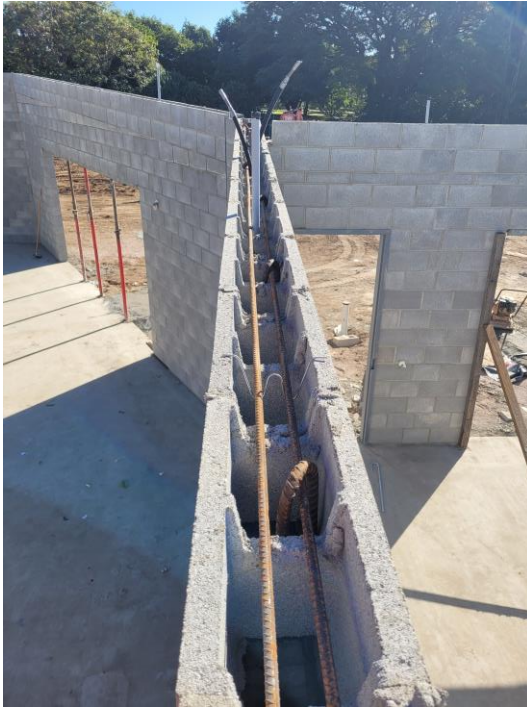
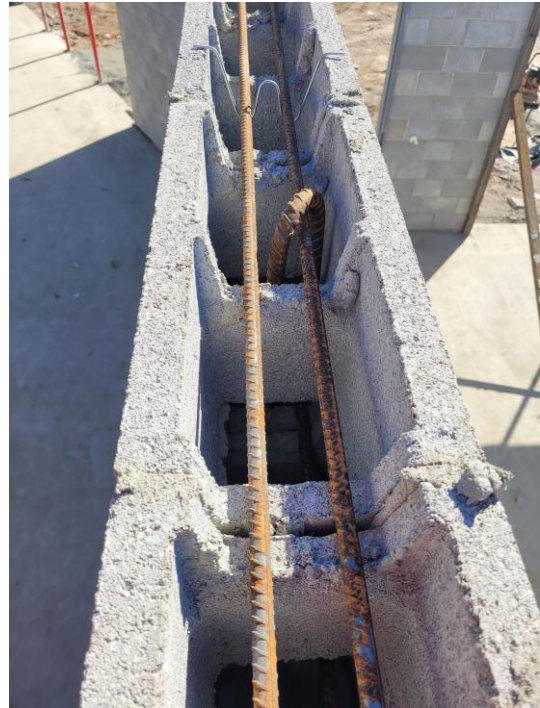
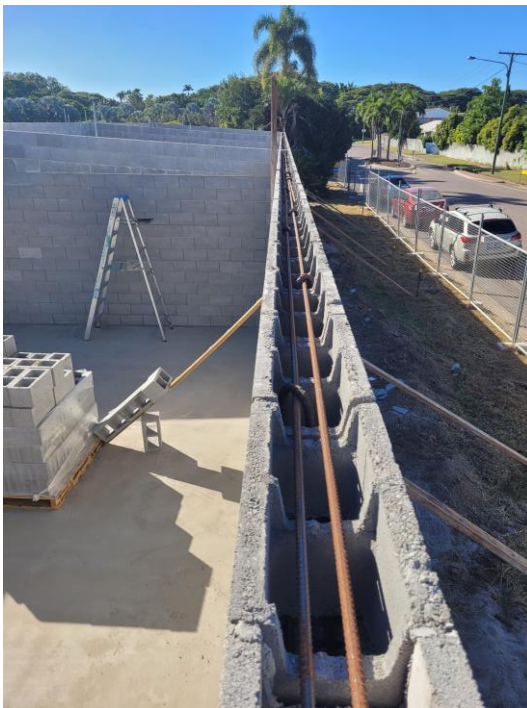
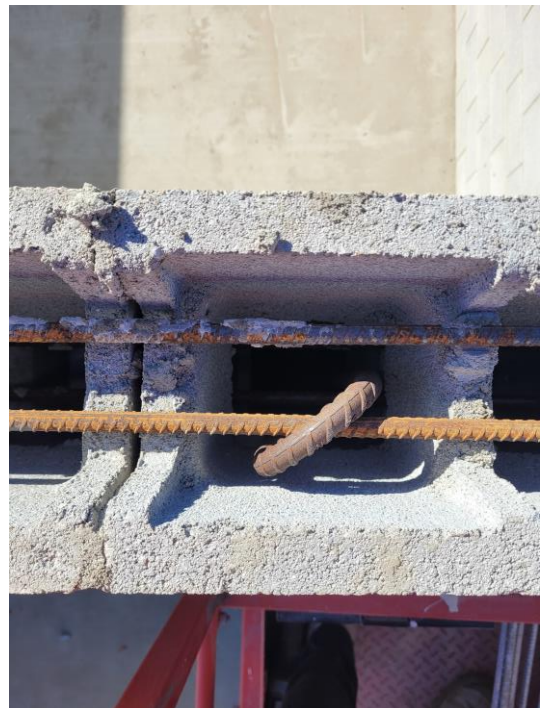
Inspected irrigation and workshop bond beam.

C.M walls complete.

Reinforcing correct. Cover adequate.

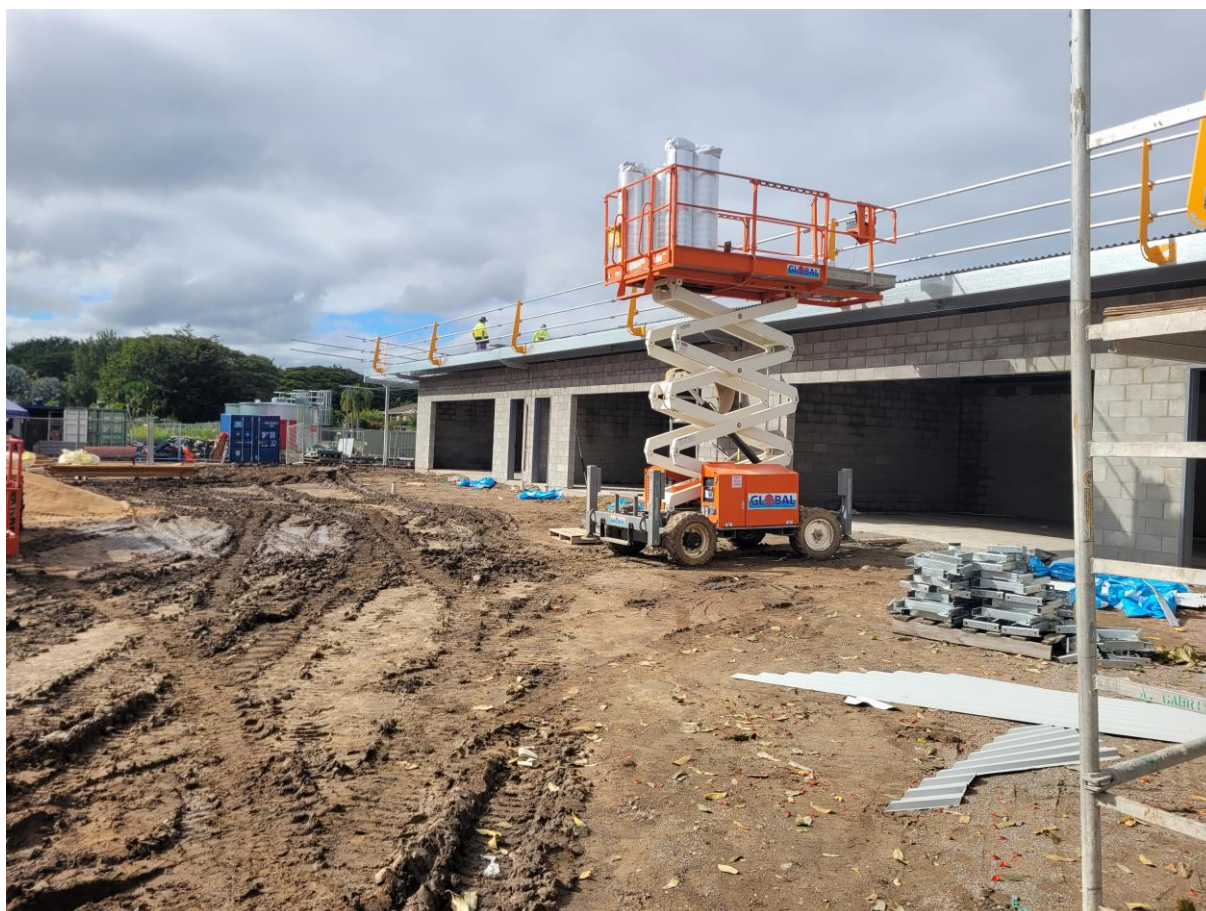
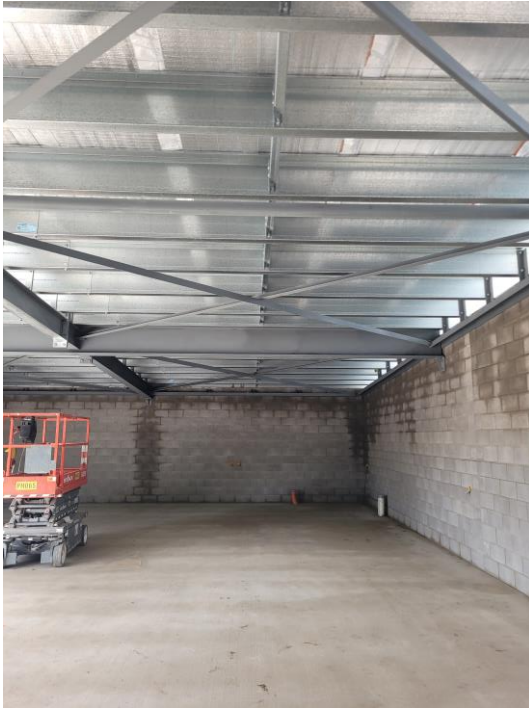
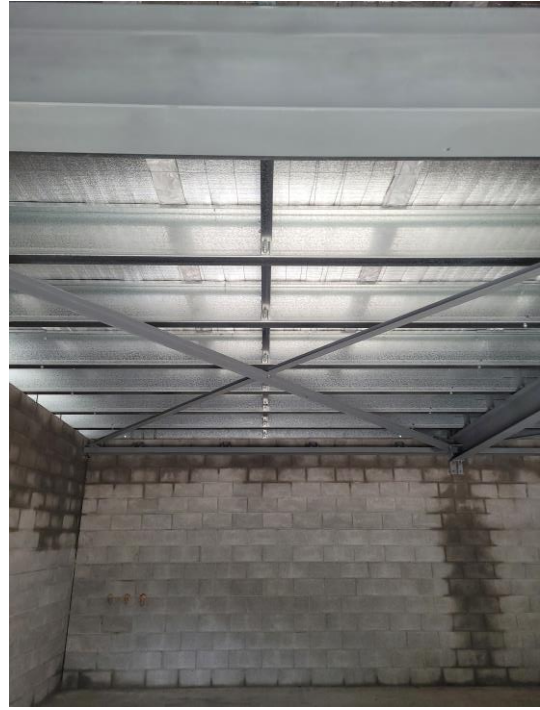
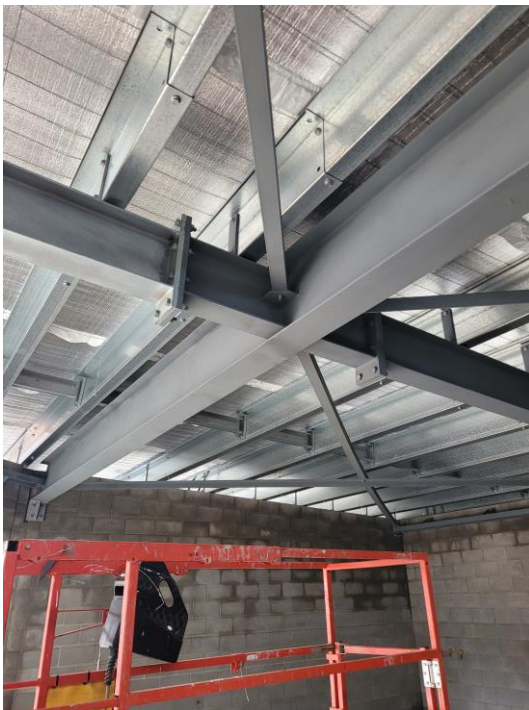
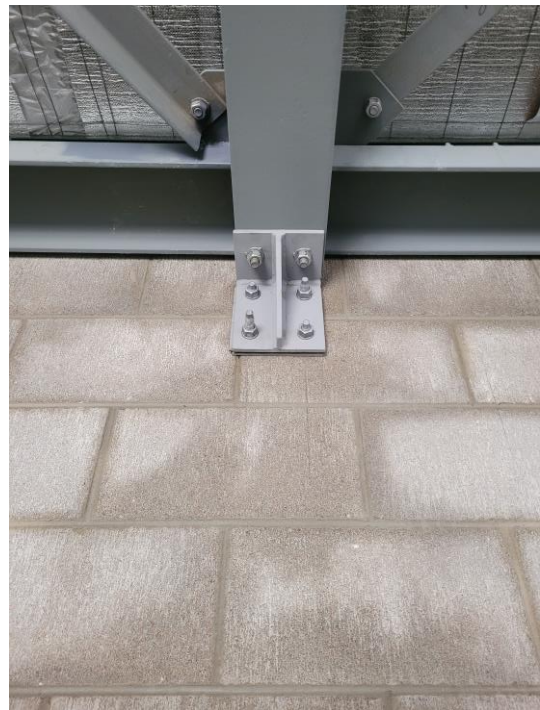
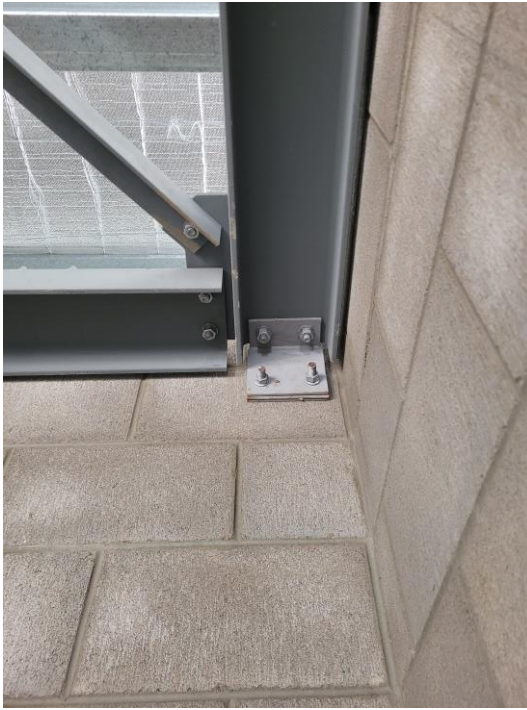
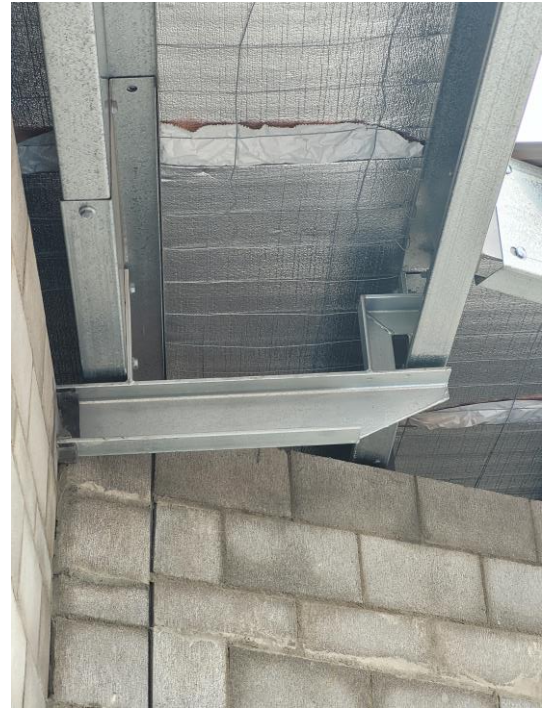
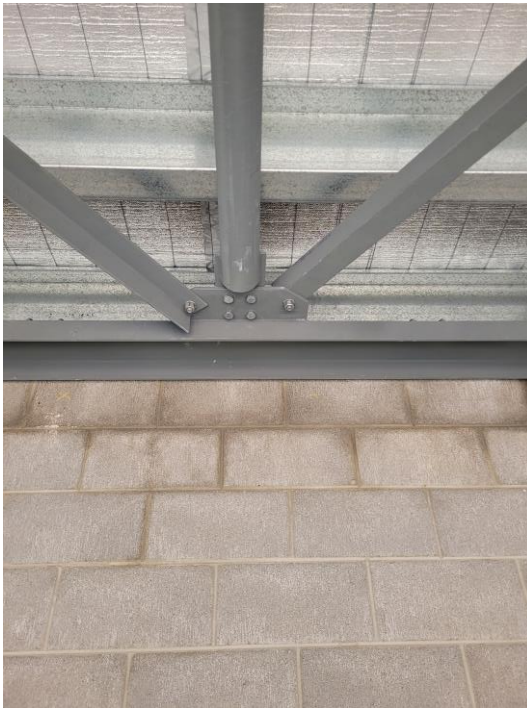
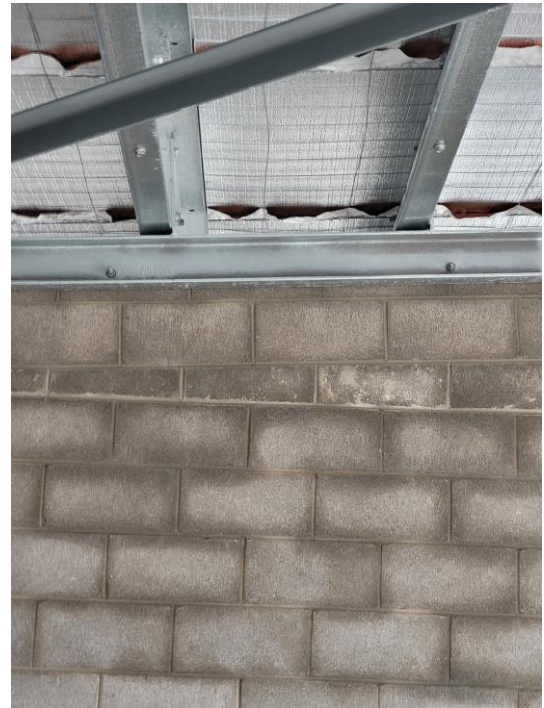
Inspected irrigation workshop roof frame.

Structural framing complete.

Member sizes and connections are consistent with construction issue drawings.

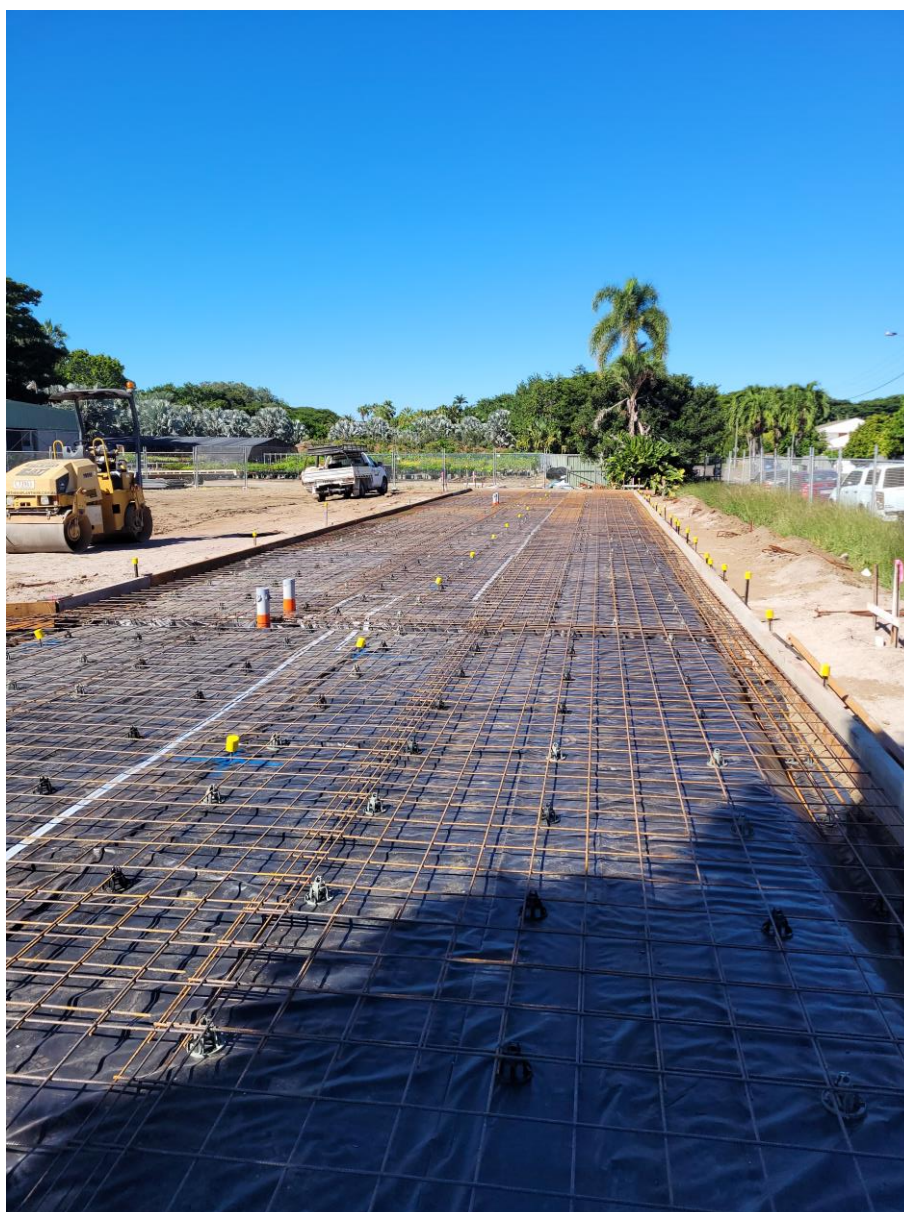
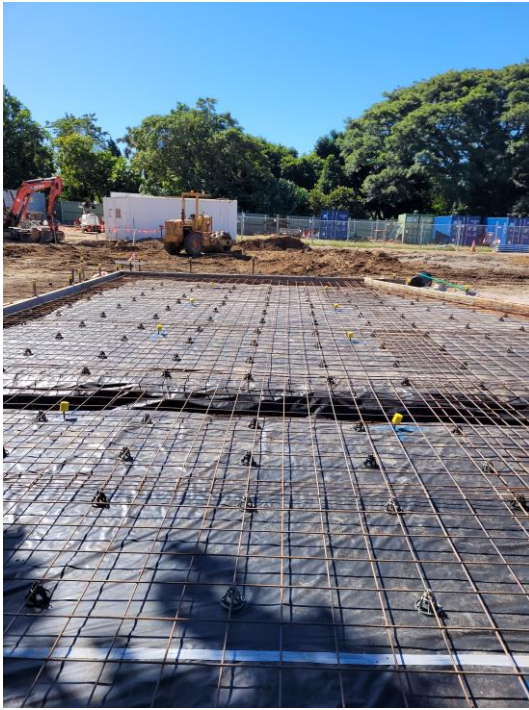
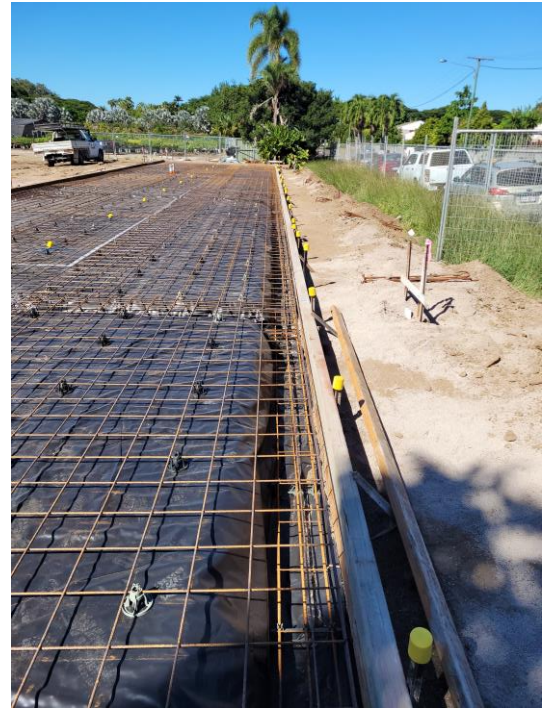
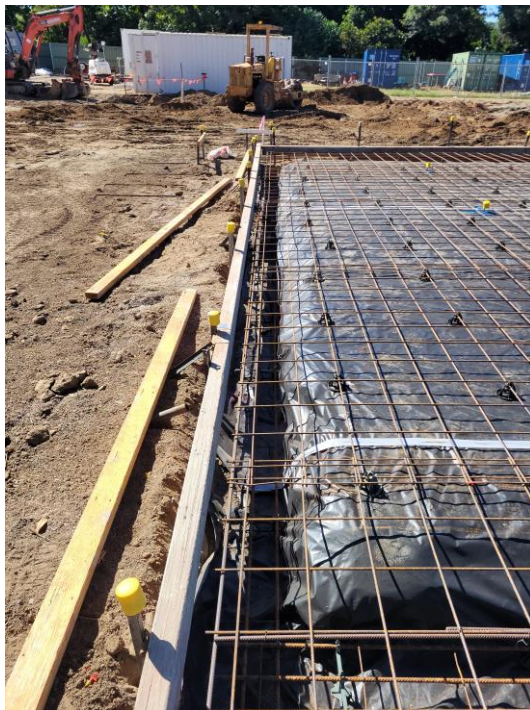
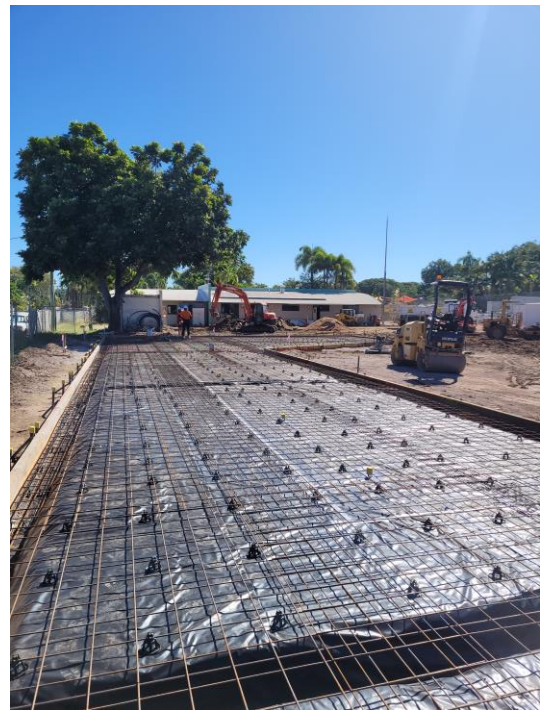
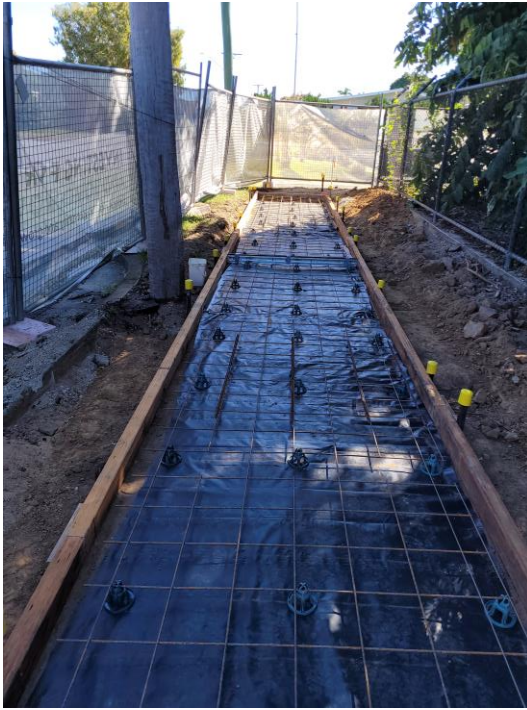
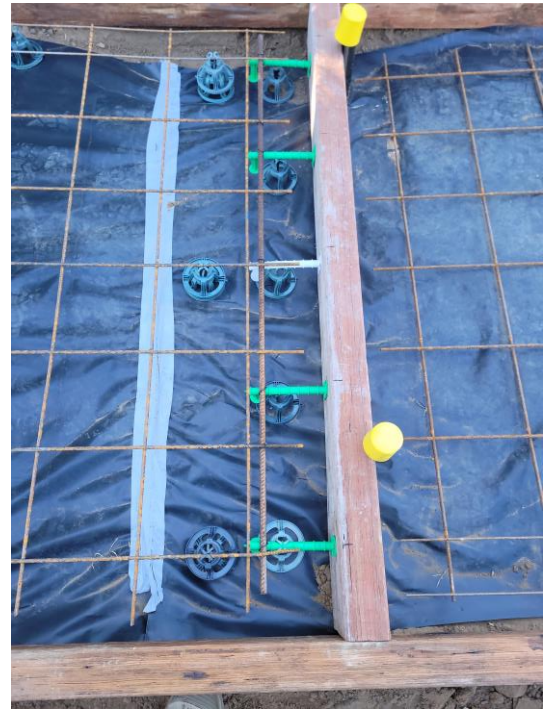
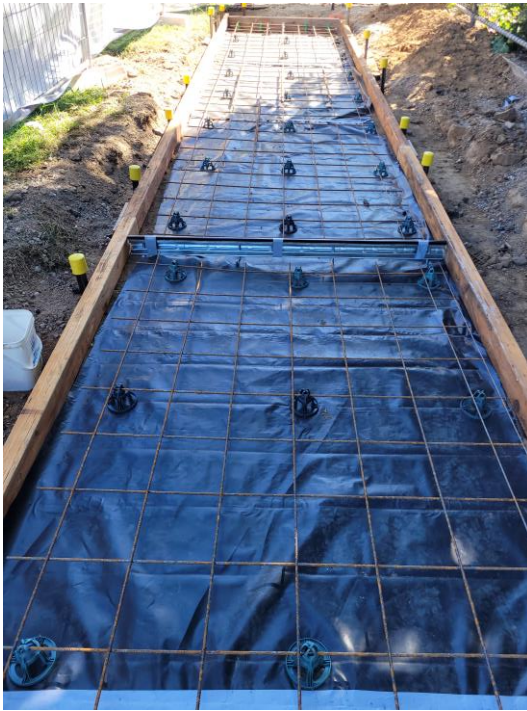
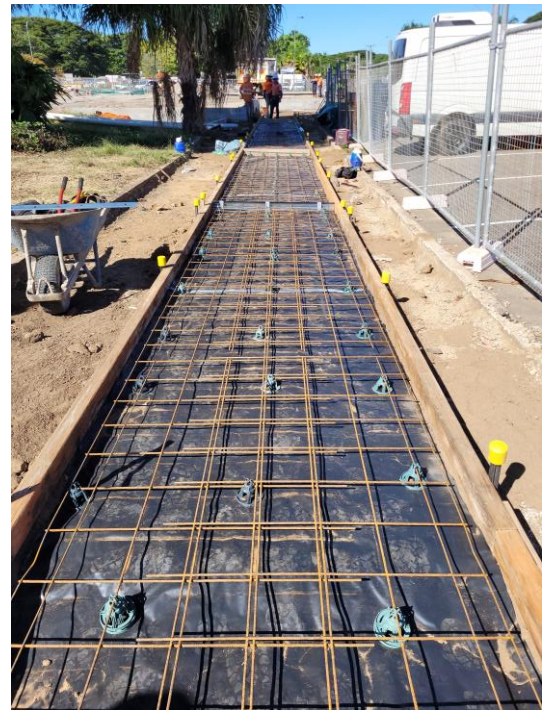
Inspected Amenities slab and Wellington Street concrete path.

Slab reinforcing complete.

Reinforcing correct. Cover adequate.

- Ensure N16 starter bars are placed at all corners, intersections and at 800 crs max.
- Vibrate concrete.
- Maintain minimum cover.

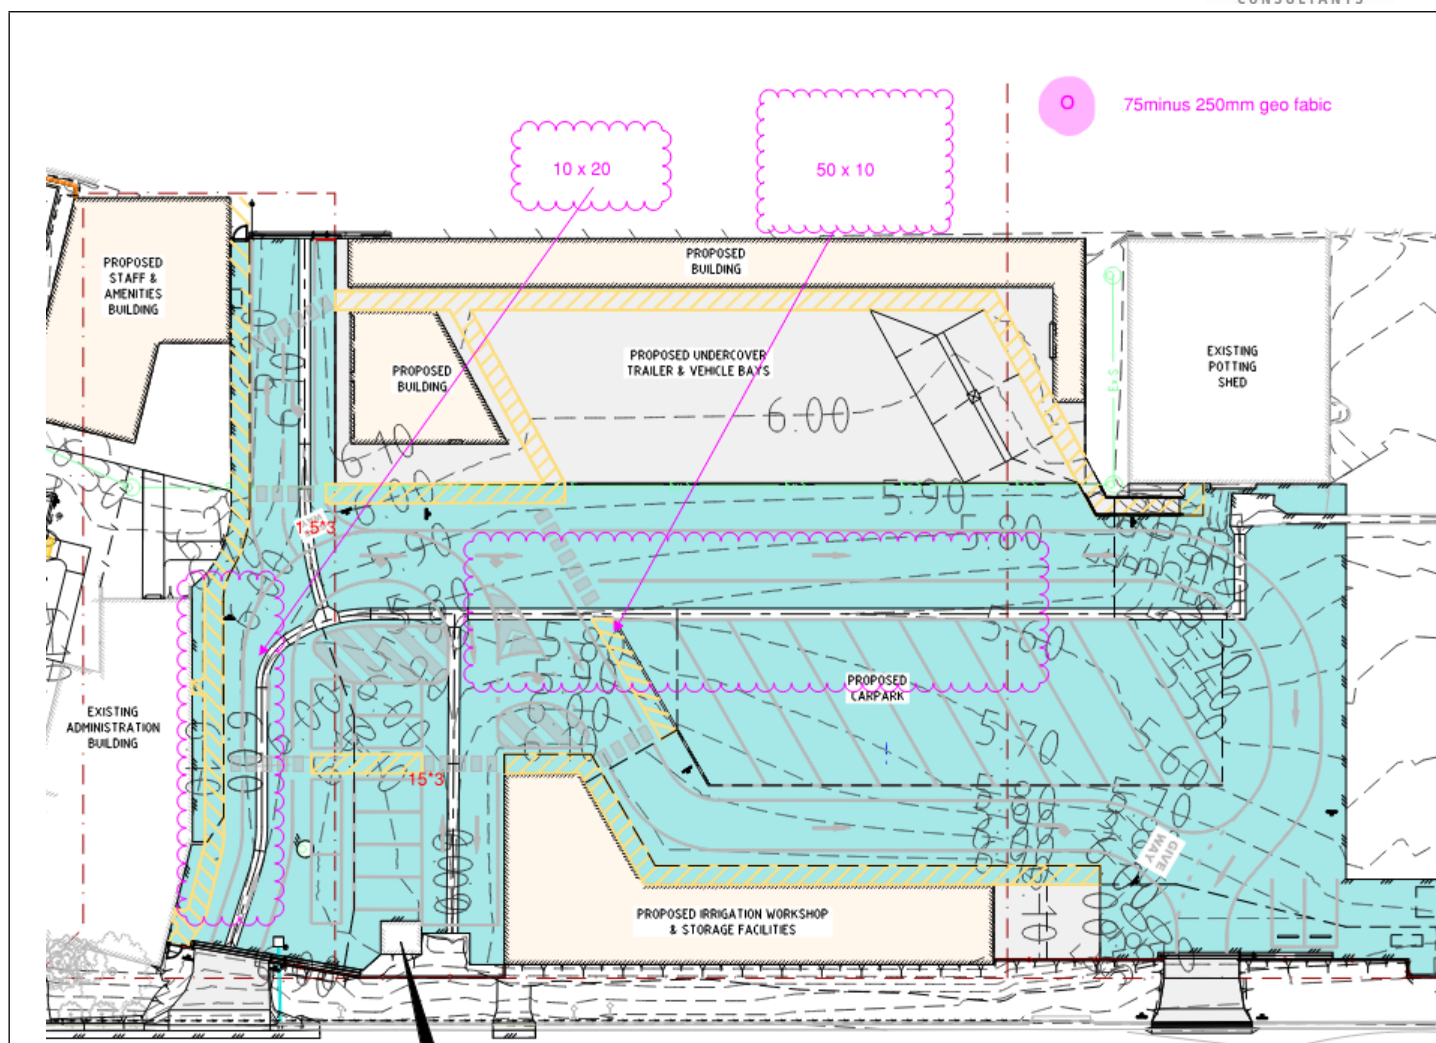
| Comments |
|---|
| <p><b>Work Elements Inspected:</b></p> <ul style="list-style-type: none"> <li>Subgrade layer Stage 2 hardstand proof roll.</li> </ul> <p><b>Machinery Employed:</b></p> <ul style="list-style-type: none"> <li>A 3-axle water truck was organised and loaded on the day of the test.</li> </ul> <p><b>Conformance with Design and Documentation:</b></p> <ul style="list-style-type: none"> <li>The extent of subgrade is in accordance with the STP plans and documentation and recommendations.</li> </ul> <p><b>Quality of Workmanship:</b></p> <ul style="list-style-type: none"> <li>The presentation of the worked subgrade was clean, free of debris, and of natural site won material.</li> </ul> <p><b>Defects:</b></p> <ul style="list-style-type: none"> <li>Deflections noted as per the site markup below.</li> </ul> <p><b>Conclusion:</b></p> <p>Subgrade layer <b>FAILED</b> the proof roll inspection and will not be approved without further remediation.</p> <p>Recommended remediation measure for the areas detailed below are as follows:</p> <ul style="list-style-type: none"> <li>Remove existing subgrade to a depth of 250mm.</li> <li>Trim and compact exposed surface.</li> <li>Install layer of A44 Geofabric</li> <li>Install 250mm layer of 75minus material.</li> <li>Compact and trim.</li> <li>Further proof roll required over remediated areas.</li> </ul> |

Additional inspections were also undertaken on this occasion for pre-pour of an electrical pit walls and the lintels and grates of the stormwater pits in Stage 1.

Inspection of these items was satisfactory, and works may proceed.
