| Client | Gabrielli Constructions Pty Ltd | | <h2 style="margin: 0;">INSPECTION AND TEST PLAN</h2> |
| Project Name: | Wellington Street Depot | | |
| Task: | Inground Stormwater – Stage 1 Carpark | ITP: In Ground Stormwater | |

| Client | | Gabrielli Constructions Pty Ltd | | <h1 style="text-align: center;">INSPECTION AND TEST PLAN</h1> | | | |
|---|---|---|---|---|---|---|--|
| Task: | | Inground Stormwater Pits – Stage 1 Carpark | | ITP: In Ground Stormwater Pit | | ITP No. 015 | |

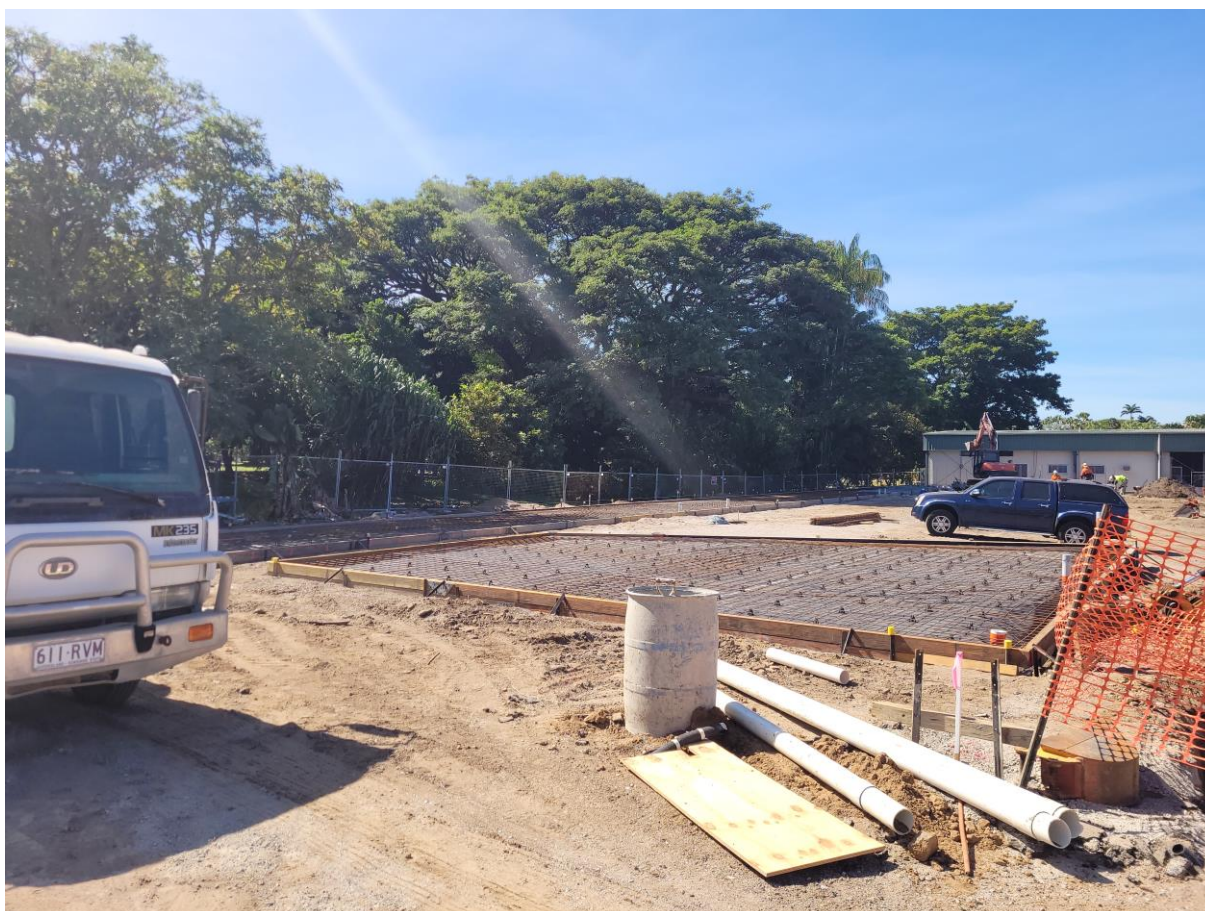
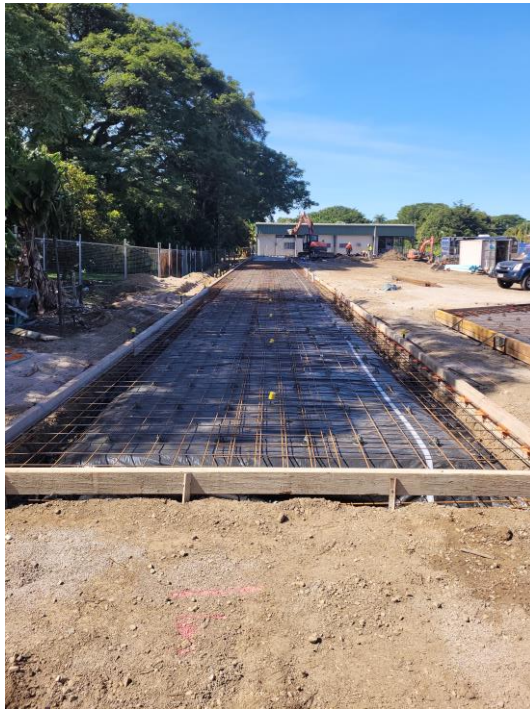
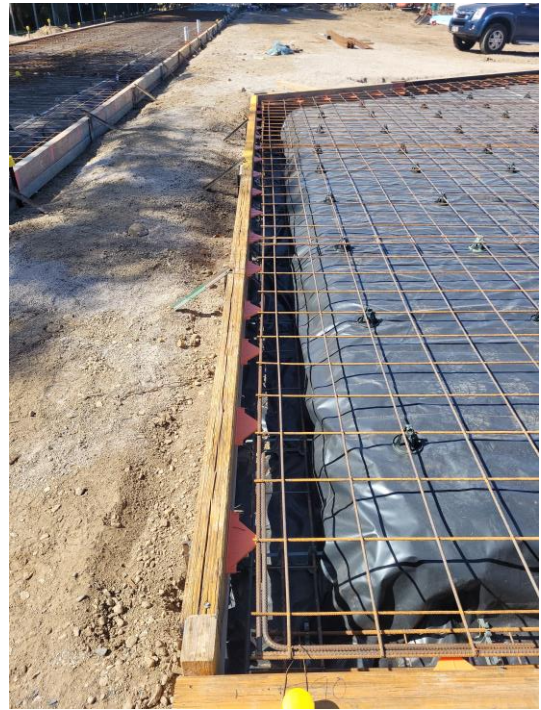
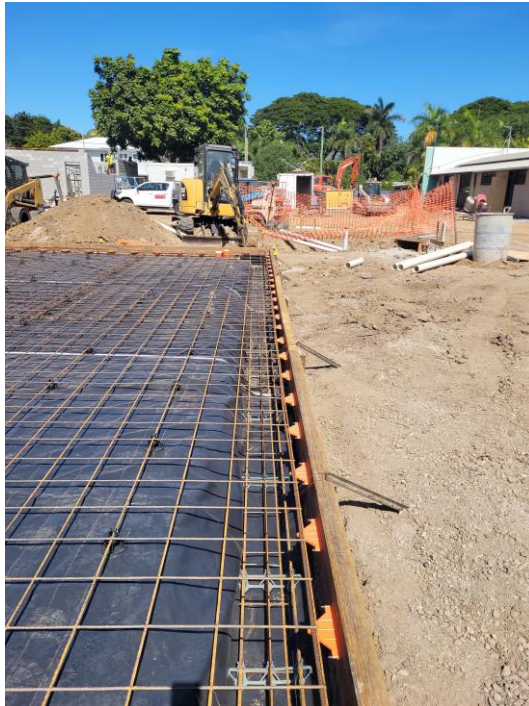
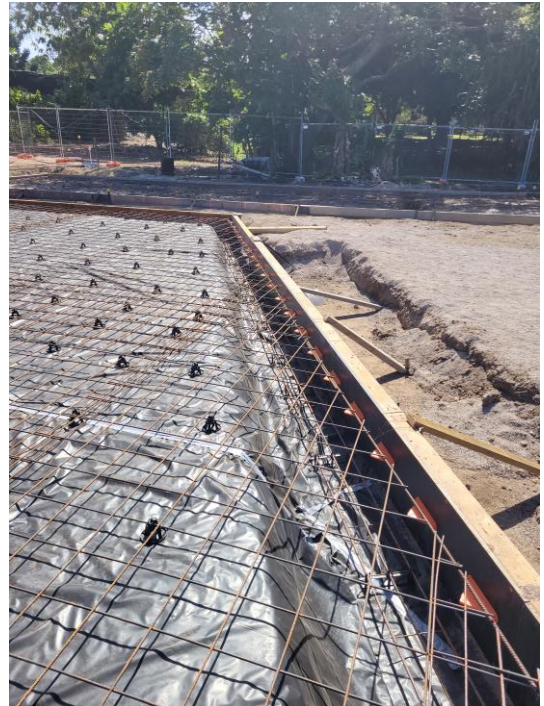
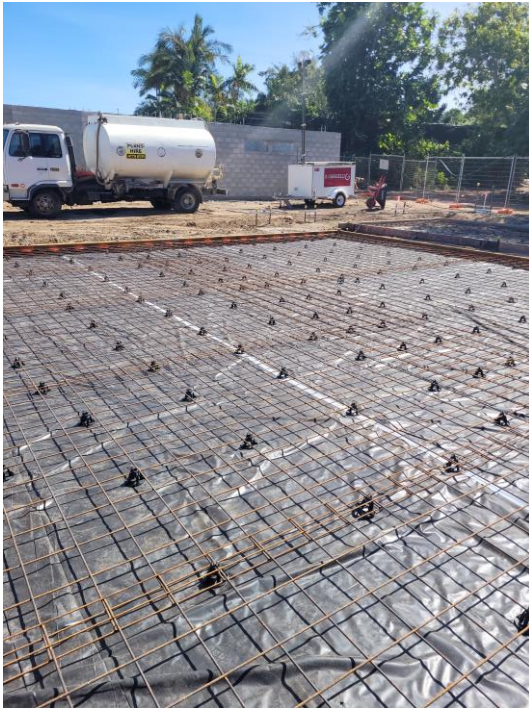
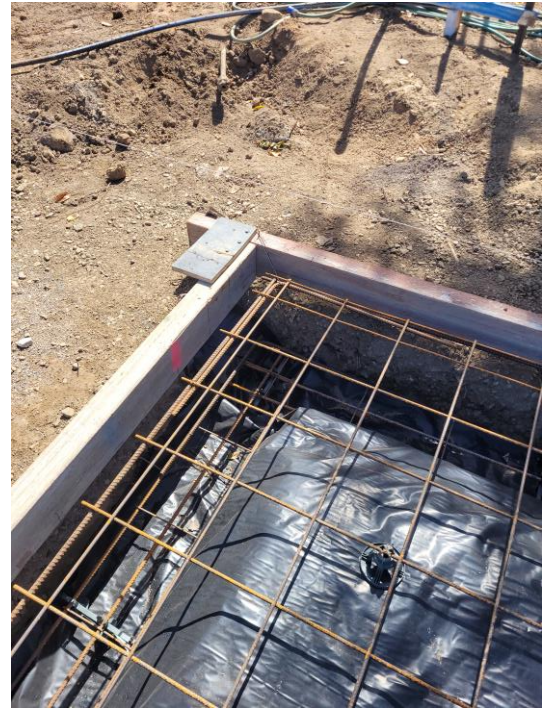
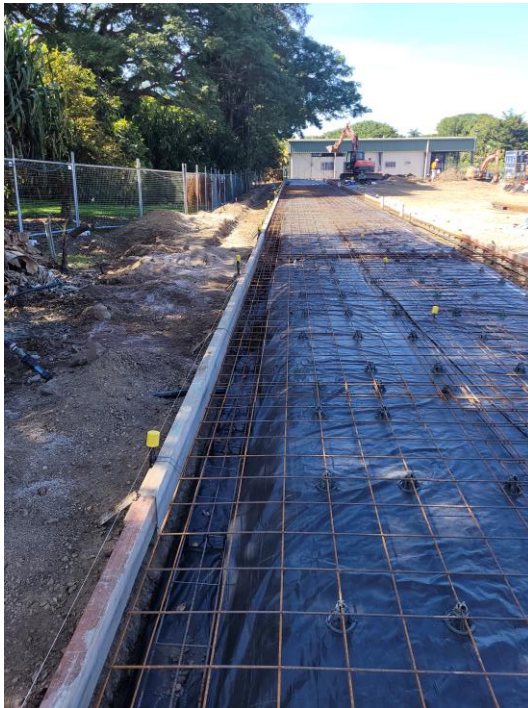
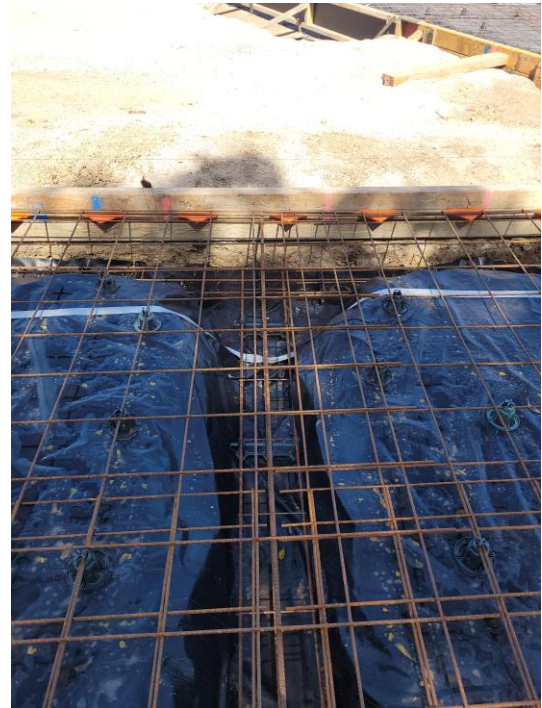
Inspected workshop and trailer bay slab.

Slab reinforcing complete.

Reinforcing correct. Cover adequate.

- Ensure N16 starter bars are placed at all corners, intersections and at 800 crs max.
- Vibrate concrete.
- Maintain minimum cover.

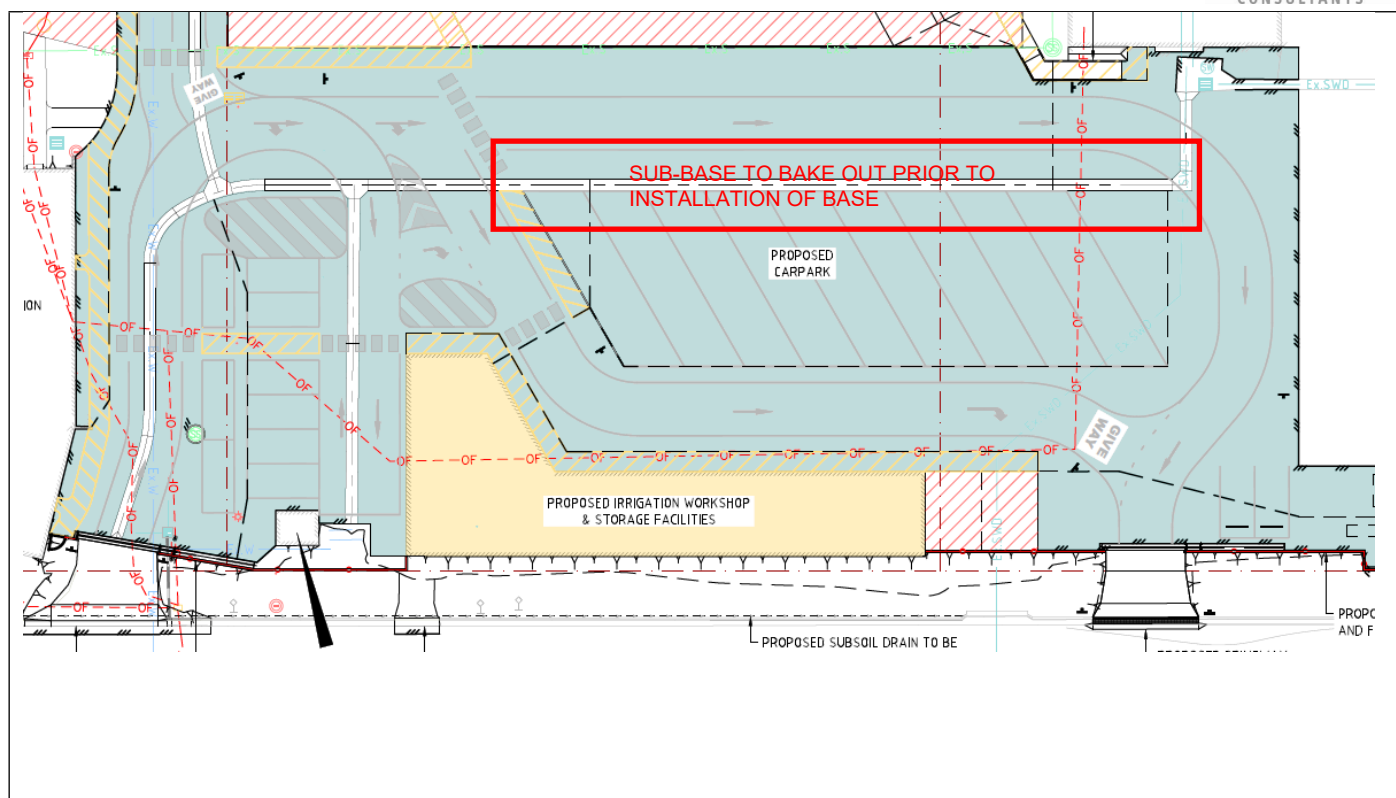
| Comments |
|---|
| <p><b>Work Elements Inspected:</b></p> <ul style="list-style-type: none"> <li>Sub-base layer Stage 2 hardstand proof roll following subgrade approval.</li> </ul> <p><b>Machinery Employed:</b></p> <ul style="list-style-type: none"> <li>A 3-axle water truck was organised and loaded on the day of the test.</li> </ul> <p><b>Conformance with Design and Documentation:</b></p> <ul style="list-style-type: none"> <li>The extent of sub-base is in accordance with the STP plans and documentation and recommendations.</li> </ul> <p><b>Quality of Workmanship:</b></p> <ul style="list-style-type: none"> <li>The presentation of the graded sub-base was wet in the invert section and showed ponding in several places.</li> </ul> <p><b>Defects:</b></p> <ul style="list-style-type: none"> <li>Deflections were observed in the area shown, to 3m each side of the invert.</li> </ul> <p><b>Conclusion:</b></p> <p>Subgrade layer has partially <b>PASSED</b> the proof roll inspection and will be approved after allowing the centre section to bake out.</p> <p>Next inspection to be proof roll of the base surface prior to sealing.</p> |

Approved to proceed with work
