# Geotechnical Investigation Report

## **MACKAY BASE HOSPITAL – BLOCK P EXPANSION**

Prepared for Conrad Gargett

11 November 2022

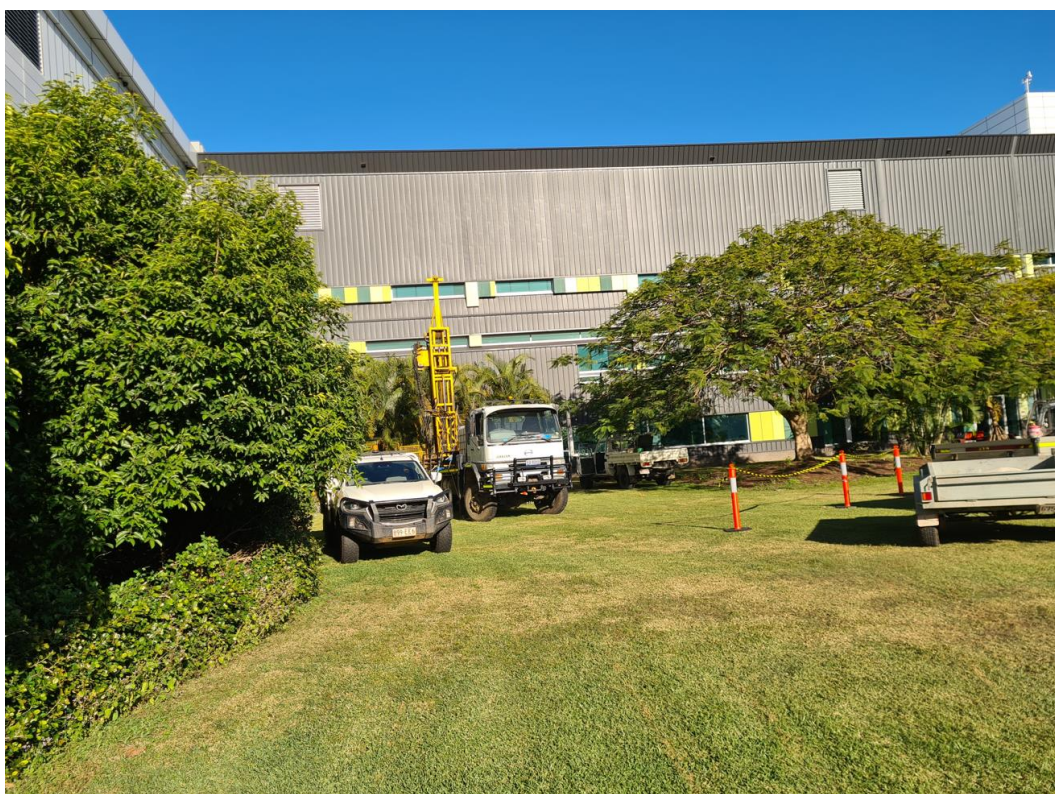
*Figure 2.1 East Facing toward BH01 Location.*

Refer to Figure 2.1 for typical site conditions encountered during the investigation.

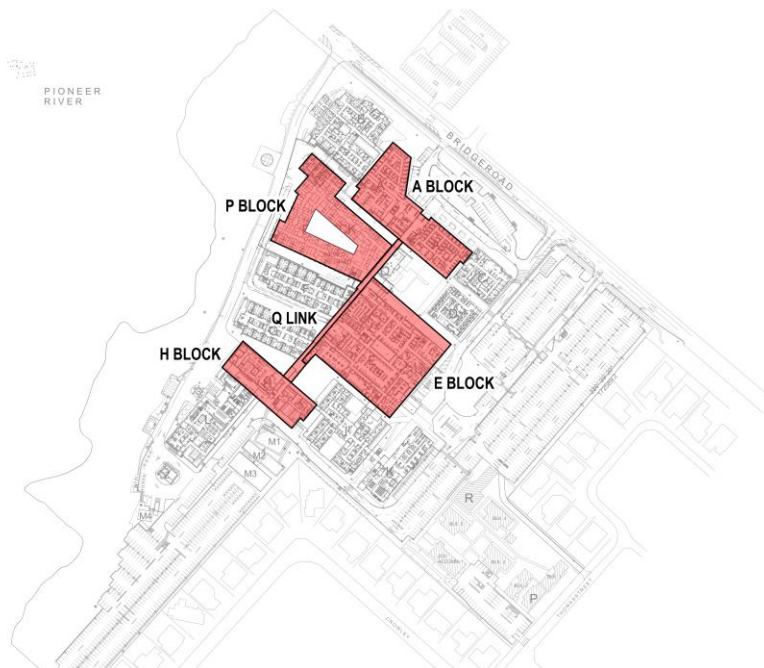
The geotechnical investigation is to inform the design of a proposed new building (P Block) at the Mackay Base Hospital. The project consists of a 4 storey building with an internal courtyard (refer part site plan below).

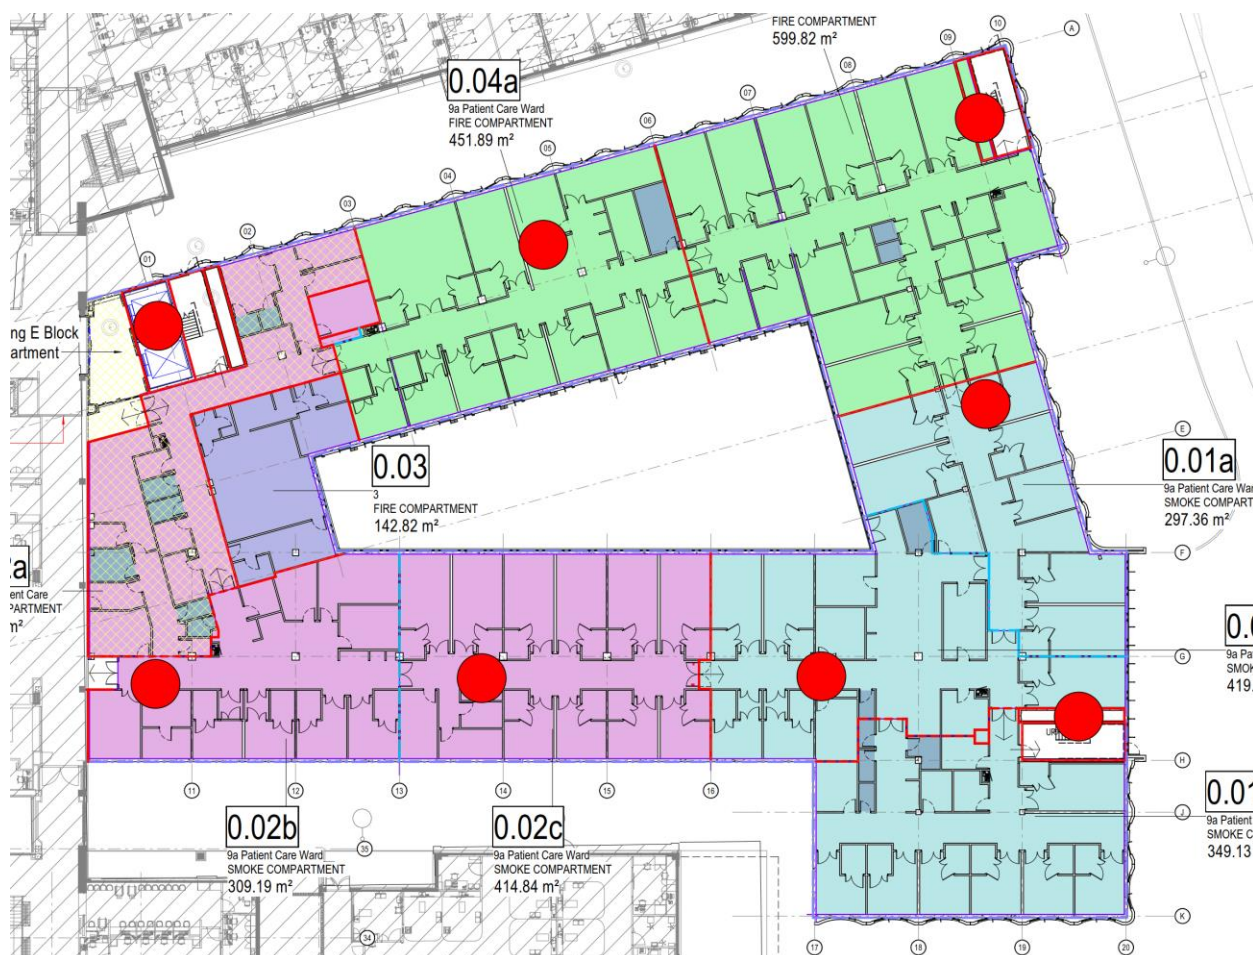
The figure below shows the proposed borehole layout. The final layout may need to be adjusted for any site obstructions etc.
