## New Construction Inspection - Handover Stage (QLD)

Inspection Date: Mon, 29 Apr 2019

Property Address: Lot 16 Dell Street, Rochdale Qld 4123

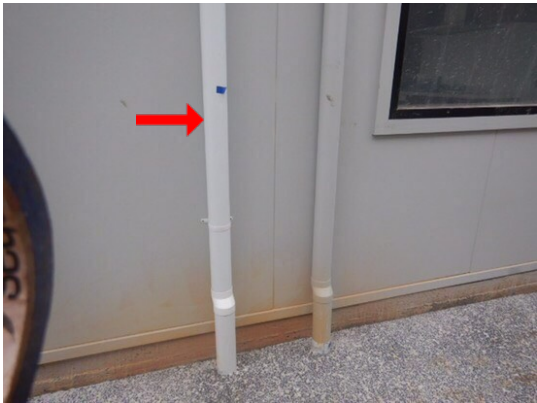
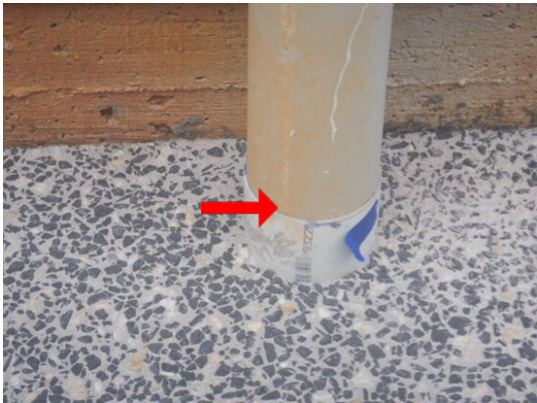
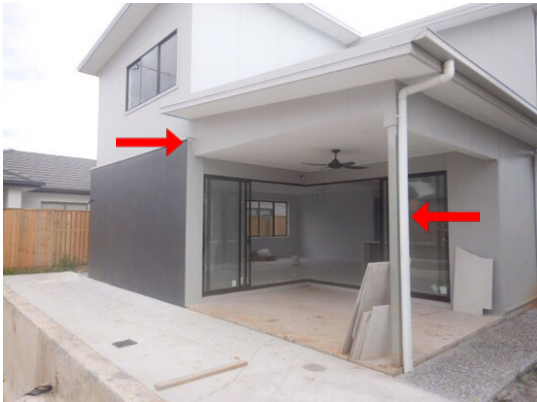
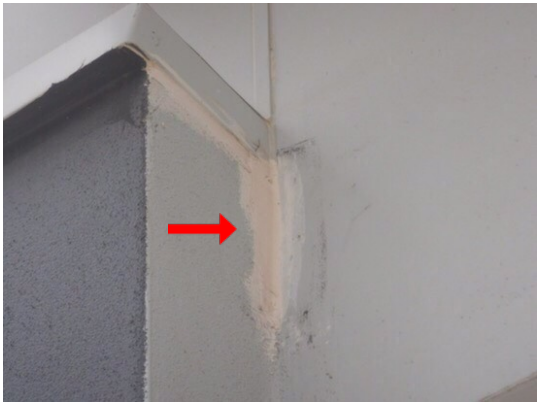
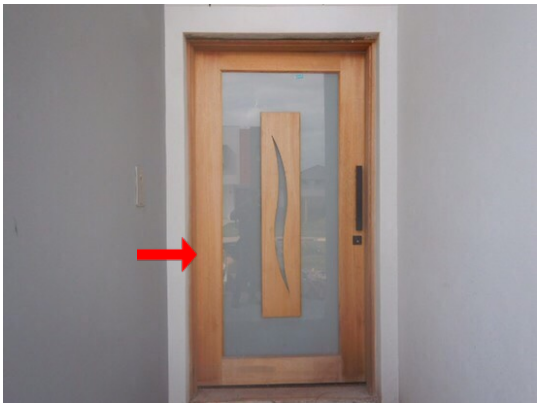
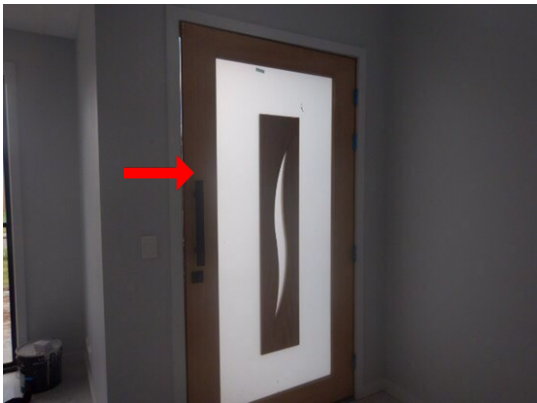
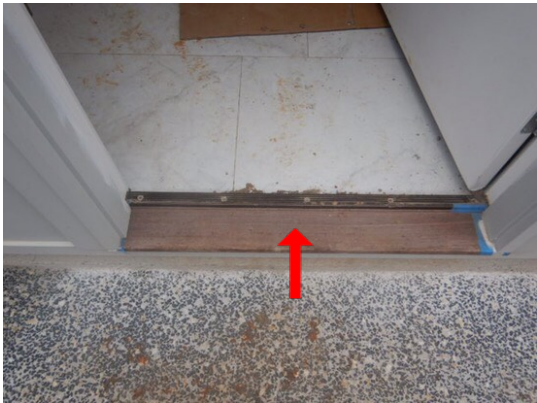
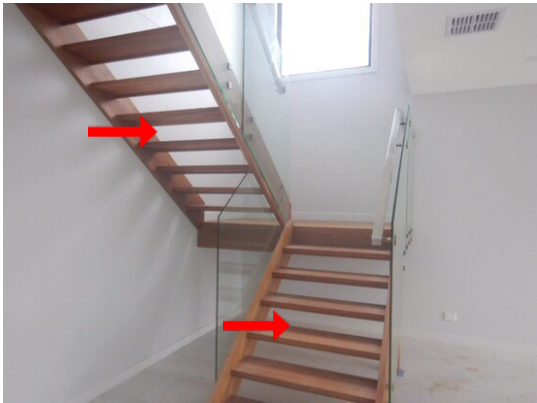
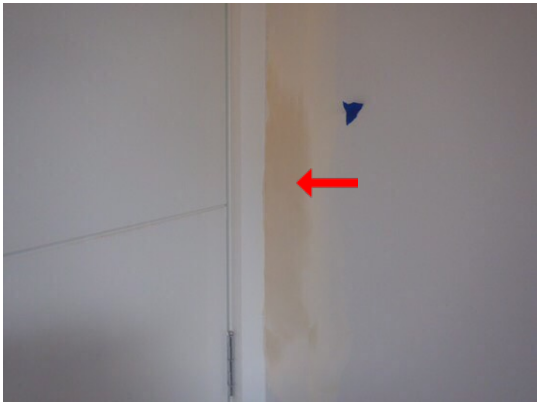
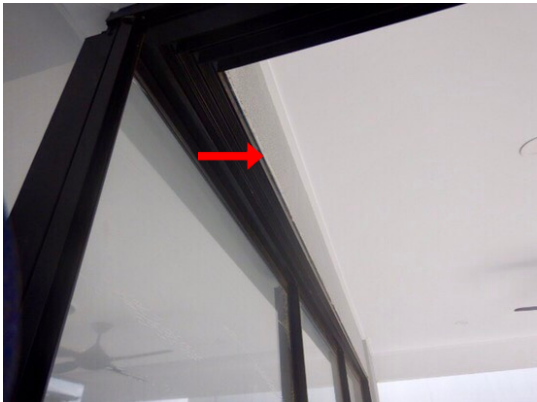
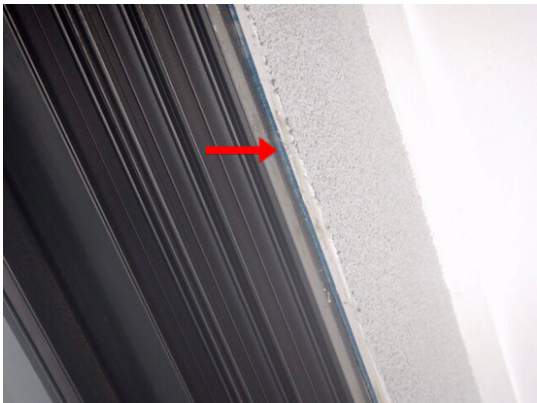
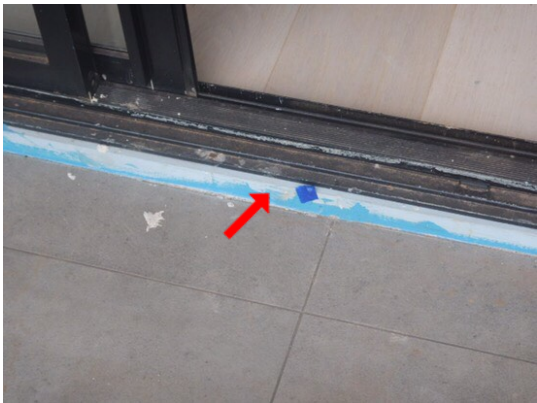
### Defects 2.02

Information: The paint finish in these areas was found to be incomplete at the time of inspection. Whilst incomplete or missing paint finish is generally an appearance defect, it can also lead to the development of secondary building defects over time.

Incomplete areas of paint finish exposes the area to moisture which could lead to deterioration of underlying building materials.

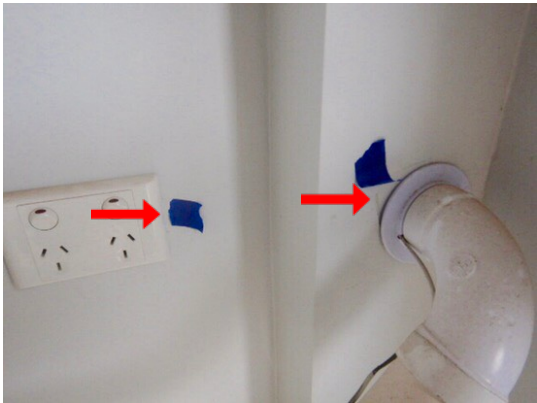
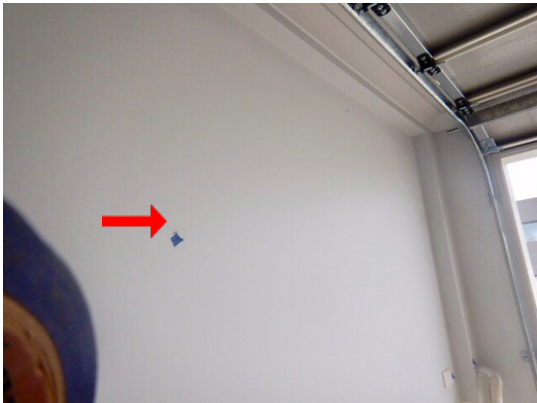
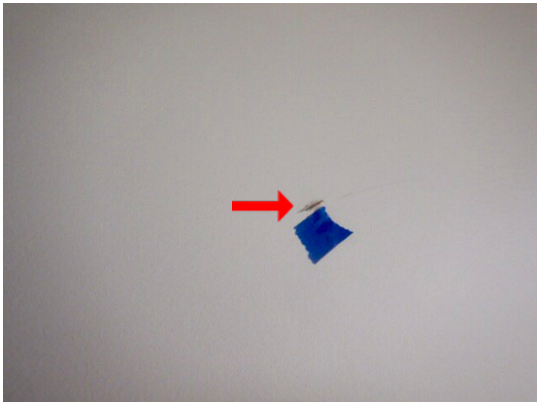
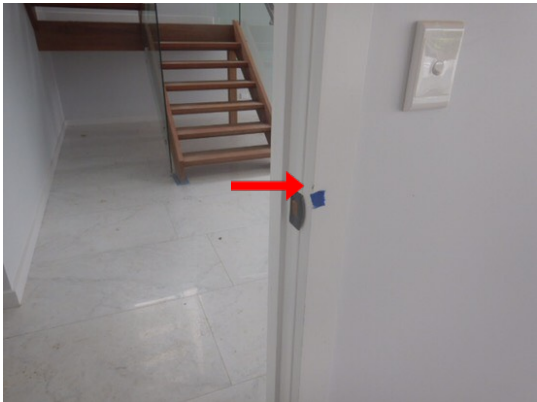
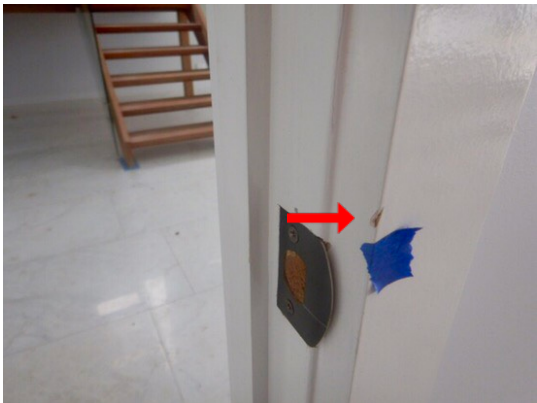
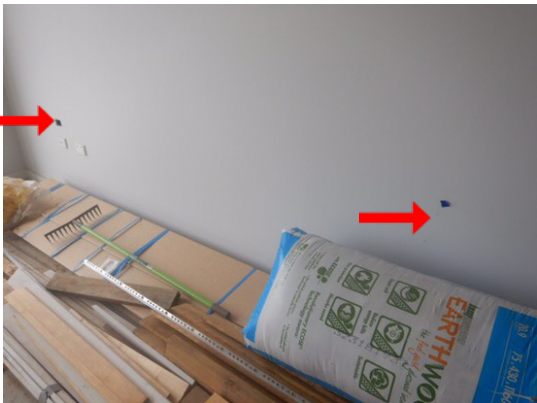
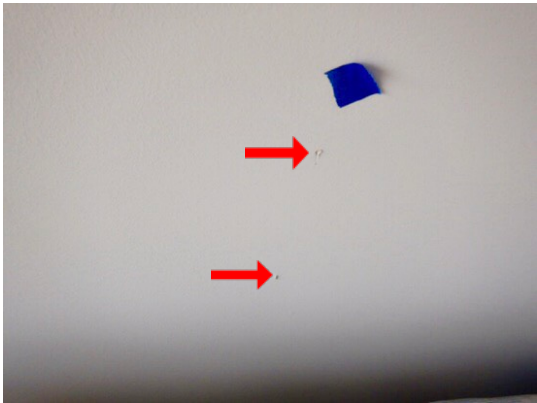
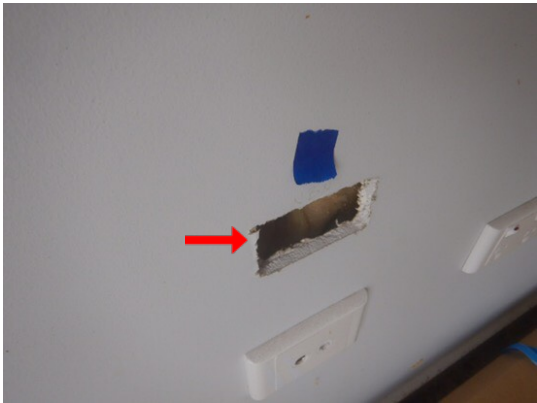
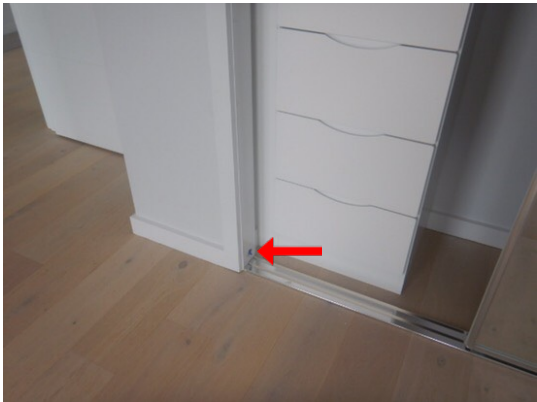
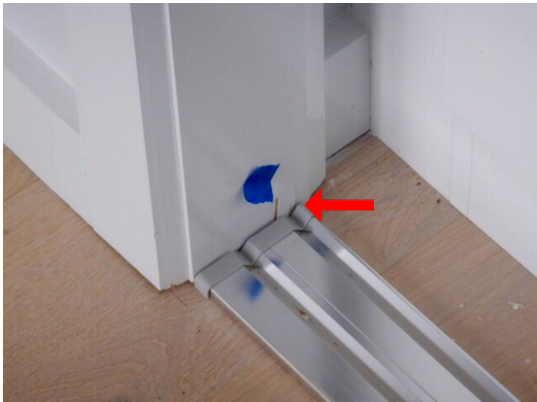
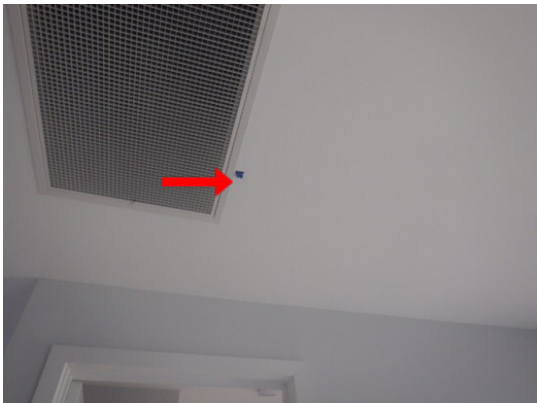
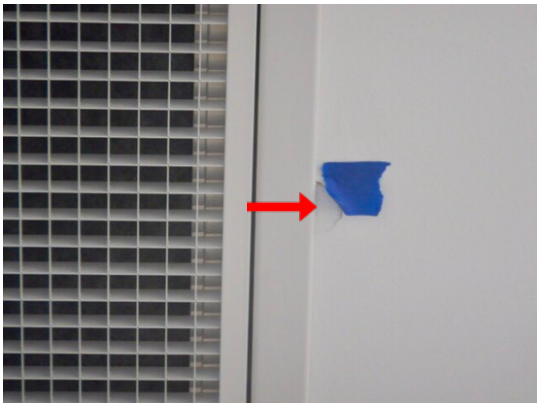
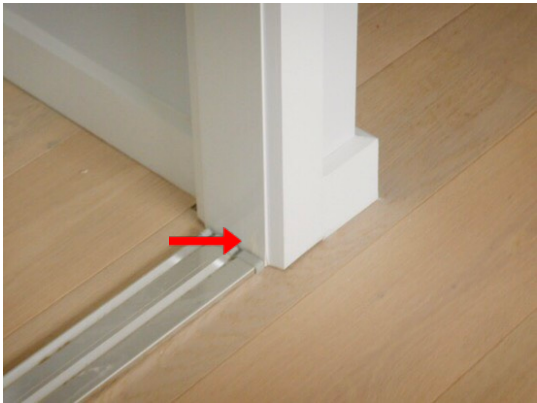
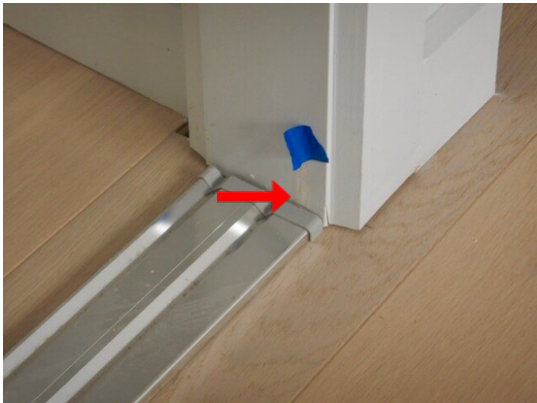
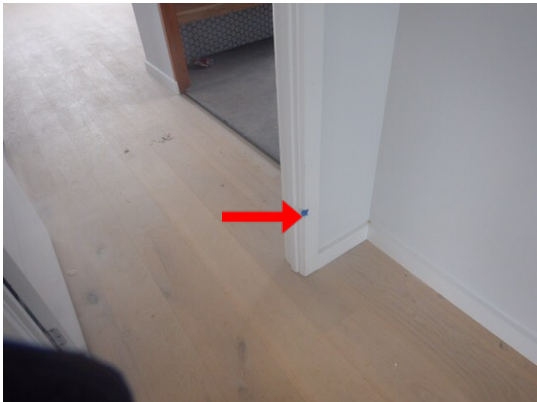
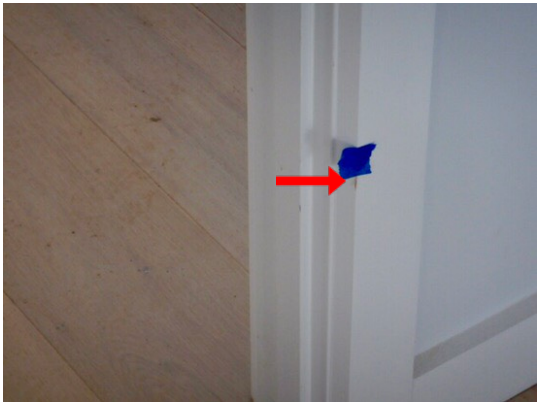
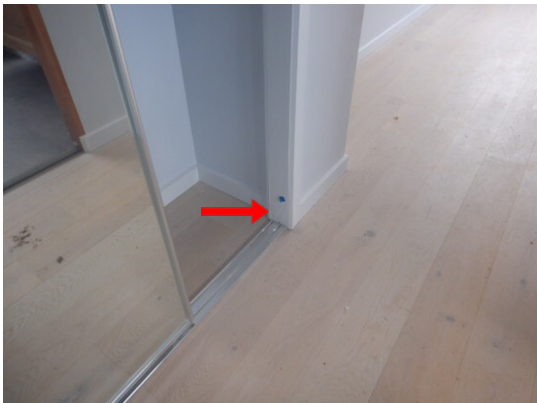
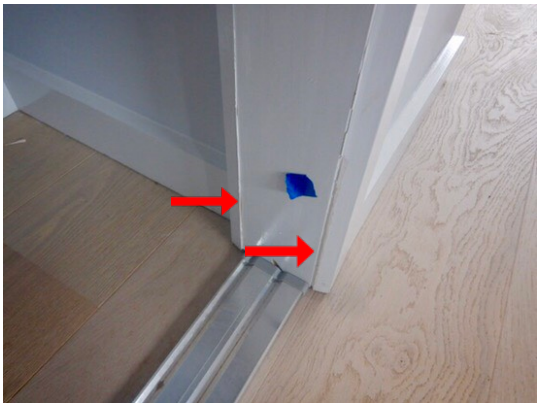
### Defects 2.03

Finding: Paint Finish - Damage (mechanical)

Information: Holes and / or other unfilled depressions resulting from mechanical damage are present to a number of different areas as indicated by the blue tape. Where these are visible from a normal viewing position they are considered a defect.

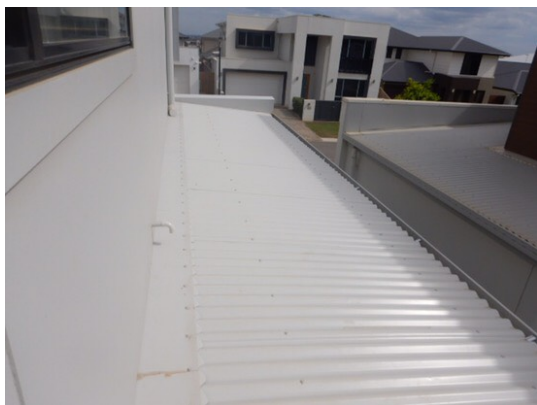
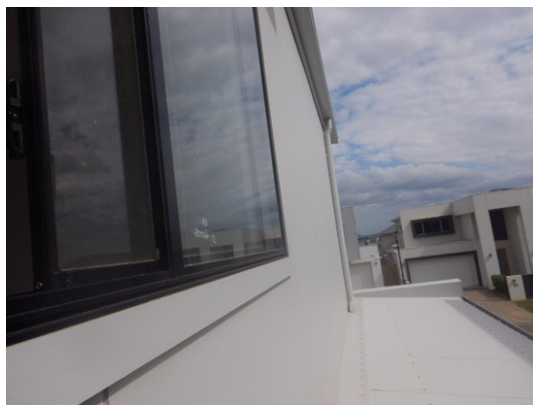
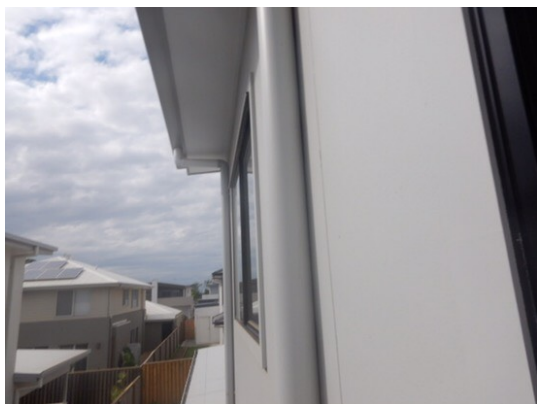
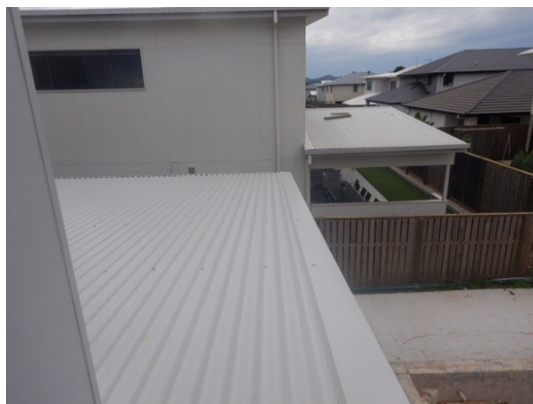
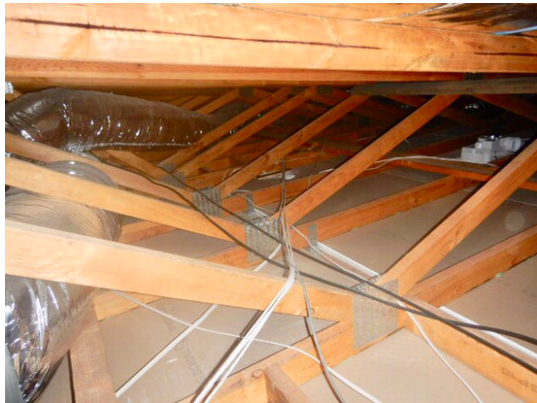
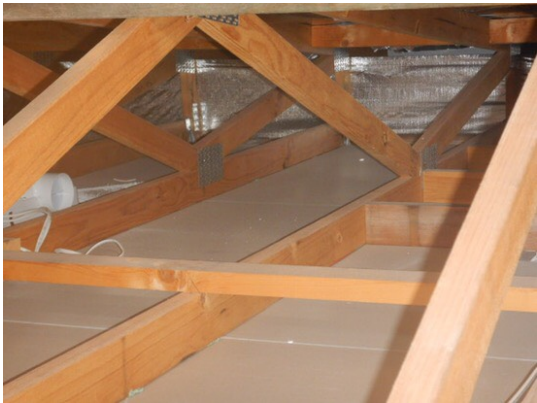
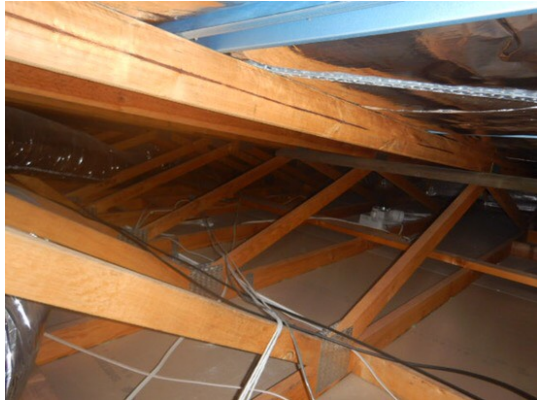
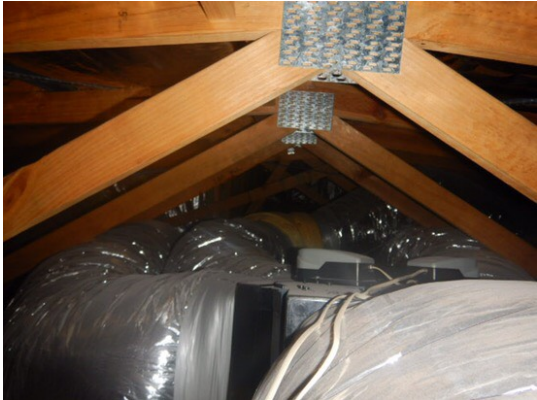
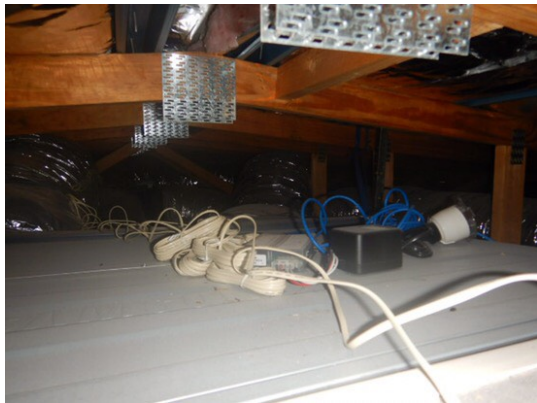
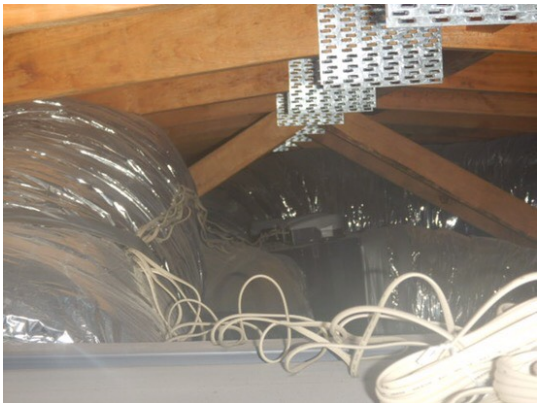
Building: Main Building  
Location: All Areas  
Finding: Additional Photos  
Information: Additional photos are provided for your general reference. Arrows have been included to highlight areas of importance.
