Southern Queensland Correctional Precinct, Stage 2 or SQCP2

Site Works - Work list

May 16, 2025

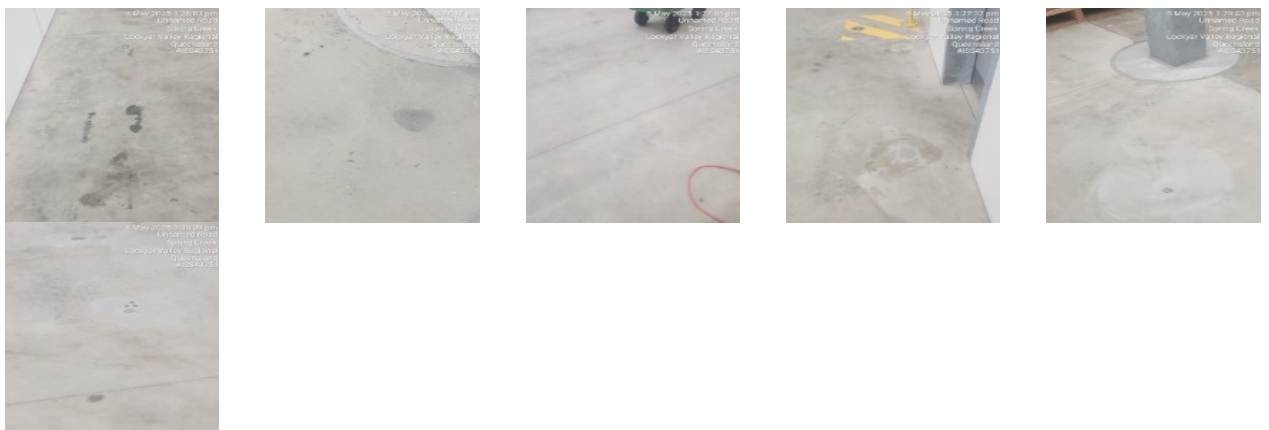
May 13, 2025 11:38 AM - Matthew Orourke (Delta Group Qld): In Progress  
May 13, 2025 11:36 AM - Matthew Orourke (Delta Group Qld): Work Completed  
May 9, 2025 7:08 AM - Matthew Orourke (Delta Group Qld): Industries concrete slab floor patches multiple across back warehouses inside roller doors

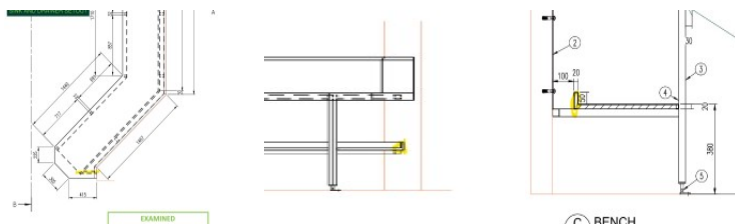
DOC146135-THS-SHD-  
AR-TH2-004 [1] Item  
TH2-S2-50 Kitchen Sink  
Bench.pdf

Mar 18, 2025 12:50 PM - Desirae Jessup (John Holland Delivery - Building): Assigned to T&H Sheetmetal Pty Ltd  
Mar 17, 2025 9:04 AM - Nelsi Patel (John Holland Delivery - Building): Updated  
Mar 14, 2025 2:44 PM - Daniel Russell (GBA - Guymer Bailey Architects): Assigned to John Holland Delivery - Building  
Mar 14, 2025 2:44 PM - Daniel Russell (GBA - Guymer Bailey Architects): Shelf support not done as per shop drawings. Please close in open end as per shop drawings where marked up on image

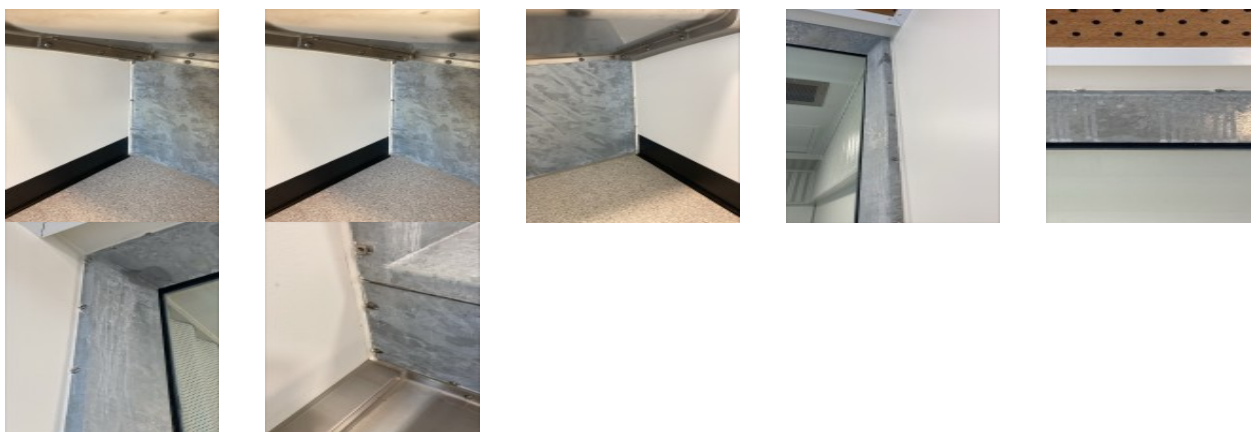
Apr 7, 2025 2:38 PM - Karl Ho (GBA - Guymer Bailey Architects): Photos attached  
Mar 31, 2025 1:31 PM - Ewelina Wdowikowska (John Holland Delivery - Infrastructure): Work Completed  
Mar 31, 2025 1:31 PM - Ewelina Wdowikowska (John Holland Delivery - Infrastructure): No photo provided. Please provide photo otherwise item to be closed.  
Mar 25, 2025 10:10 PM - Karl Ho (GBA - Guymer Bailey Architects): Assigned to John Holland Delivery - Building  
Mar 25, 2025 10:09 PM - Karl Ho (GBA - Guymer Bailey Architects): The inadvertent of non-pick sealant which has covered the rivets is what I was defecting, Wasn't talking about the glazing beads. So please tidy up the aesthetically unappealing of the non-pick  
Mar 24, 2025 9:55 AM - Eddie Verhoef (John Holland Delivery - Building): Work Completed  
Mar 24, 2025 9:55 AM - Eddie Verhoef (John Holland Delivery - Building): Updated  
Mar 24, 2025 9:54 AM - Eddie Verhoef (John Holland Delivery - Building): Not defect. It appears that the architects' design did not account for the necessary tolerances for the glazing beads. The window mullions should have been designed with greater dimensions to facilitate maintenance of the glazing beads. In this case, the security requirements are prioritized over the architectural visual preferences. Furthermore, the junction between the glazing bead and the wall has been sealed with a non-pick sealant, which has inadvertently covered some of the rivets, resulting in a finish that is somewhat aesthetically unappealing.

Mar 19, 2025 7:19 AM - Matt Swift (Queensland Glass): Qldglass not sealing to the plaster  
Feb 27, 2025 9:18 AM - Desirae Jessup (John Holland Delivery - Building): Assigned to Queensland Glass  
Feb 27, 2025 8:06 AM - Luke Sawyer (Amalgamated Group): Painting is fine  
Caulking needs to be fixed  
Caulking not in our scope  
Feb 13, 2025 3:28 PM - Renarldo Richani (John Holland Delivery - Building): Assigned to Amalgamated Group  
Feb 4, 2025 9:41 PM - Karl Ho (GBA - Guymer Bailey Architects): Assigned to John Holland Delivery - Building  
Feb 4, 2025 9:41 PM - Karl Ho (GBA - Guymer Bailey Architects): Updated  
Feb 4, 2025 9:41 PM - Karl Ho (GBA - Guymer Bailey Architects): There is only one viewing window in the room. Refine all paint work and caulking around the entire window frame. No photo needed.  
Jan 7, 2025 3:54 PM - Katie Perri: Updated  
Dec 19, 2024 5:32 PM - Katie Perri: Updated  
Oct 21, 2024 5:58 PM - Muhammad Nadeem (John Holland Delivery - Building): Assigned to GBA - Guymer Bailey Architects

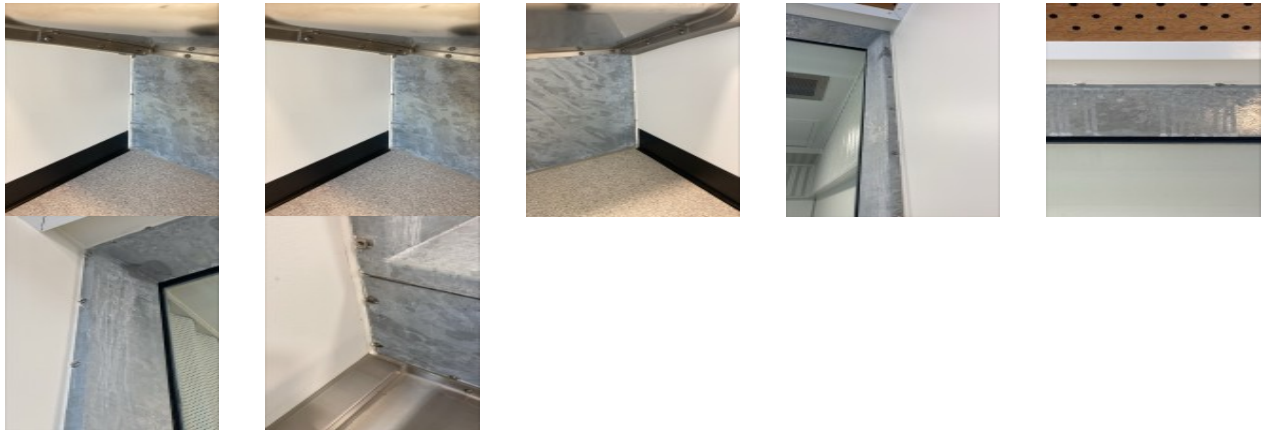
Apr 7, 2025 2:38 PM - Karl Ho (GBA - Guymer Bailey Architects): Photos attached  
Mar 31, 2025 1:31 PM - Ewelina Wdowikowska (John Holland Delivery - Infrastructure): Work Completed  
Mar 31, 2025 1:31 PM - Ewelina Wdowikowska (John Holland Delivery - Infrastructure): No photo provided. Please provide photo otherwise item to be closed.  
Mar 25, 2025 10:10 PM - Karl Ho (GBA - Guymer Bailey Architects): Assigned to John Holland Delivery - Building  
Mar 25, 2025 10:09 PM - Karl Ho (GBA - Guymer Bailey Architects): The inadvertent of non-pick sealant which has covered the rivets is what I was defecting, Wasn't talking about the glazing beads. So please tidy up the aesthetically unappealing of the non-pick  
Mar 24, 2025 9:55 AM - Eddie Verhoef (John Holland Delivery - Building): Work Completed  
Mar 24, 2025 9:55 AM - Eddie Verhoef (John Holland Delivery - Building): Updated  
Mar 24, 2025 9:54 AM - Eddie Verhoef (John Holland Delivery - Building): Not defect. It appears that the architects' design did not account for the necessary tolerances for the glazing beads. The window mullions should have been designed with greater dimensions to facilitate maintenance of the glazing beads. In this case, the security requirements are prioritized over the architectural visual preferences. Furthermore, the junction between the glazing bead and the wall has been sealed with a non-pick sealant, which has inadvertently covered some of the rivets, resulting in a finish that is somewhat aesthetically unappealing.

Mar 19, 2025 7:19 AM - Matt Swift (Queensland Glass): Not qldglass, we not sealing to plaster  
Feb 27, 2025 9:18 AM - Desirae Jessup (John Holland Delivery - Building): Assigned to Queensland Glass  
Feb 27, 2025 8:06 AM - Luke Sawyer (Amalgamated Group): Painting is fine  
Caulking needs to be fixed  
Caulking not in our scope  
Feb 13, 2025 3:28 PM - Renarldo Richani (John Holland Delivery - Building): Assigned to Amalgamated Group  
Feb 4, 2025 9:40 PM - Karl Ho (GBA - Guymer Bailey Architects): Assigned to John Holland Delivery - Building  
Feb 4, 2025 9:40 PM - Karl Ho (GBA - Guymer Bailey Architects): Updated  
Feb 4, 2025 9:40 PM - Karl Ho (GBA - Guymer Bailey Architects): There is only one viewing window in the room. Refine all paint work and caulking around the entire window frame. No photo needed.  
Jan 7, 2025 3:54 PM - Katie Perri: Updated  
Dec 19, 2024 5:32 PM - Katie Perri: Updated

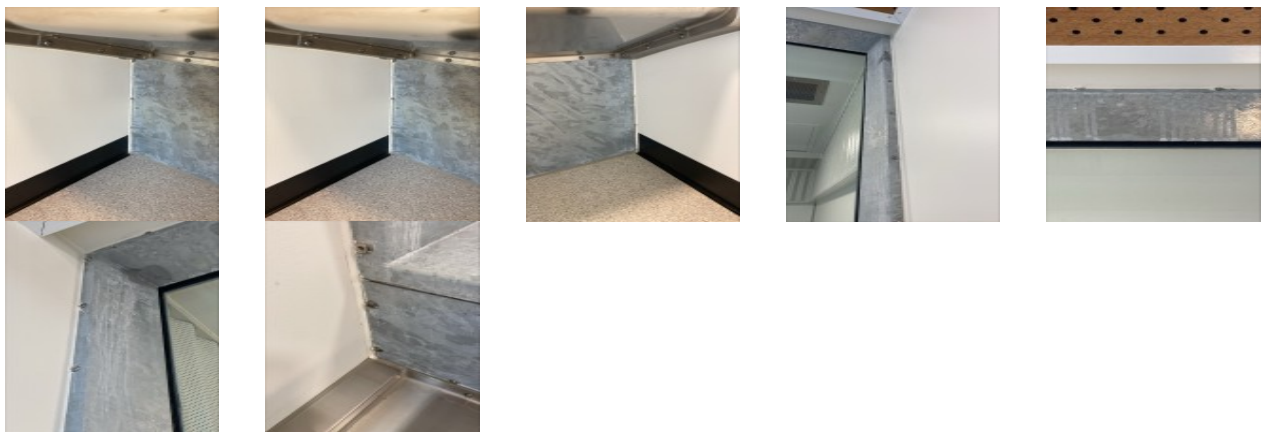
Mar 25, 2025 10:09 PM - Karl Ho (GBA - Guymer Bailey Architects): The inadvertent of non-pick sealant which has covered the rivets is what I was defecting, Wasn't talking about the glazing beads. So please tidy up the aesthetically unappealing of the non-pick

Mar 24, 2025 9:54 AM - Eddie Verhoef (John Holland Delivery - Building): Not defect. It appears that the architects' design did not account for the necessary tolerances for the glazing beads. The window mullions should have been designed with greater dimensions to facilitate maintenance of the glazing beads. In this case, the security requirements are prioritized over the architectural visual preferences. Furthermore, the junction between the glazing bead and the wall has been sealed with a non-pick sealant, which has inadvertently covered some of the rivets, resulting in a finish that is somewhat aesthetically unappealing.

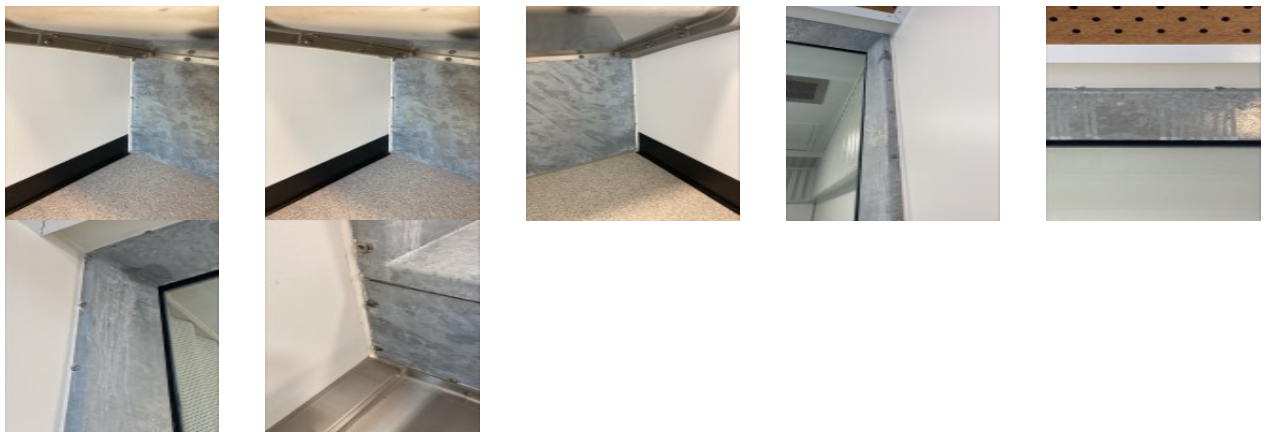
Mar 25, 2025 10:09 PM - Karl Ho (GBA - Guymer Bailey Architects): The inadvertent of non-pick sealant which has covered the rivets is what I was defecting, Wasn't talking about the glazing beads. So please tidy up the aesthetically unappealing of the non-pick

Mar 24, 2025 9:53 AM - Eddie Verhoef (John Holland Delivery - Building): Not defect. It appears that the architects' design did not account for the necessary tolerances for the glazing beads. The window mullions should have been designed with greater dimensions to facilitate maintenance of the glazing beads. In this case, the security requirements are prioritized over the architectural visual preferences. Furthermore, the junction between the glazing bead and the wall has been sealed with a non-pick sealant, which has inadvertently covered some of the rivets, resulting in a finish that is somewhat aesthetically unappealing.

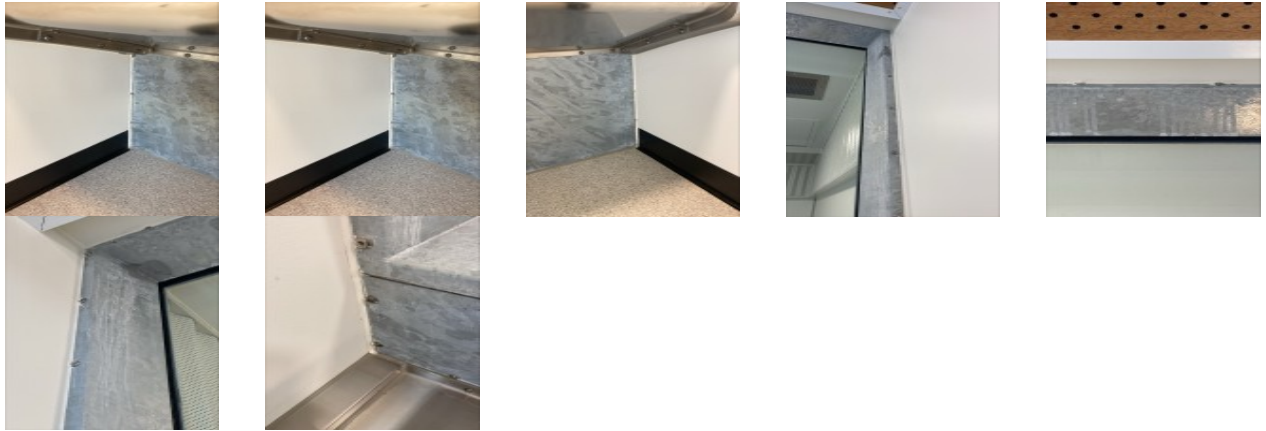
Mar 25, 2025 10:09 PM - Karl Ho (GBA - Guymer Bailey Architects): The inadvertent of non-pick sealant which has covered the rivets is what I was defecting, Wasn't talking about the glazing beads. So please tidy up the aesthetically unappealing of the non-pick

Mar 24, 2025 9:51 AM - Eddie Verhoef (John Holland Delivery - Building): Not a defect. It appears that the architects' design did not account for the necessary tolerances for the glazing beads. The window mullions should have been designed with greater dimensions to facilitate maintenance of the glazing beads. In this case, the security requirements are prioritized over the architectural visual preferences. Furthermore, the junction between the glazing bead and the wall has been sealed with a non-pick sealant, which has inadvertently covered some of the rivets, resulting in a finish that is somewhat aesthetically unappealing.
