Core4 Services  
9a/62 Bishop St,  
Kelvin Grove QLD 4059

13<sup>th</sup> Jun 2024  
Job No. S5466

## Concrete Remedial Works - 85 Deakin St, Kangaroo Point

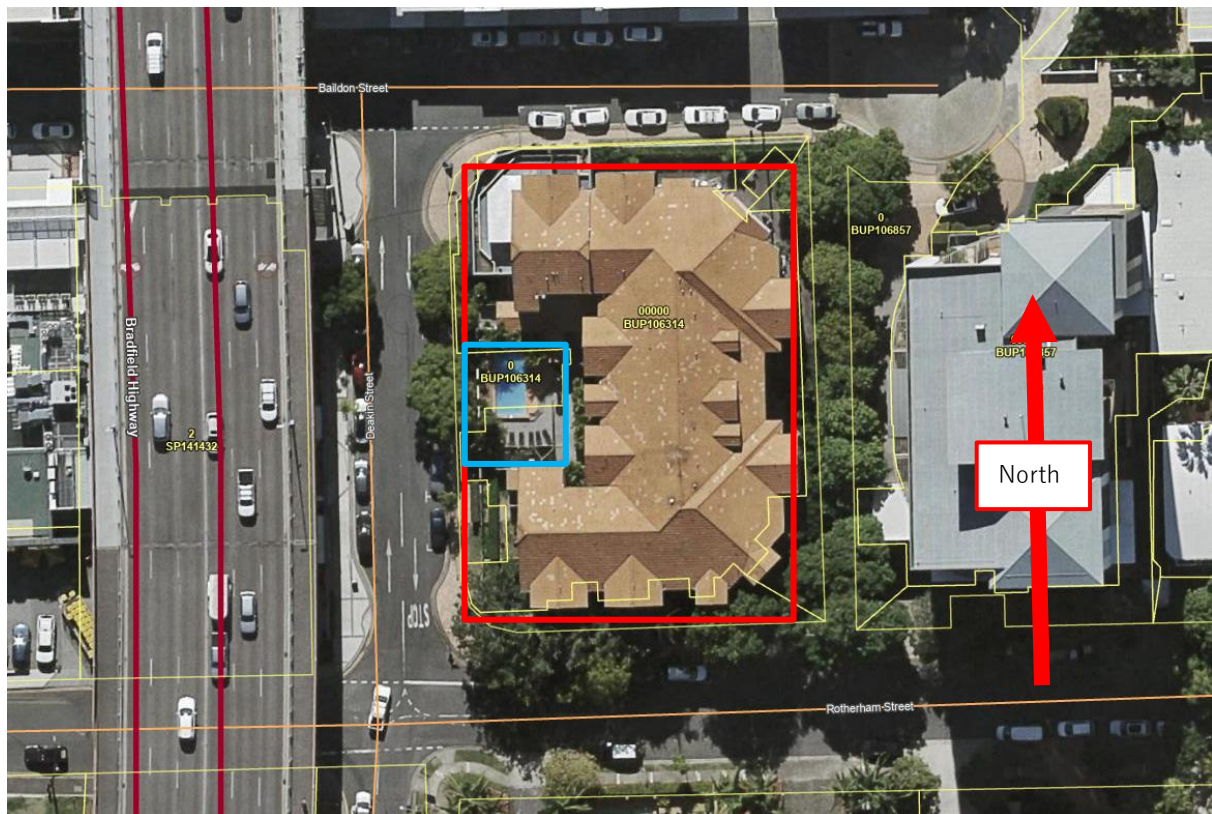
The pool on the ground floor above is supported by a concrete beam on each side, the concrete beam as indicated in figure 1, has sever concrete cancer. Large cracks approx. 3-5mm in width can be seen along the length of the beam, refer photo 17-20

**FIGURE 1:** Site Plan: 85 Deakin St. Kangaroo Point - Red outline indicates site, blue indicates focus of investigation
